Appendix A

Park Inventory and Assessment Report

Dubuque
Parks and Recreation
Comprehensive Plan

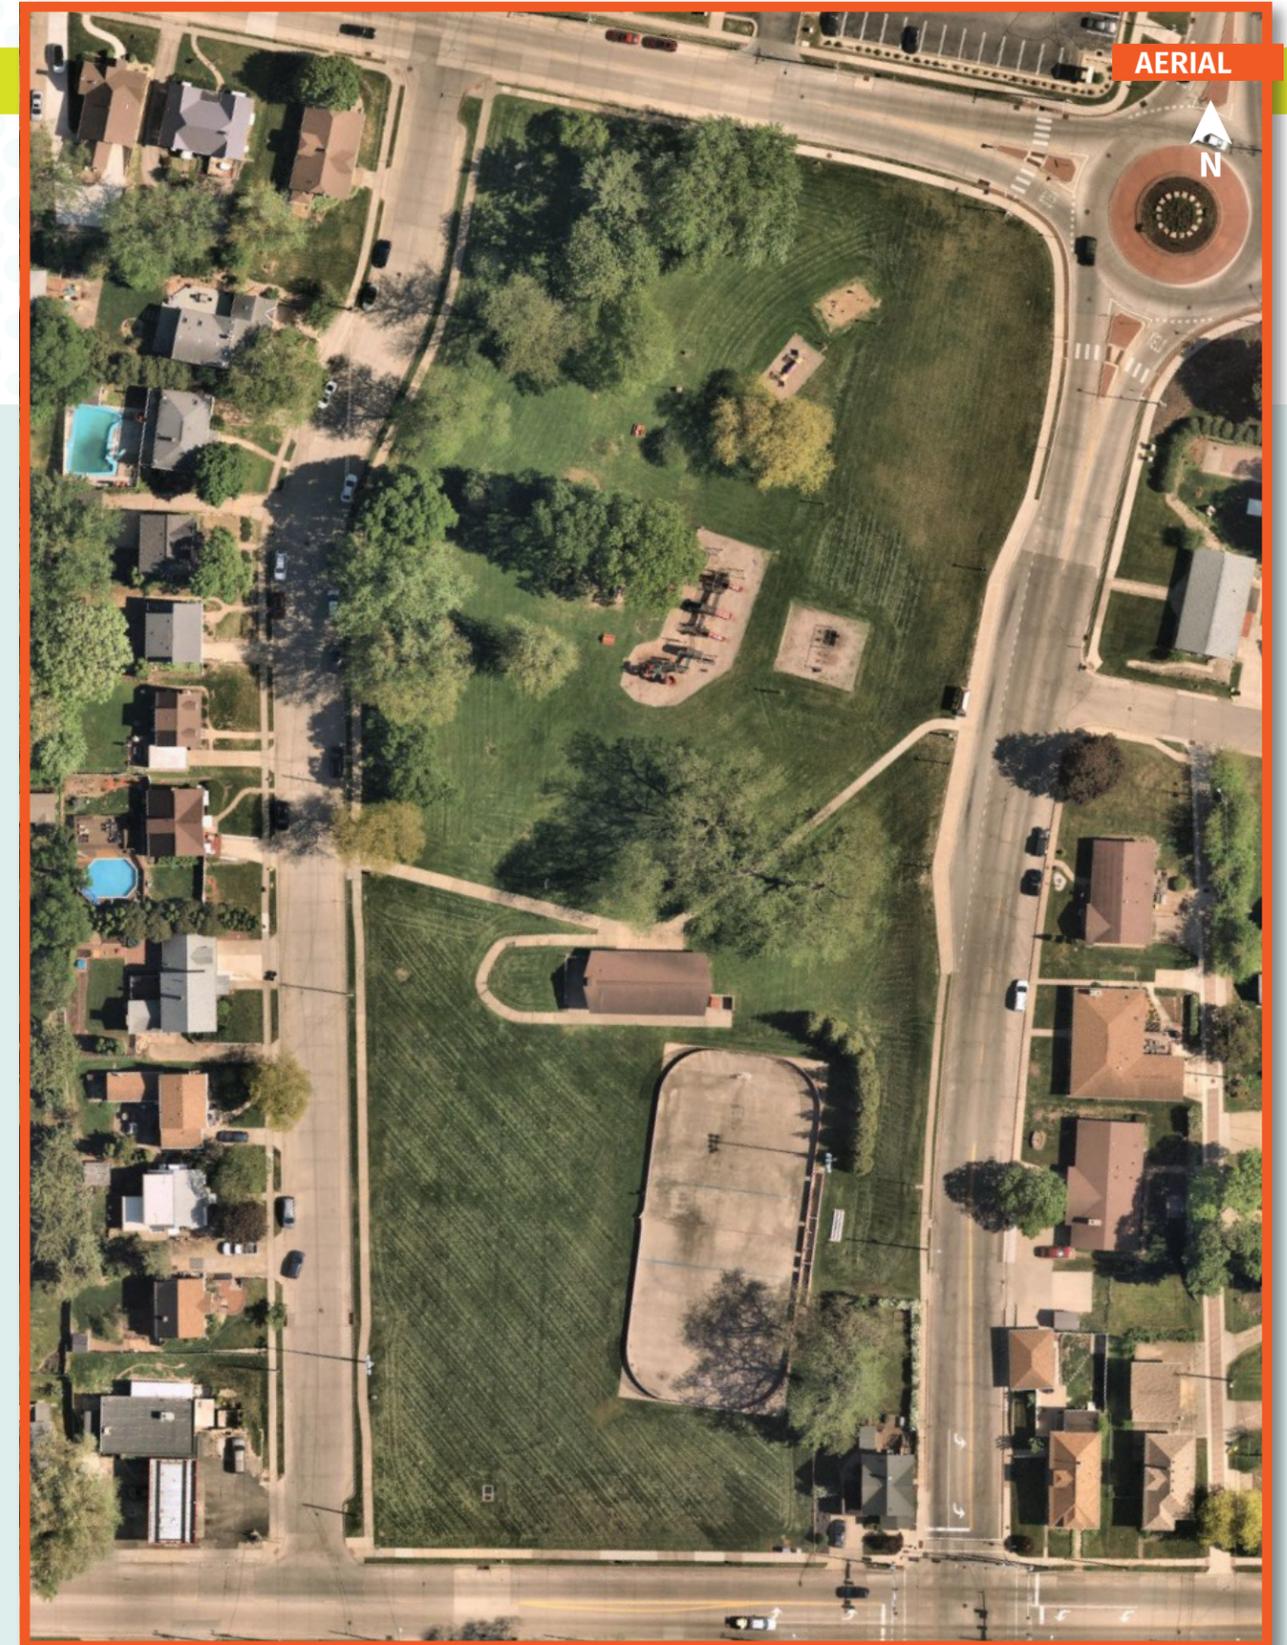
Allison Henderson Park is a centrally located 5.2-acre park with various amenities. These include swing sets, playgrounds, a hockey rink, digging equipment for toddlers, and a multipurpose building with open classroom space. All the playground equipment is in decent shape with only minor wear present. ADA access to the play equipment, and most of the park is nonexistent. The park has large open spaces and big, mature trees provide nice shade to areas in the park.

AMENITY TYPE	QTY	GRADE	NOTES
Drinking Fountain	1	4	ADA. Some wear and rusting.
Lighting	8	2	Major wear, not all LED/2 stadium lights around hockey rink.
Other	1	4	Hockey rink. Concrete is in good shape.
Other	2,135 SF	4	Multipurpose building, great condition.
Security Camera	1	5	Camera mounted on pole.
Other	1	4	Emergency 911 beacon. Minor wear.
Pet Waste Station	1	4	
Picnic Table (Metal)	2	3	Some wear, no ADA.
Picnic Table (Wood)	4	3	
Playground (5-12)	1	3	Lacks ADA access.
Playground (2-5)	1	3	2-5 age play area. Decent shape. No access.
Playground Equipment	4	3	2 spring rockers/2 sand diggers. Decent condition.
Playground Surfacing (Wood Mulch)	6,225 SF	1	Needs refreshed, but decent condition.
Retaining Wall (Railroad Tie)	85 LF	2	Appears to be failing/old.
Sidewalk (Plain Grey)	4,950 SF	3	Concrete sidewalk panels cracked, tripping hazard.
Swing (2 Bay)	1	3	Two regular, two tot swings. Wearing and rusting.

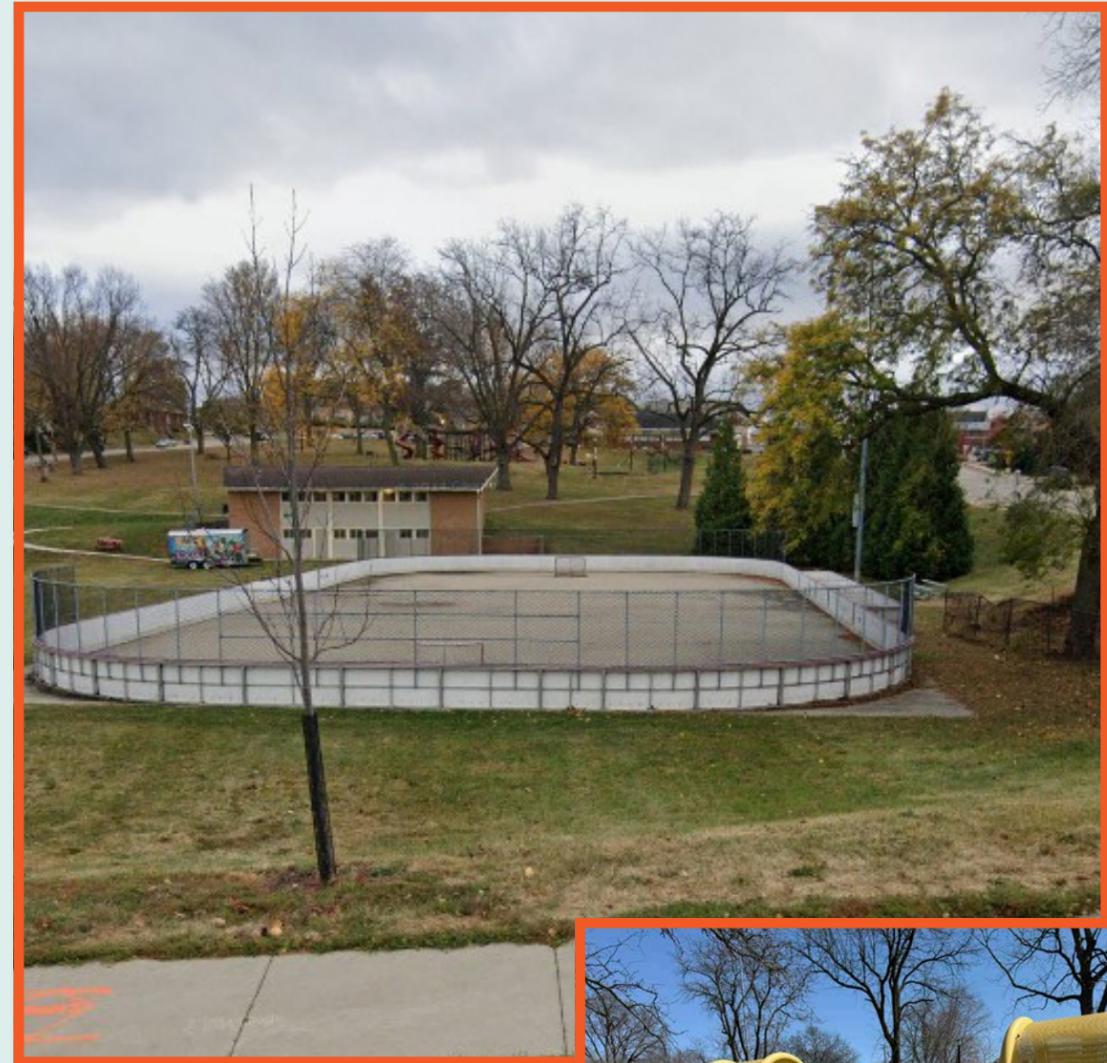
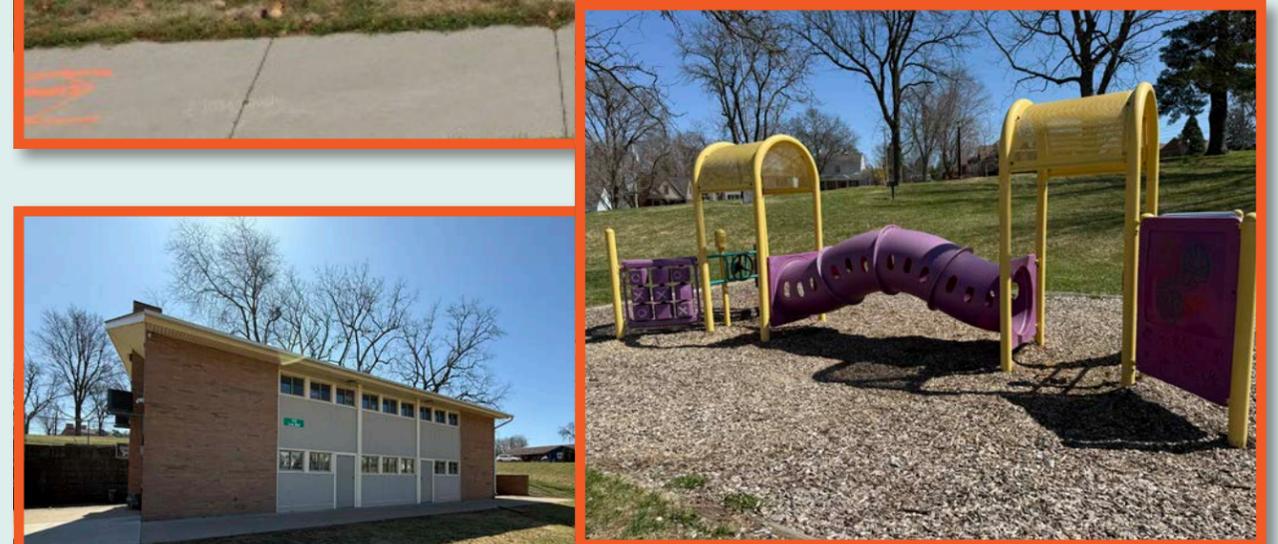
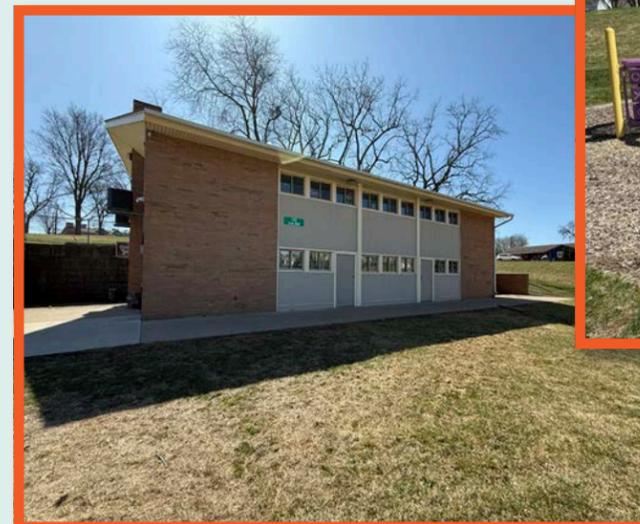
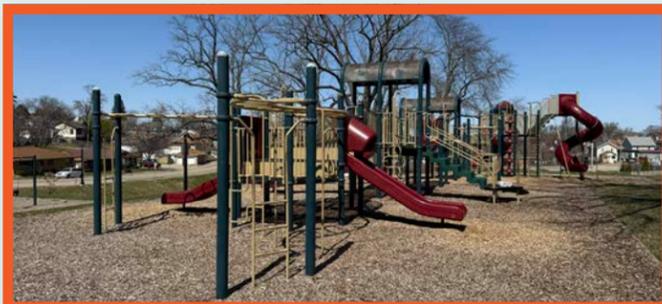
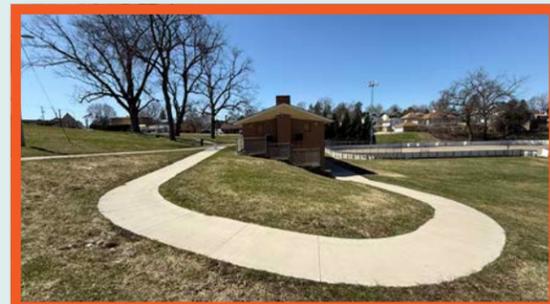
Sign (Monumentation)	1	4	Stone monument sign, good condition.
Sign (Traffic style with post)	4	5	Park hours sign, new.
Trash, Plastic Roller Bin	2	3	Decent condition

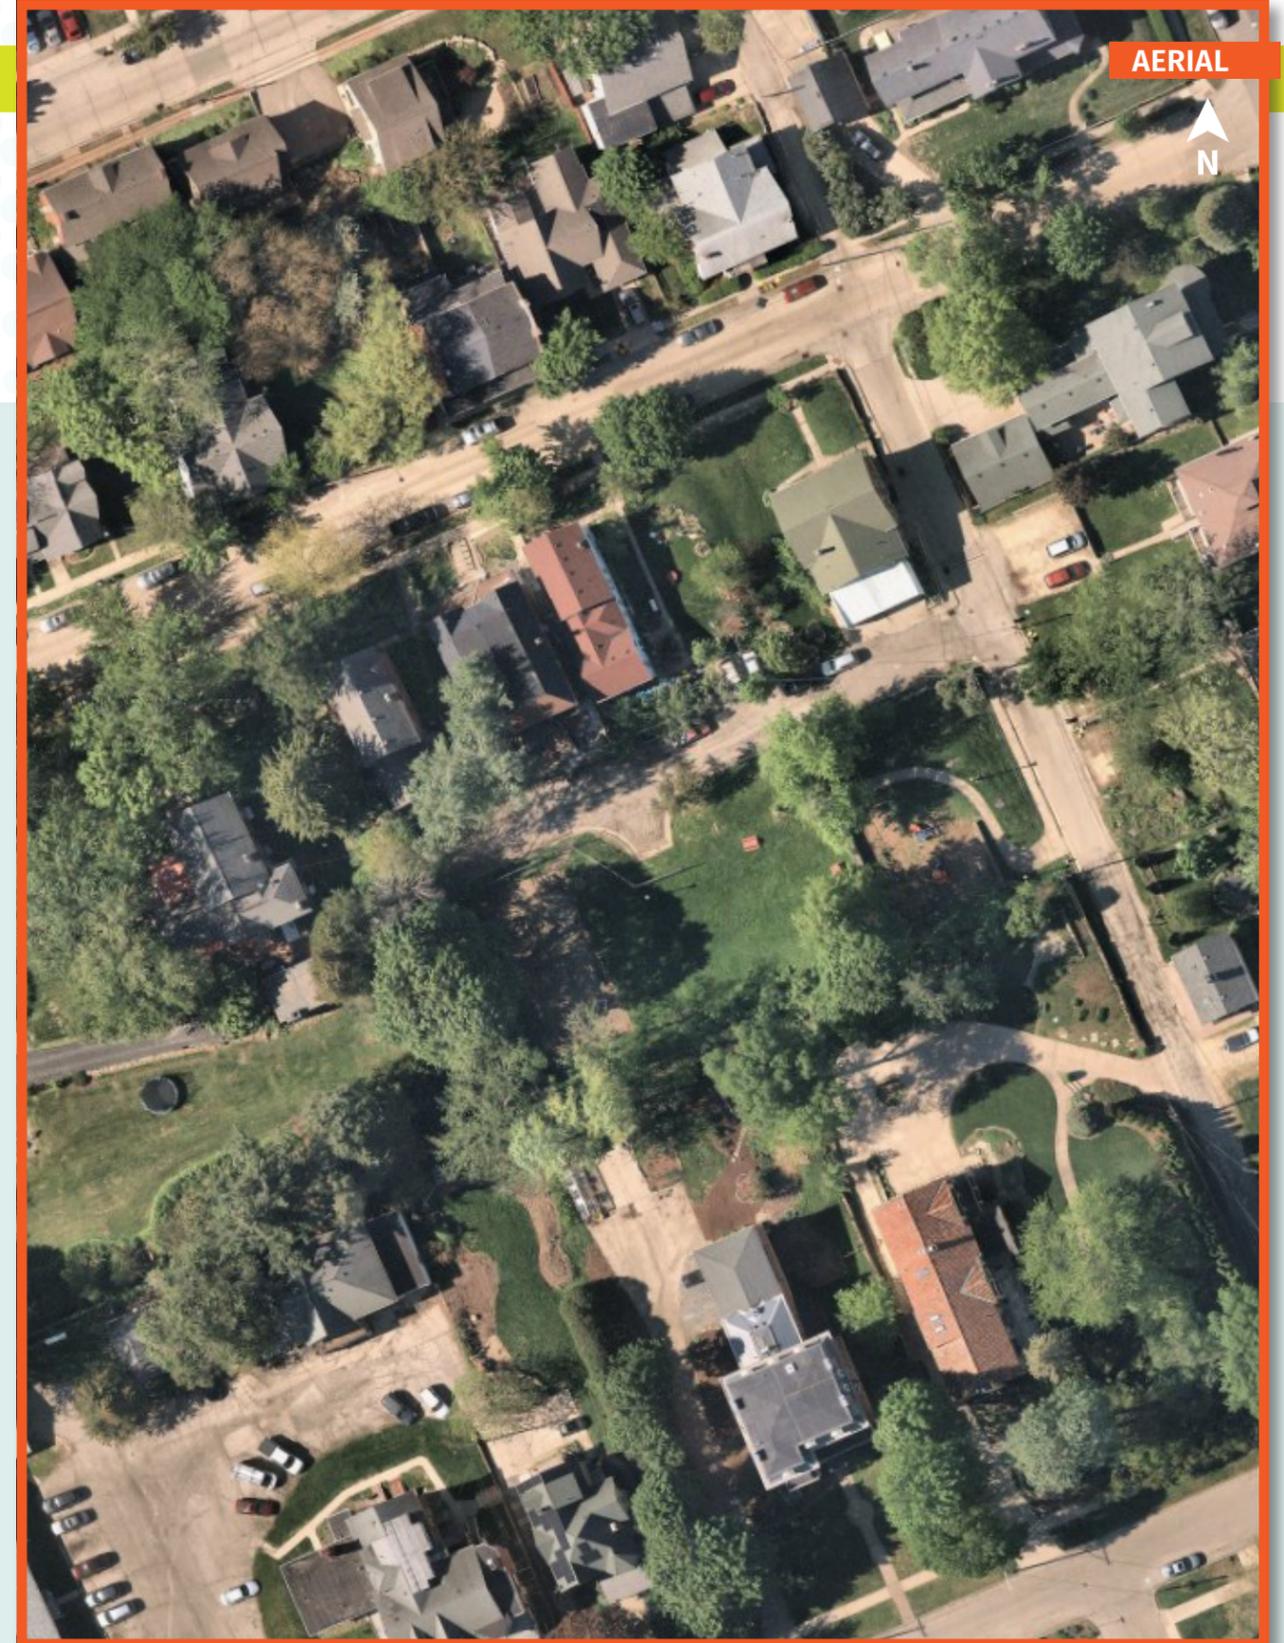
Avon Park includes several amenities such as benches, trash receptacles, a playground, a drinking fountain, and a basketball court. The park's benches show varying conditions with chipping and some rusting. Trash bins are generally in decent shape. The playground is a small tot lot in new condition with a fresh rubberized surface but lacks shade. Walkway lighting fixtures, though older and with some paint chipping, are functional. The basketball court has an unscripted surface with minor heaving and cracking issues. The park has a cozy neighborhood feel and is flanked by a large beautiful retaining wall.

AMENITY TYPE	QTY	GRADE	NOTES
Basketball Goal (Rim, Backboard, Net Pole)	2	4	Great condition.
Basketball Court Surface (Asphalt)	3,100 SF	3	No striping, some cracking.
Bench	3	2	Some rusting, chipping.
Chain Link Fence	455 LF	2	Okay condition, overgrown in some areas with plants.
Drinking Fountain 1 bubbler	1	3	Good condition.
Lighting Pathway	5	3	Older fixture model, some paint chipping.
Picnic Table (Wood)	2	3	Decent condition.
Playground Equipment (tot Lot 2-5 Years)	1	4	Small tot lot, new condition, new pour-in-place surfacing, no shade.
Playground Surface (Rubberized Surface)	1,280 SF	4	Good condition.
Playground curb turndown	150 LF		
Retaining Wall Stone <3 ft.	365 LF	3	
Sidewalk Plain Grey	670 SF	3	Decent condition.
Sign Specialty / Memorial	1	4	Park name sign attached to retaining wall.
Sign (Traffic style)	3	3	Traffic style park name signs and Park rules signs.
Trash Plastic Roller Bin	3	3

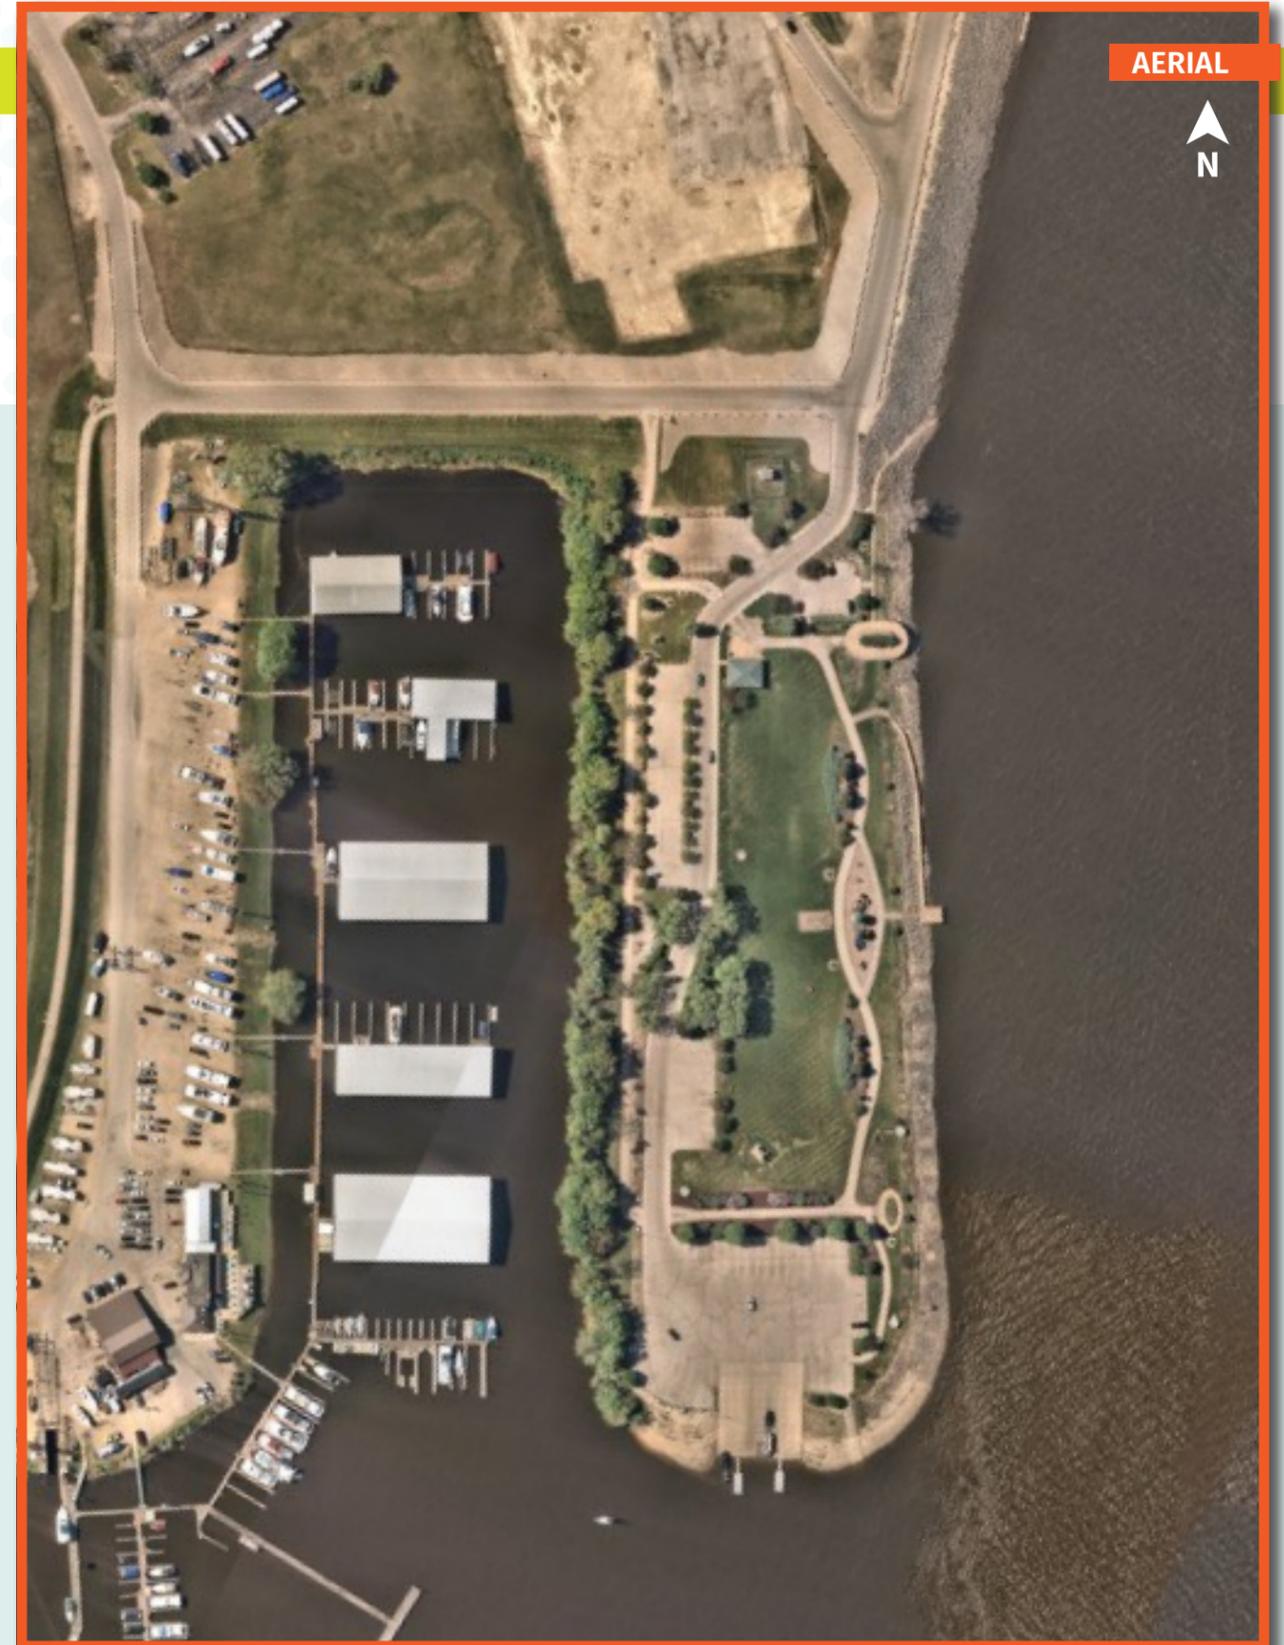
AY McDonald Park is a very nice open community park directly on the Mississippi River. There are multiple lighted parking lots and extended parking spaces for boat trailers. Some of the play equipment feels dated but overall it is in great condition. ADA-accessible paths encircle the park offering access to all and plenty of opportunities to take in the amazing views of the river. Although it is slightly out of the way from residential areas, it is a key stopping point along the Dubuque bike paths.

AMENITY TYPE	QTY	GRADE	NOTES
Bench	11	4	Three new benches, remainder are heavily worn.
Bike Rack	2	2	Rusting, exposed metal, chipped coating.
Bollard (Stone)	75	4	
Drinking Fountain with Bottle Filler	1	3	Building attached, ADA, regular and pet fountain.
Electric Pedestal (50 AMP)	10	N/A	
Lighting Bollard	11	3	Bollard lighting with concrete foundation. Decent condition, some wear present.
Lighting Parking	7	4	25' Light, LED. Some wear, decent condition.
Lighting Pathway	9	3	Metal pole with ornate glass housing.
Other	1	4	Art installation with plaque, not ADA.
Parking - Asphalt with Striping	117,000 SF	3	Faded striping, cracks present 1/4"+, drainage issues.
Picnic Table (Metal/Wood)	8	2	4 metal picnic tables, 4 wood picnic tables rusting, exposed metal, chipped coating, no ADA.
Pier Dock	350 SF	5	
Playground 5-12 years	1	2	Lacks ADA access.
Playground Equipment (Small)	5	2	Small playground equipment, spinners and rockers.

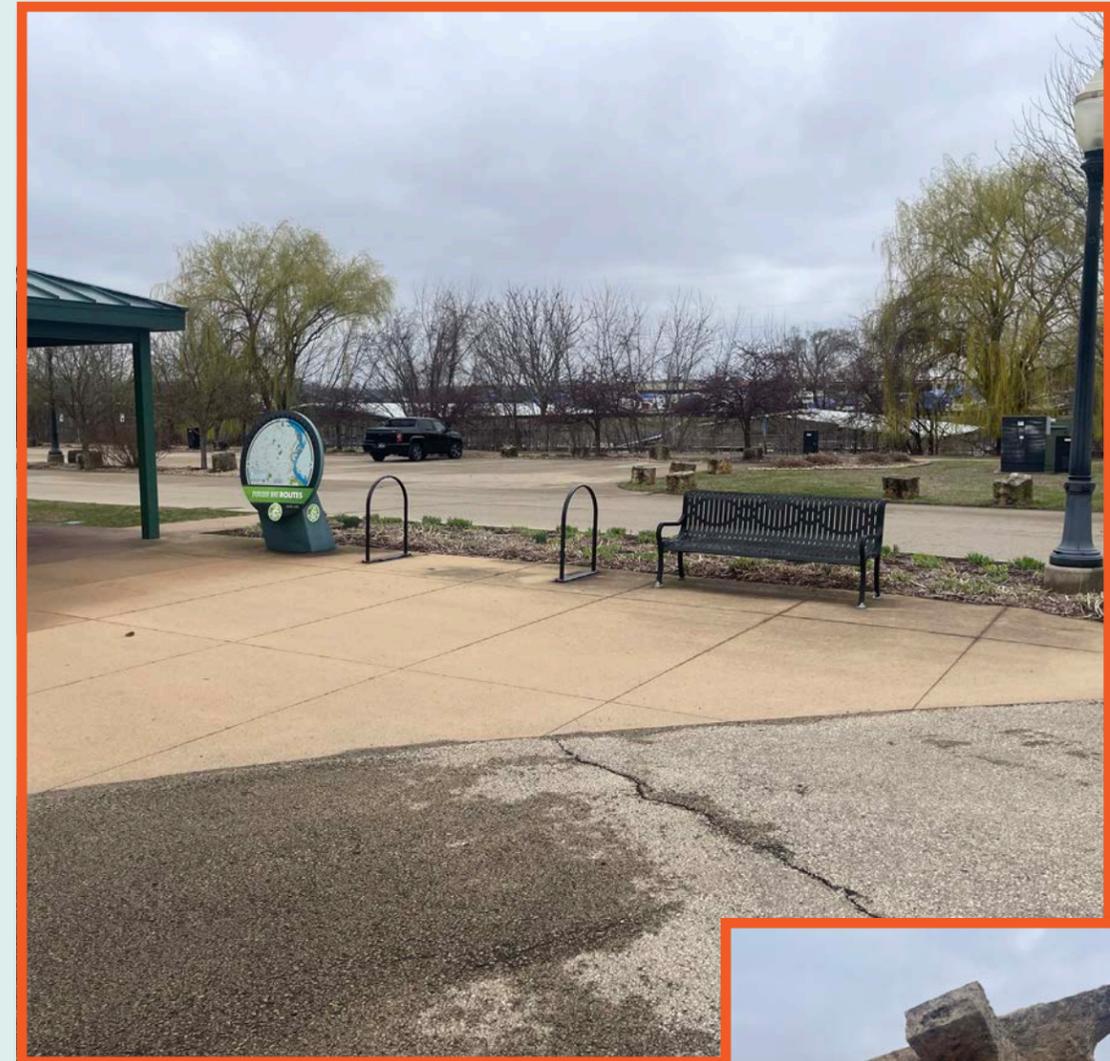
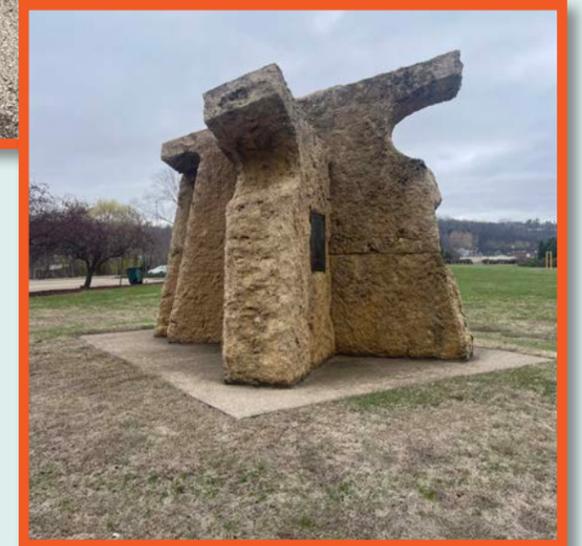
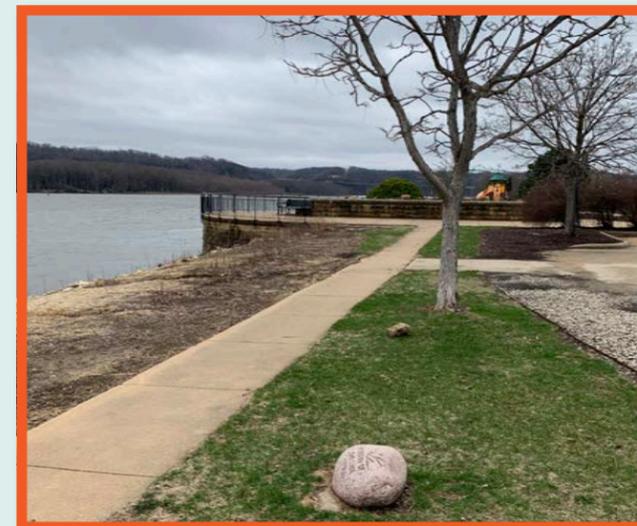
AY MCDONALD PARK

Playground Equipment (Swings 1 - Bay)	2	2	
Playground surfacing (Wood Mulch)	3,600 SF	1	Wood mulch needs refreshed.
Railing	390 LF	4	Wrought iron railing around viewing platform. Good condition.
Restroom	1,385 SF	3	
Retaining Wall	405 LF	4	Type 2 <3 ft. 70LF, type 1 Concrete 245 LF, Type 3 Stone >3 ft, 90 LF
Sidewalk (Integral Color)	7,000 SF	4	
Sign (Specialty/Dubuque Bike Map/Interpretive Sign)	3	3	AY McDonald sign in parking area/Dubuque bike map and interpretive sign.
Sign (Traffic Style)	7	3	Different park signage, decent condition.
Swing (1 Bay)	1	3	Wear on frame.
Trail (Paved Asphalt)	3,000 LF	3	Decent condition.
Trash Plastic Roller Bin	9	3	Some rusting, some chipping, faded/worn.

AMENITY TYPE	QTY	GRADE	NOTES
Planter (Raised) Type 1 (24")	75 LF	4	Raised Planter Limestone (Ht=24-inches)
Planter (Raised) Type 2 (36-inch)	100 LF	4	Raised Planter Limestone (Ht=32-inches)
Retaining Wall, Type 1 - Concrete	245 LF	5	
Retaining Wall, Type 2 - Stone (<3 ft)	70 LF	4	Block Retaining Wall (Ht=8ft)
Retaining Wall, Type 3 - Stone (>3 ft)	90	4	Block Retaining Wall (Ht=10ft)
Sign (Interpretive Display with Post and Footing)	1	4	
Sign (Plaque)	2	4	Plaque at AY McDonald Monument Sign and at Art Installation.

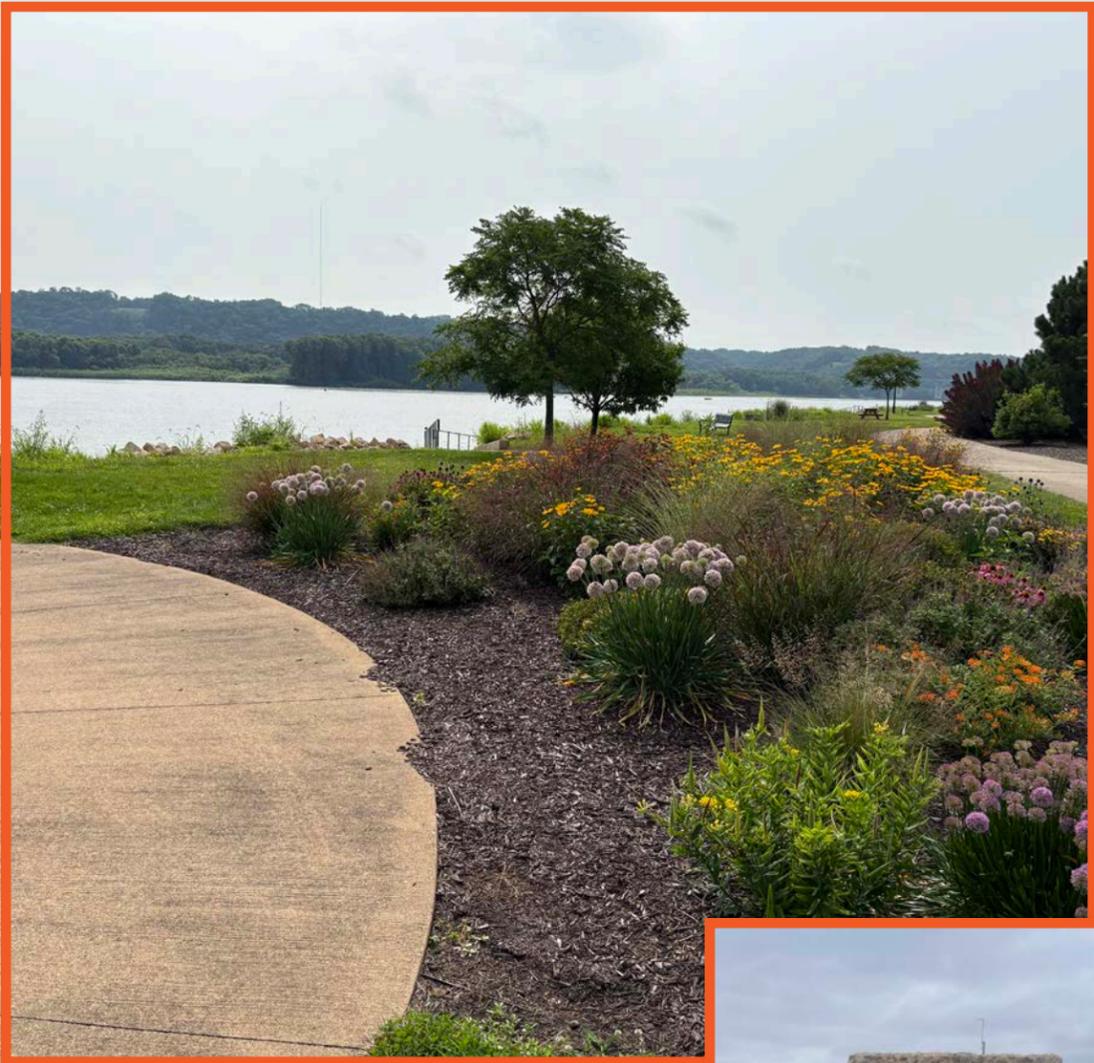
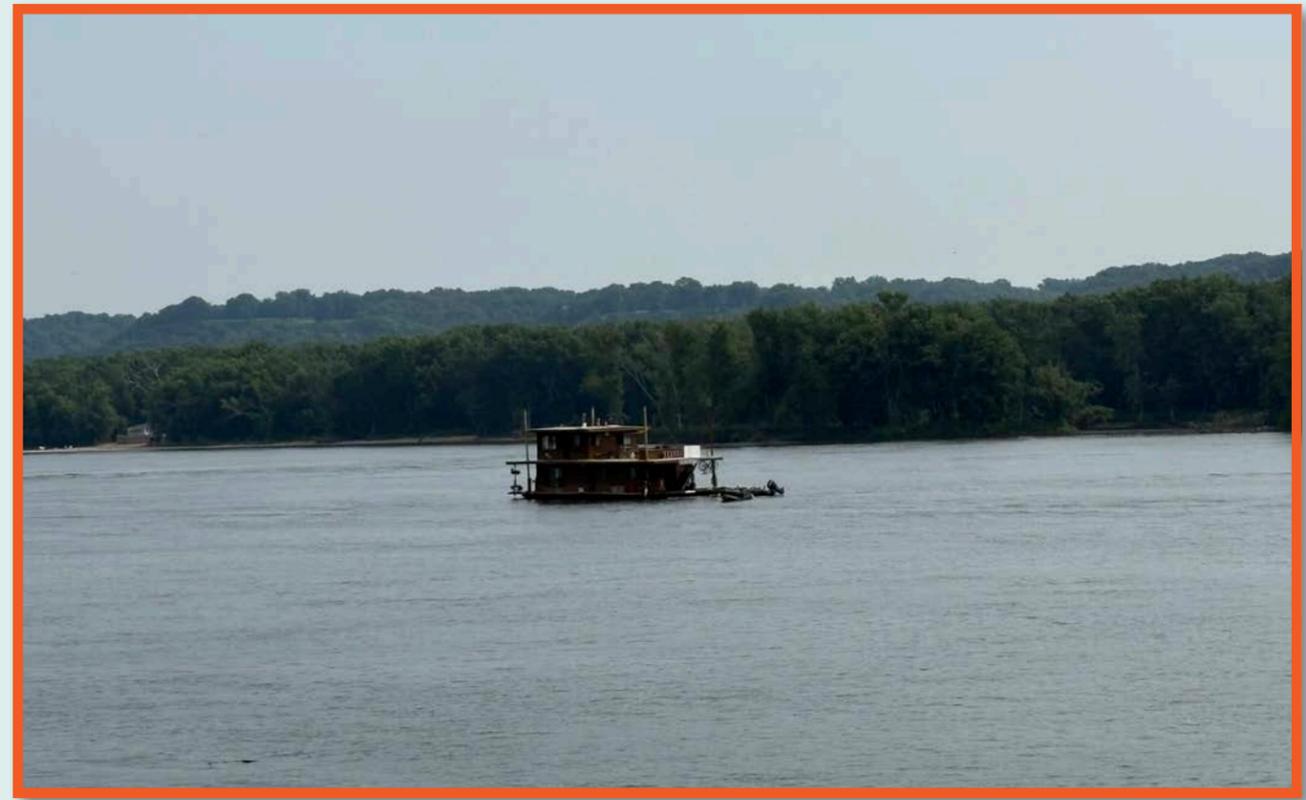
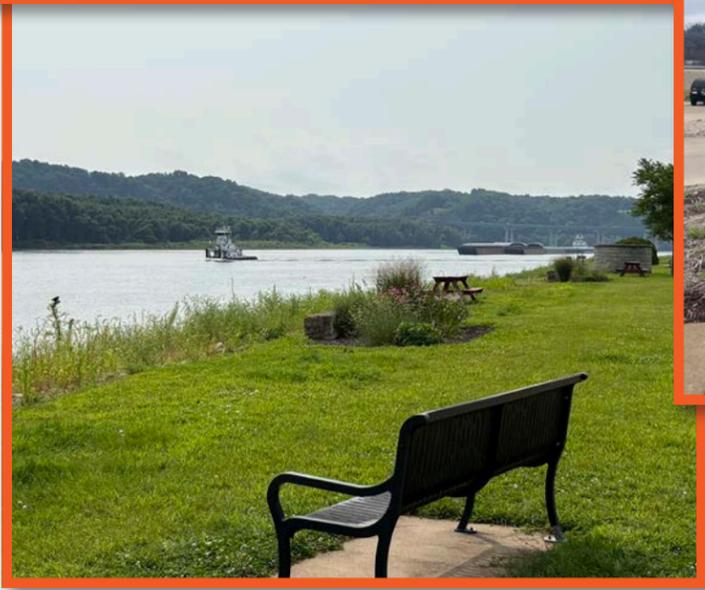
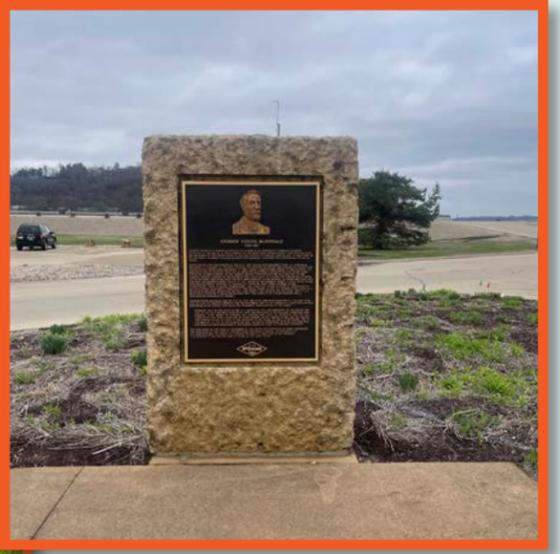
BEE BRANCH GREENWAY

Bee Branch Greenway offers walking, biking, and play opportunities around a multi-use trail connecting Chaplain Schmitt Island with Dubuque's North End. The greenway functions as both a beautiful linear park and a green infrastructure system to control flooding. Various overlooks highlight views of the Mississippi River, and an outdoor amphitheater, rest and seating areas, and a bioswale board walk offer respite areas. Most amenities within the linear park are new or well-maintained, with minor wear and erosion. The greenway is part of the Bee Branch Watershed Flood Mitigation Project to help improve water quality and management, and stimulate investment within the Bee Branch Watershed.

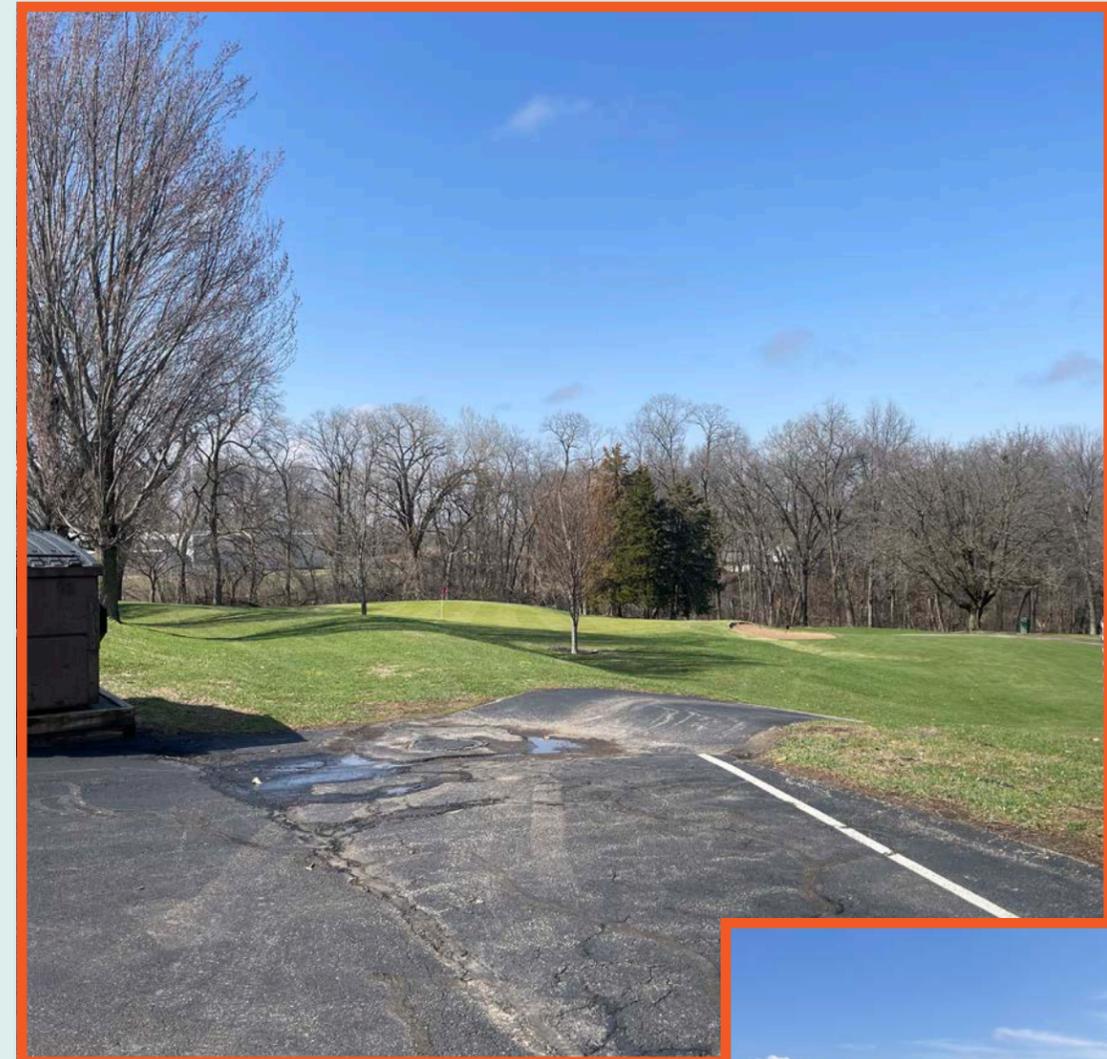
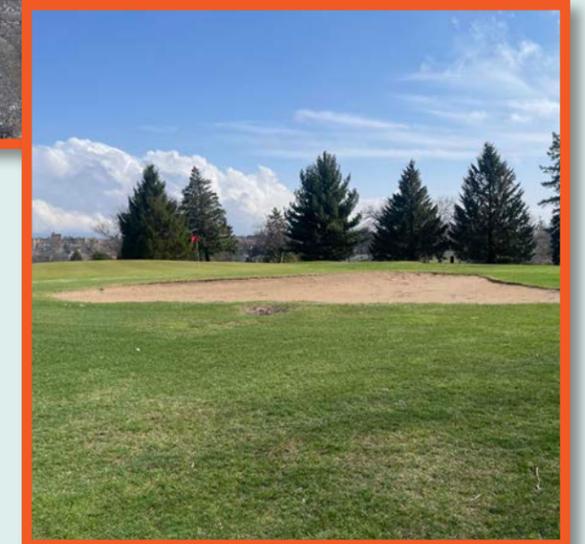
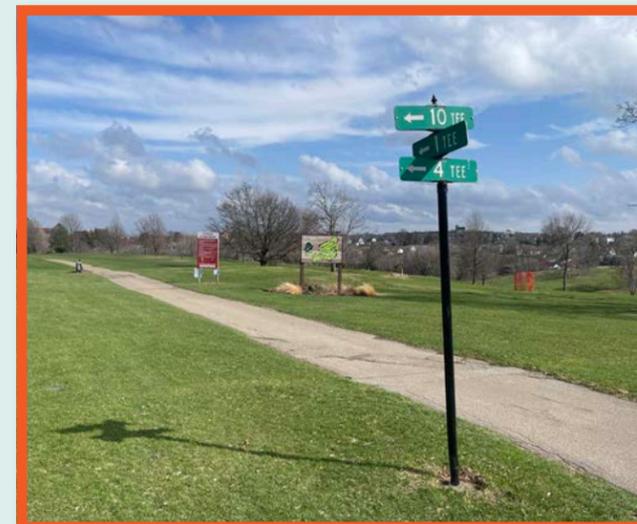
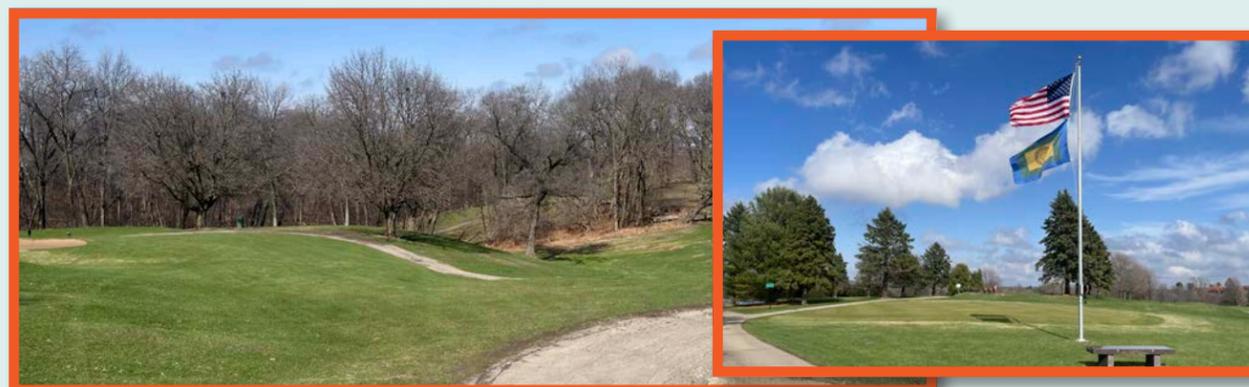
Bunker Hill Golf Course offers affordable golf rates for the public and is overall a nice looking course. The clubhouse is warm and inviting with a stocked pro shop and lots of food and drink options. The parking lot was in poor shape and the surrounding maintenance areas, although functional, did not mirror the same beauty as the course.

AMENITY TYPE	QTY	GRADE	NOTES
Bench (Golf)	12	4	
Bench (Memorial)	1	4	Granite bench, great condition.
Bench (Wrought-Iron Without Back)	15	2	Rust and signs of wear present.
Golf Ball Washer With Trash Can	12	4	
Golf Irrigation System Complete	4,800,000 SF	3	
Lighting Parking	1	3	One fixture in parking lot, wooden pole.
Maintenance Yard	4,945 SF	2	Superficial damage to metal exterior, paint chipping on buildings.
Parking (Asphalt With Striping)	44,640 SF	3	Large cracks 1/2"+, has been patched previously.
Pavilion Open	2	4	
Retaining Wall, Type 4 - Keystone Block	60 LF	4	
Sign (Golf Hole)	18	4	
Sign (Monumentation With Planter)	2	4	Wooden park sign at the end of its life, needs replaced with Dubuque City Monumentation standard.
Sign (Traffic With Post)	10	3	Fading, cracking, signs of wear.
Trash Plastic Roller Bin	3	2	Rusting, fading.
Trail (Paved)	7,350 SF	4	8' Wide Asphalt pathway

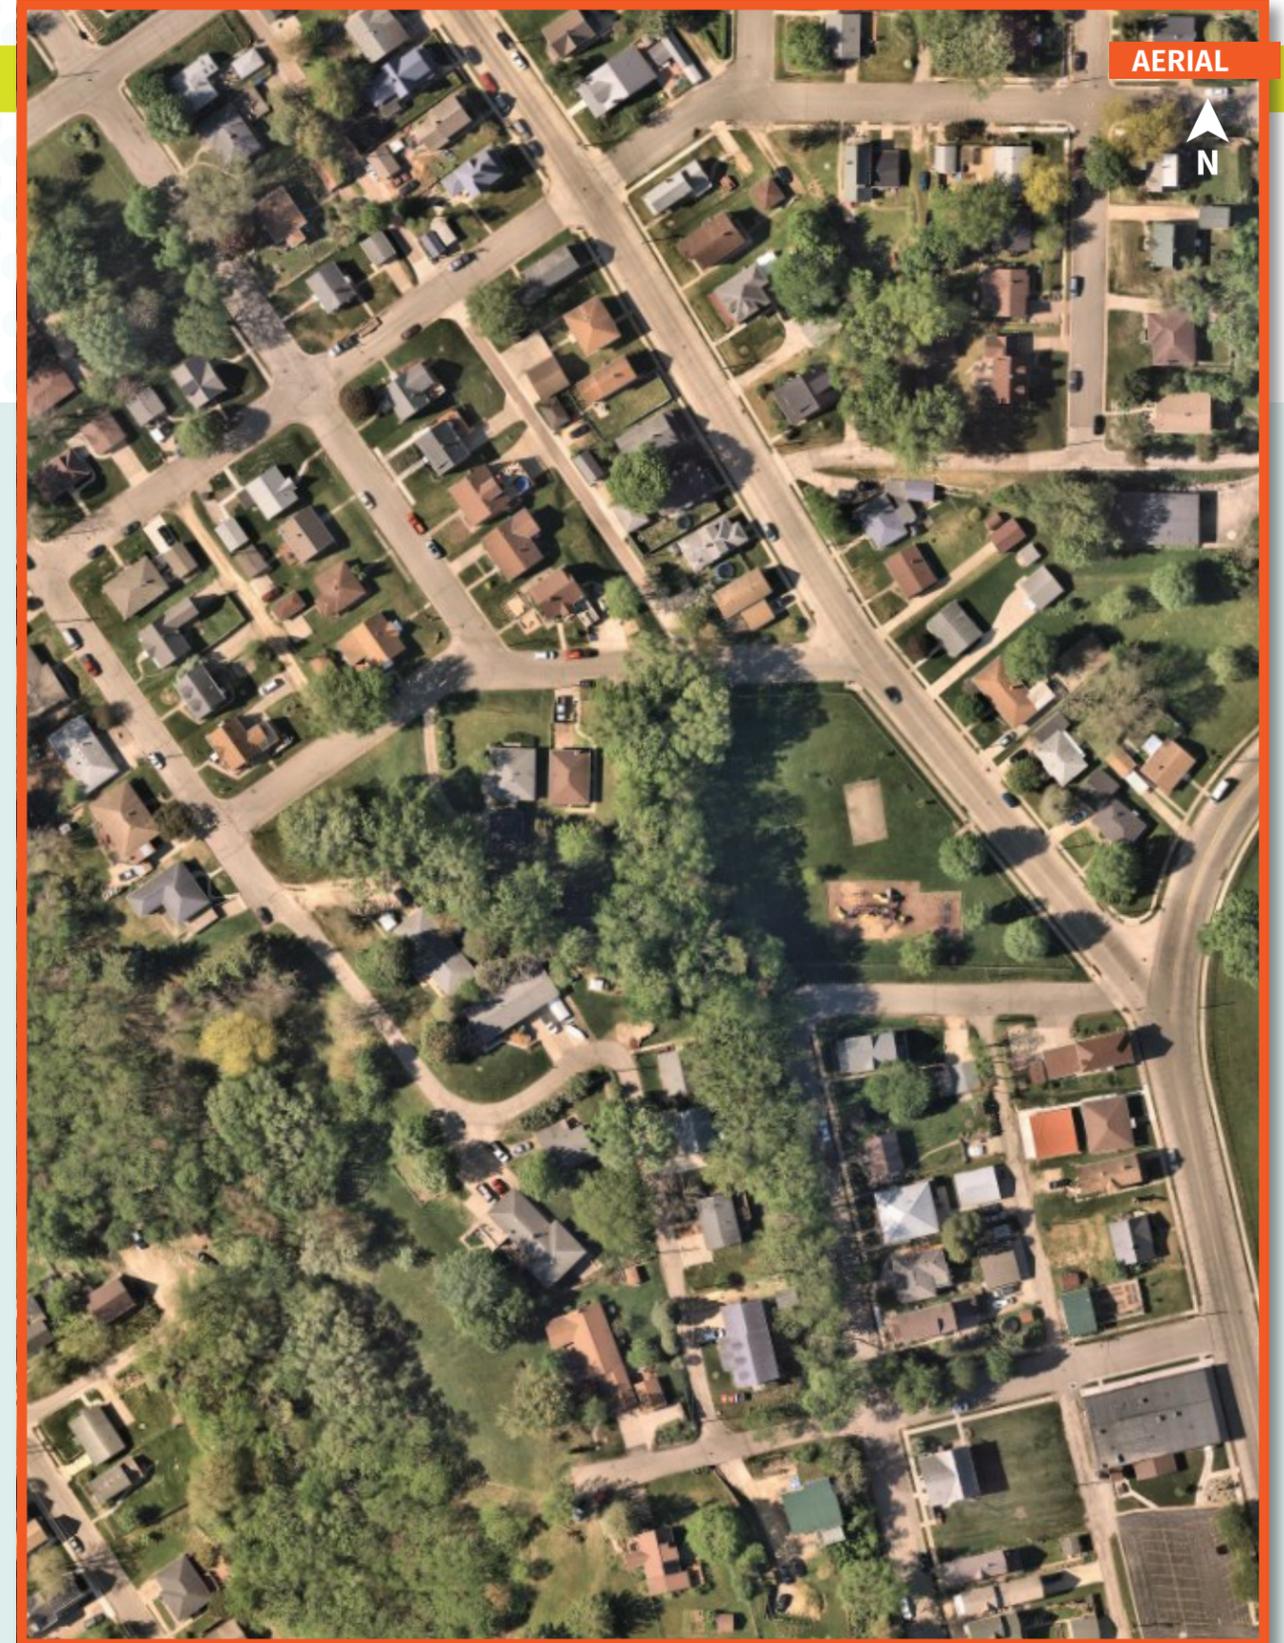
Burden Park offers amenities such as picnic tables, a swing set, playground, and basketball court. The swing set has rust issues and the playground equipment is visibly rusting, dented, and scratched, with low wood chip coverage. The picnic tables are severely rusting. The basketball court is in poor condition with cracked asphalt, no striping. Unfortunately ADA access ends at the park entrance and no amenities on site are readily accessible.

AMENITY TYPE	QTY	GRADE	NOTES
Basketball (Backboard, Net, Pole)	1	5	Good, looks new.
Basketball Court Surface	1,450 SF	2	Asphalt, cracking, not striped, no ADA access.
Bench (Wrought Iron w/o Back)	1	2	No ADA access.
Chain Link Fence	785 LF	3	
Picnic Table (Metal)	2	2	No ADA access, rusting.
Picnic Table (Wood)	3	3	
Playground 5-12 Years	1	2	No ADA access, rusting, denting.
Playground Surfacing (Wood Mulch)	4,365 SF	1	Wood mulch needs replaced.
Playground Equipment Swings (2 Bay)	1	2	Rust present.
Sign Monumentation	1	1	Wooden park sign at the end of its life, needs replaced with Dubuque City Monumentation standard.
Trash - Plastic Roller Bin	1	4
