Appendix A

Park Inventory and Assessment Report

Dubuque
Parks and Recreation
Comprehensive Plan

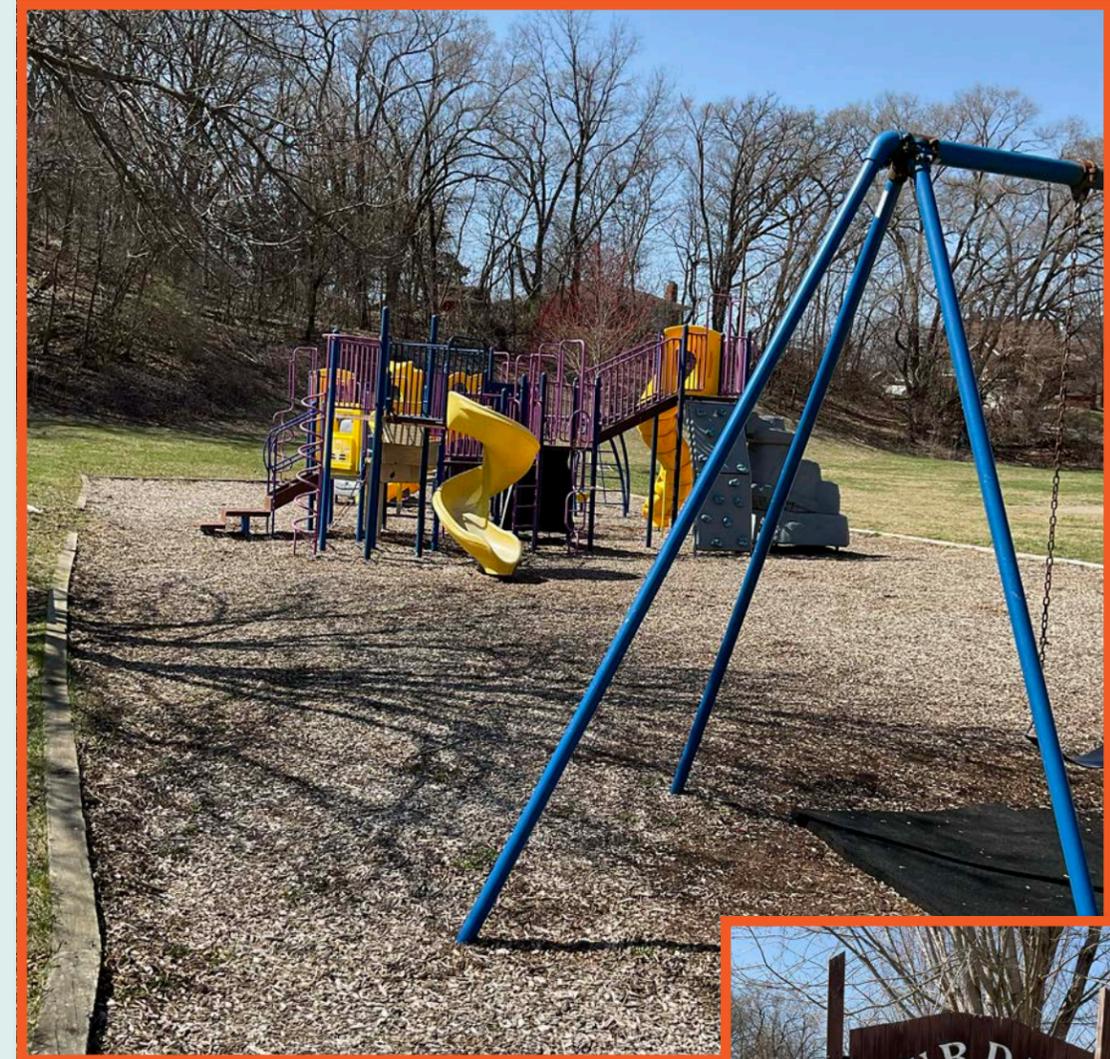
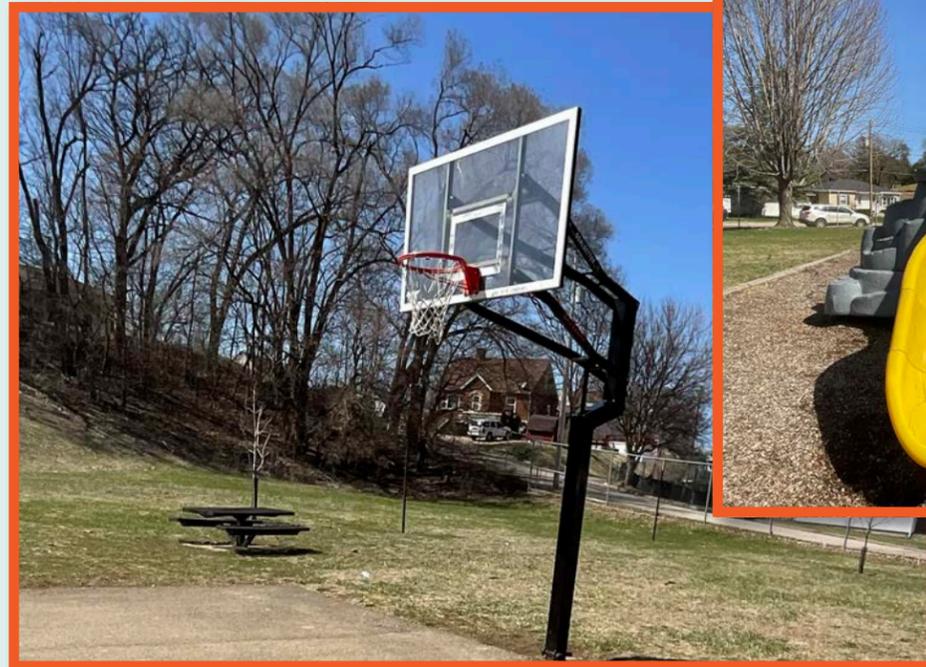
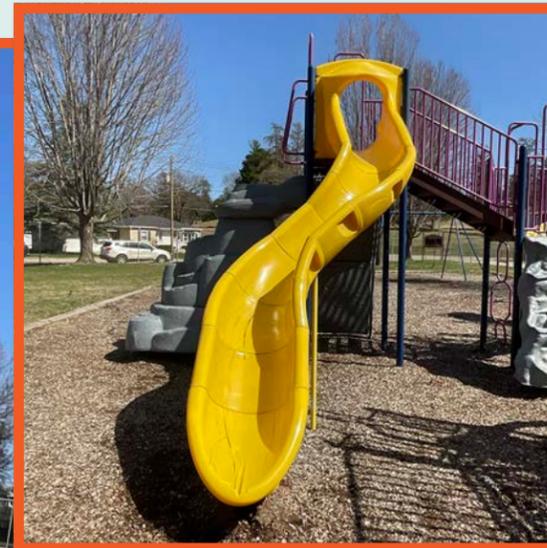
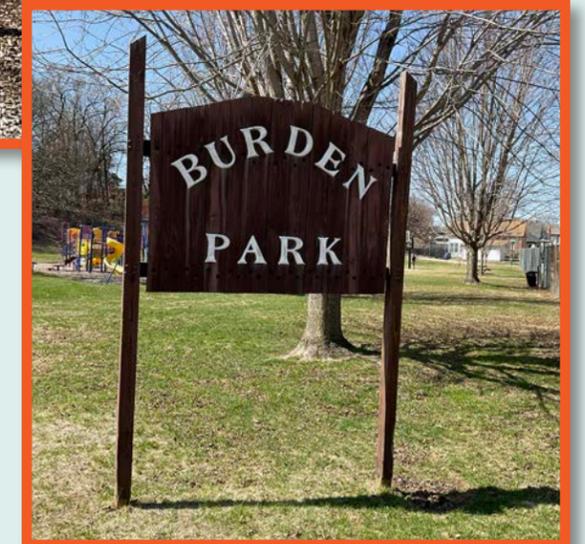
BURDEN PARK

Burden Park offers amenities such as picnic tables, a swing set, playground, and basketball court. The swing set has rust issues and the playground equipment is visibly rusting, dented, and scratched, with low wood chip coverage. The picnic tables are severely rusting. The basketball court is in poor condition with cracked asphalt, no striping. Unfortunately ADA access ends at the park entrance and no amenities on site are readily accessible.

AMENITY TYPE	QTY	GRADE	NOTES
Basketball (Backboard, Net, Pole)	1	5	Good, looks new.
Basketball Court Surface	1,450 SF	2	Asphalt, cracking, not striped, no ADA access.
Bench (Wrought Iron w/o Back)	1	2	No ADA access.
Chain Link Fence	785 LF	3	
Picnic Table (Metal)	2	2	No ADA access, rusting.
Picnic Table (Wood)	3	3	
Playground 5-12 Years	1	2	No ADA access, rusting, denting.
Playground Surfacing (Wood Mulch)	4,365 SF	1	Wood mulch needs replaced.
Playground Equipment Swings (2 Bay)	1	2	Rust present.
Sign Monumentation	1	1	Wooden park sign at the end of its life, needs replaced with Dubuque City Monumentation standard.
Trash - Plastic Roller Bin	1	4

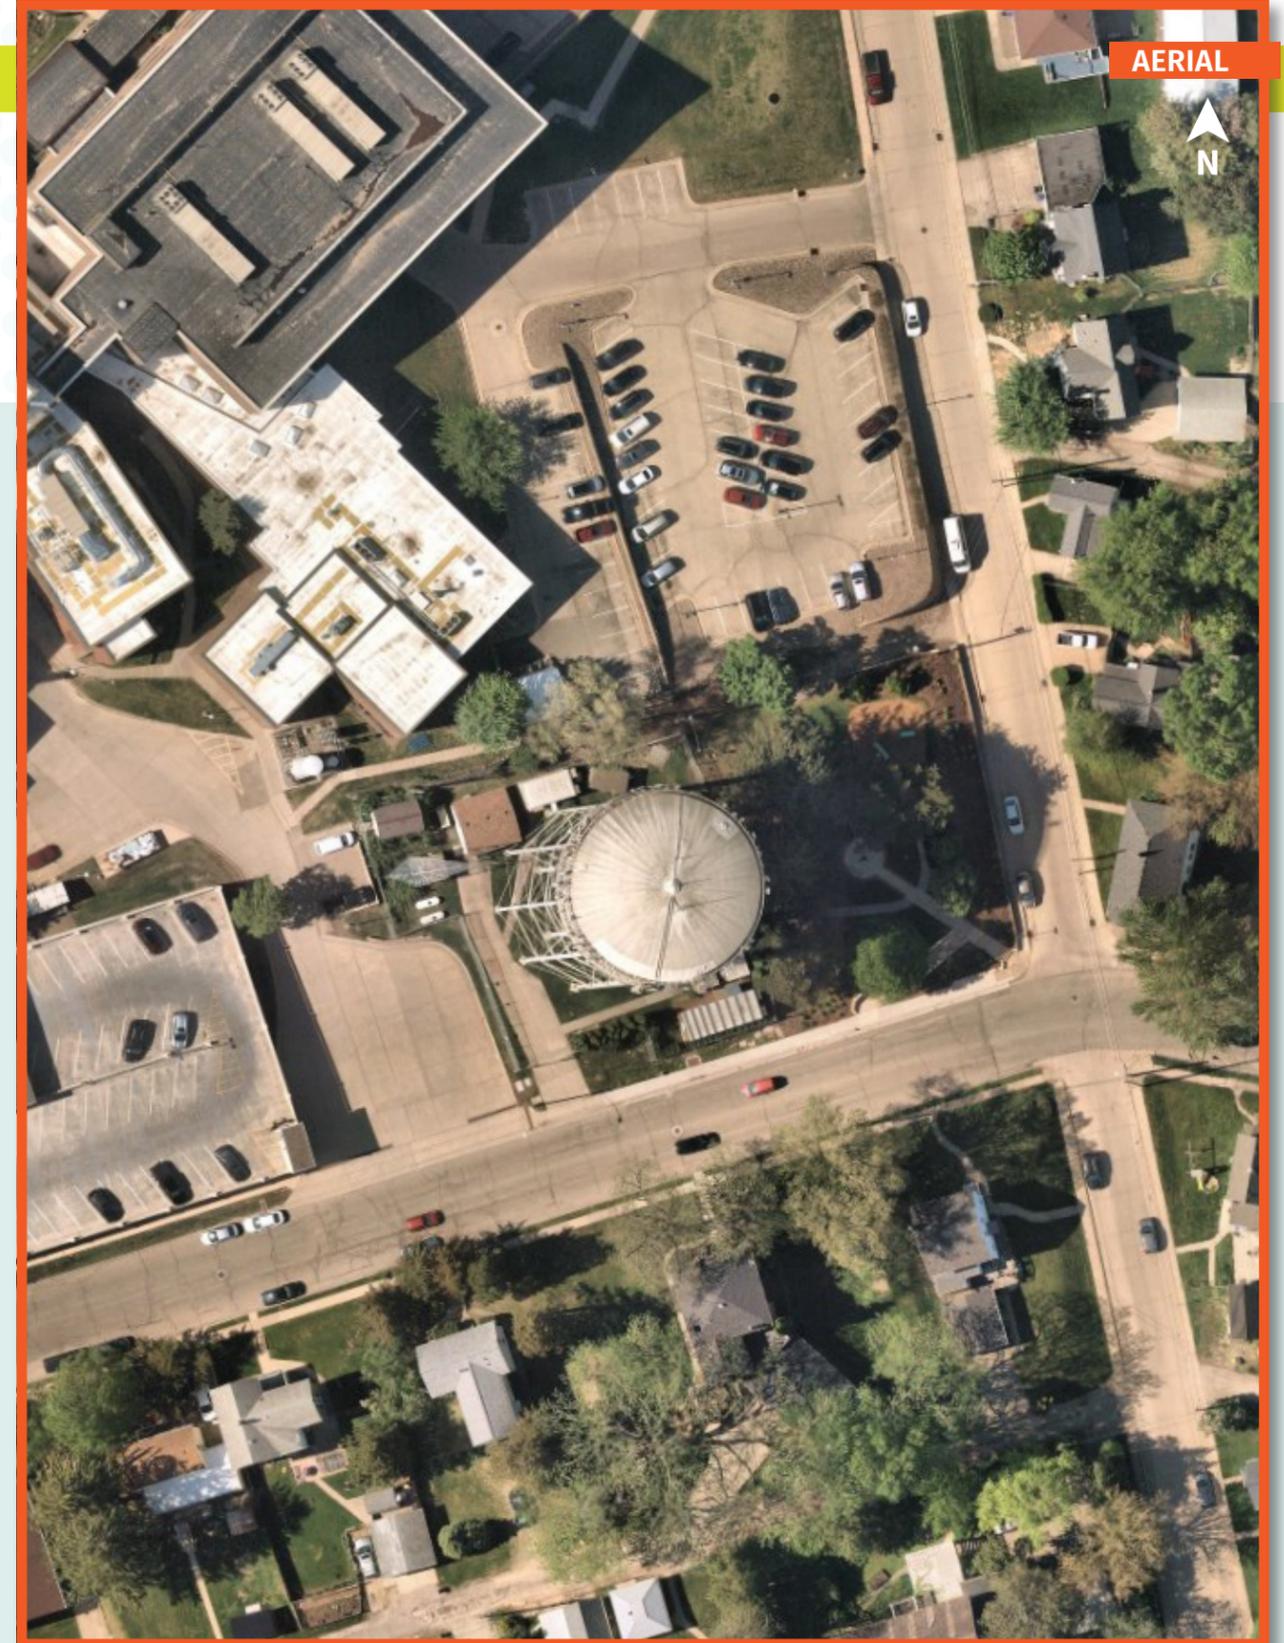
Cancer Survivor Park is a small mini park located directly Southwest of the Finley Hospital. This park hosts only a few amenities that include benches, picnic tables, a pavilion, and a single small playground. The benches and picnic table are made of stone and are in decent condition. The pavilion is of open design and the condition is fair, showing signs of aging and chipping, and is not ADA accessible. The playground is in poor condition and shows signs of erosion around the play area, minimal wood fiber for fall support, and the metal structure is aged and rusted.

AMENITY TYPE	QTY	GRADE	NOTES
Bench	2	3	Stone benches in fair condition.
Lighting Pathway	2	1	Rusting, aged lamp posts.
Pavilion (Open)	1	2	Signs of aging, chipping, no ADA access.
Picnic Table (Metal)	2	3	Stone picnic table in fair condition.
Playground equipment (Tot Lot 2-5 years)	1	1	No border around wood fiber surfacing, needs additional fiber, aging and rusting equipment.
Playground Surfacing	670 SF	1	Wood Mulch
Retaining Wall, type 4 - Keystone Block	190 LF	4	Good condition.
Sidewalk (Plain Grey)	860 Sf	3

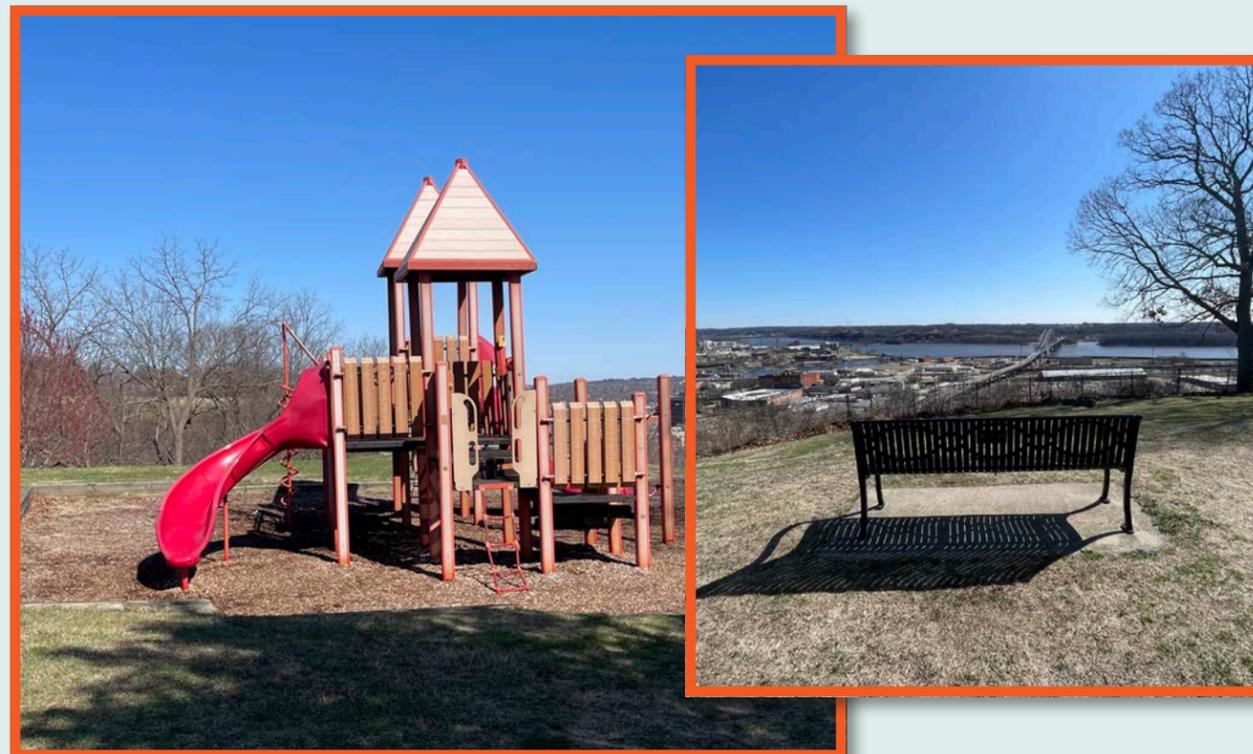
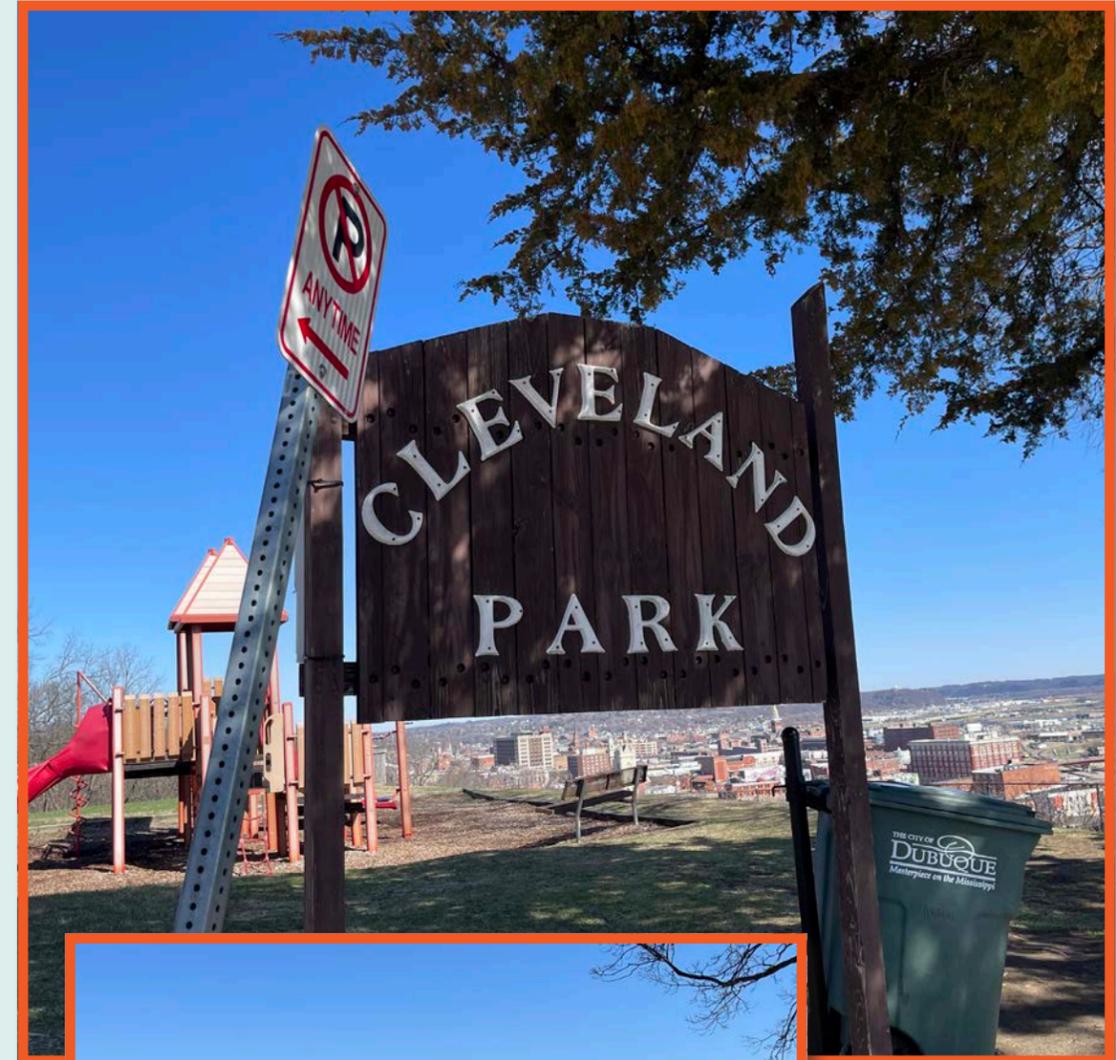
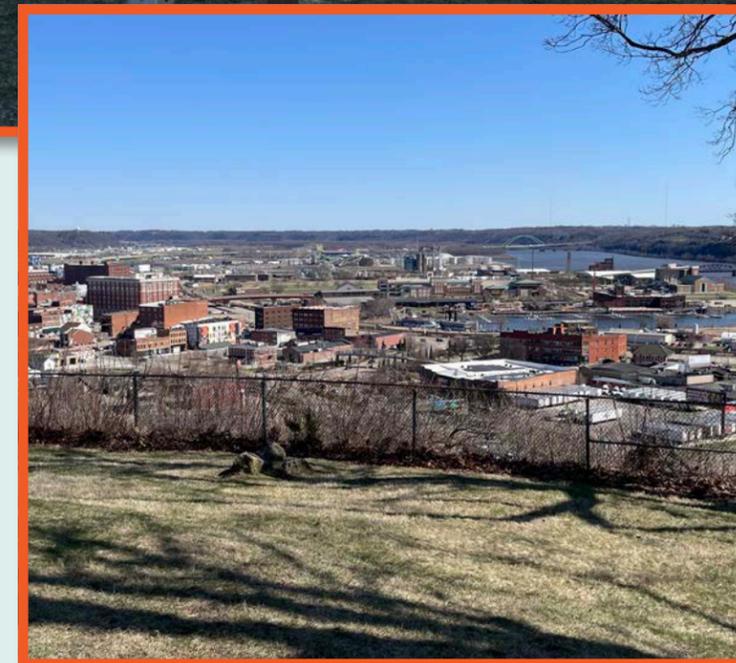
CLEVELAND PARK

Cleveland park sits atop a tall hill overlooking the Mississippi River. The playground is in decent condition but unfortunately this and the other amenities on site lack ADA access. The best element this park offers is the views of lower Dubuque and the Mississippi River which can be enjoyed from a park bench or picnic table on site.

AMENITY TYPE	QTY	GRADE	NOTES
BBQ Grill	1	2	Rusted and dilapidated. No ADA access.
Bench	2	3	Good condition, no ADA access.
Picnic Table (Wood)	1	3	Metal picnic table.
Playground 5-12 Years	1	3	Mulch not to depth, not ADA, sun faded. Some shade provided on structure, no safety signs. Equipment surface chipping and fading.
Playground Surfacing (Wood Mulch)	1,515 SF	1	
Sign Monumentation	1	1	Wooden park sign at the end of its life, needs replaced with Dubuque City Monumentation standard.
Sign (Traffic Style)	3	3	Park hours and park safety signs.
Trash (City Bin with Metal Post)	1	3	
Wooden Deck with Railing	275 SF	3	Wooden open air deck with integrated picnic table. Feels solid, wood fading, no shade.

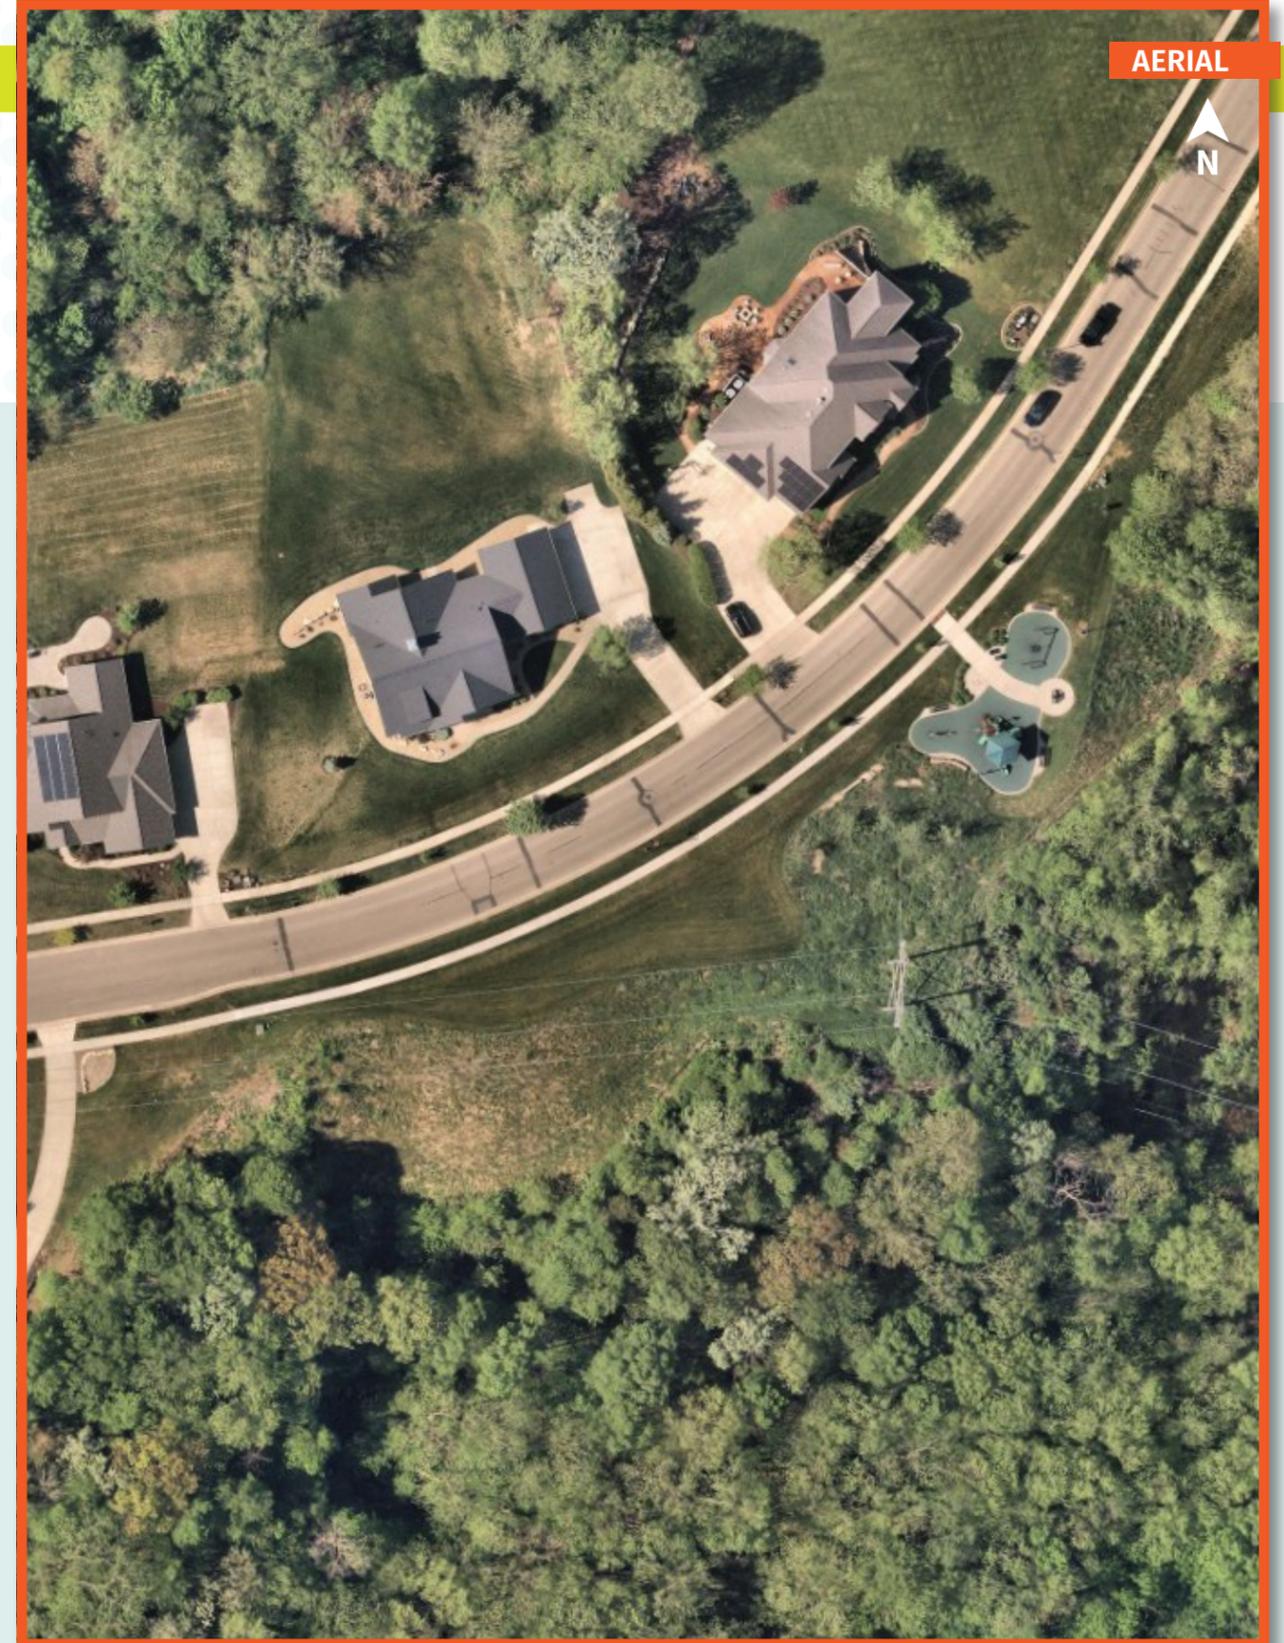
CREEK WOOD PARK CONTINUED

Creek Wood Park offers amenities including benches, picnic tables, playground equipment, a bike rack, and lighting. The park's amenities are in excellent condition, with new benches and a well-maintained playground. The playground surface is pristine and, as a whole, this park is beautiful. The only issue is that it can only serve the immediate area, as no parking is available.

AMENITY TYPE	QTY	GRADE	NOTES
Bench	3	5	Great condition.
Bike Rack	1	5	New, great condition.
Lighting Pathway	2	5	New and nice.
Picnic Table (Metal)	1	5	New and great condition.
Playground 5-12 Years	1	5	Great new equipment.
Playground Equipment (Swing - 1 Bay)	1	5	Tire swing.
Playground Equipment (Small)	1	5	See-Saw
Playground Curb Turndown	240 LF	5	
Playground Surfacing	1,770 SF	5	Brand new rubberized surfacing.
Retaining Wall, type 4 - Keystone Block	30 LF	5	
Sign (Specialty / Memorial)	1	5	Great condition.
Sign (Traffic sign w/ Post)	2	5	Located on light pole.
Trash (Metal)	2	5	Trash and recycling, great condition.

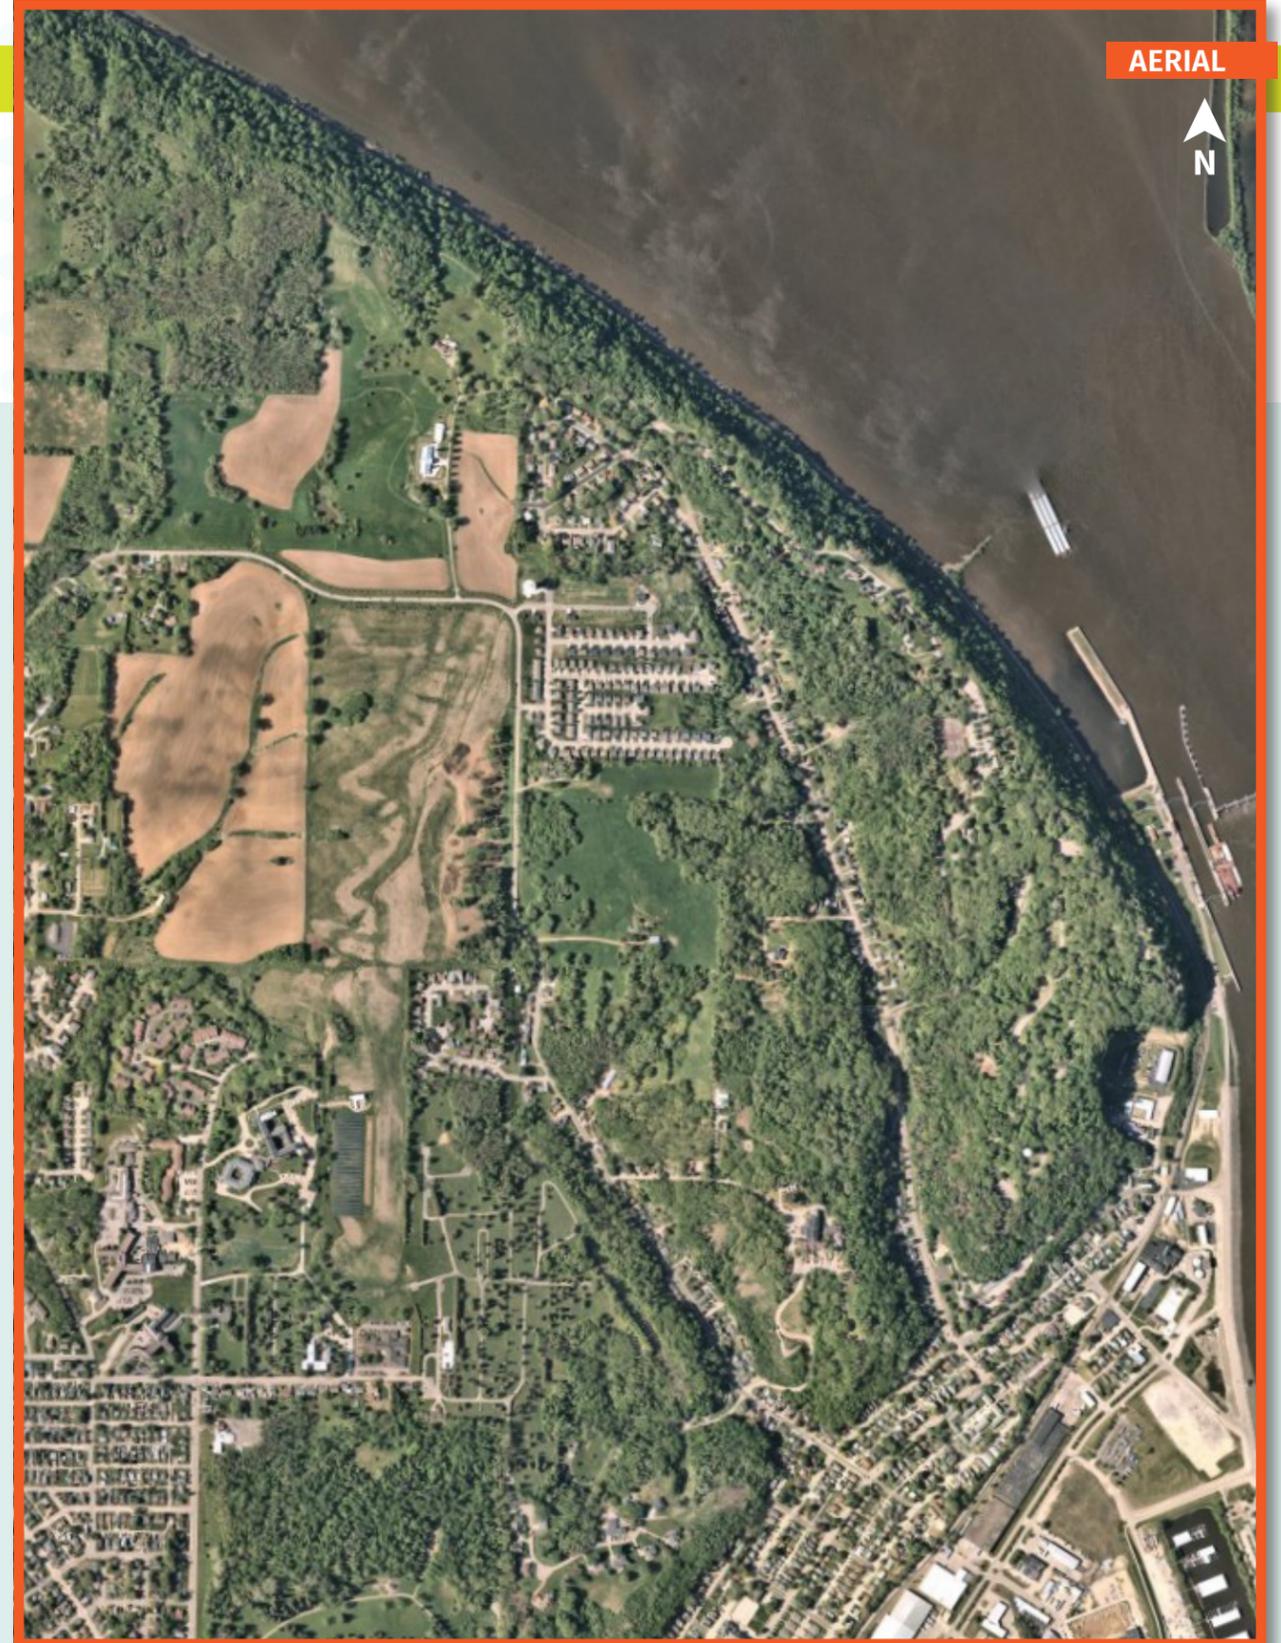
AERIAL

Eagle Point Park includes a diverse range of amenities, historical buildings, and landscape elements. Situated on a tall bluff overlooking the Mississippi River, the park itself is huge and offers a variety of experiences, views, and amenities. Unfortunately, as beautiful as this park is, a many amenities are in poor condition and cannot be used to their full potential, such as the tennis courts. This park is full of natural beauty and is amazing to walk through and enjoy.

AMENITY TYPE	QTY	GRADE	NOTES
Amphitheater	1,760 SF	3	Wear on bandshell ceiling and doors, drainage issues.
BBQ Grill	34	2	Rusting, poor condition.
Bench	45	3	Rust showing, wear and tear, most have no ADA access/1 memorial bench.
Bench (Memorial)	1	3	
Chain Link Fence	3,225 LF	3	
Drinking Fountain w/ Bottle Filler	8	2	
Horseshoe	6	2	Wood degradation.
Lighting Parking	39	3	Wooden poles show wear, LED, overall decent.
Lighting Pathway	86	3	Wooden poles showing wear, decent condition overall.
Water Feature	1	1	Potential safety issue at top of water reservoir.
Other	5	3	Metal optical binoculars, metal pitting and rusting. Still usable and in decent condition.
Parking Asphalt with striping	105,270 SF	3	Large cracks in some areas, potholing.
Pavilion Closed	1	4	
Pavilion Open	5	3	
Picnic Table (Metal)	4	3	
Picnic Table (Wood)	75	3	
Playground Surface (Wood Mulch)	16,475 SF	1	Mulch needs refreshed, not to depth.
Restroom	4,400 SF	3	One newly-renovated restroom building, remainder in need of updates.

Roadway (Asphalt)	134,130 SF	3	
Sidewalk (Plain Grey)	50,040 SF	3	
Sign (Traffic Style)	18	3	Parking, speed limit signage, and other park signs.
Sign (Specialty Memorial)	2	4	
Splash Pad	300 SF	1	Poor condition.
Swing Set	5	2	Rusting, no ADA access, chain replacement needed.
Tennis	6	1	Surfacing has degraded, broken nets, damaged striping, no ADA access, difficult to enter courts.
Trash Plastic Roller Bin	10	3

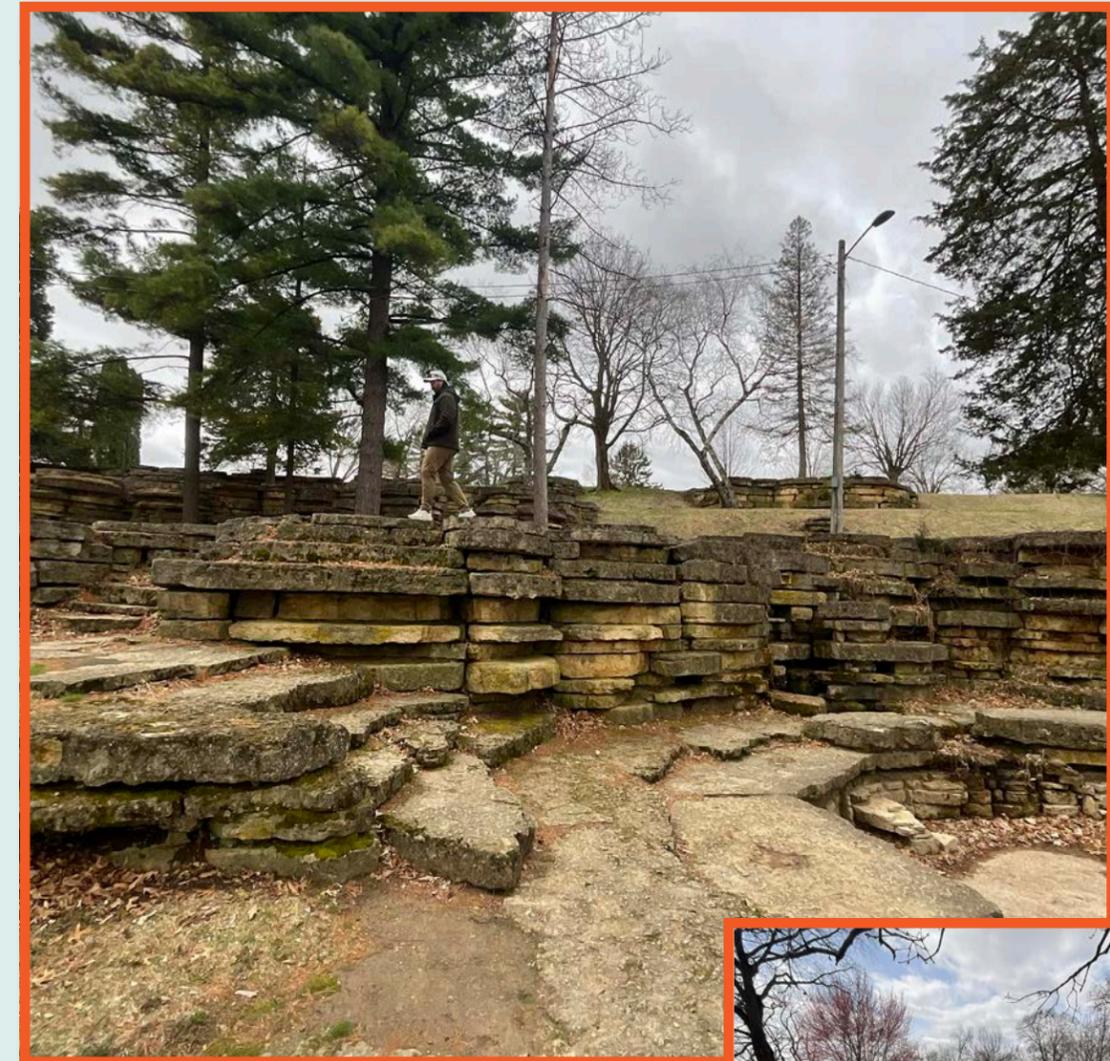
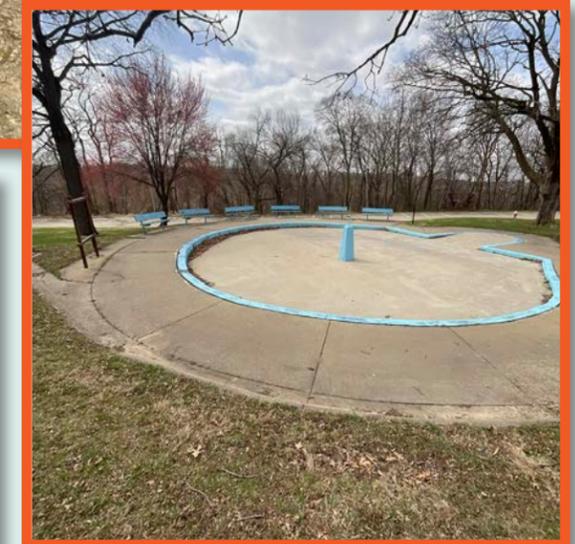
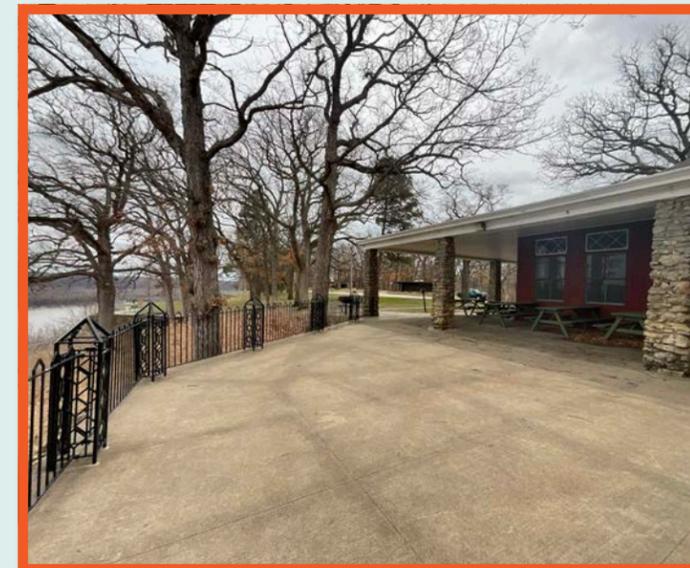
EAGLE POINT PARK CONTINUED

AMENITY TYPE	QTY	GRADE	NOTES
Retaining Wall, type 3 - Stone (>3 ft)	2,100 LF	3	
Sign (Interpretive Display with Post & Footer)	5	3	
Playground 5-12 Years	4	3	Rust showing, wear and tear, most have no ADA access/1 memorial bench.
Playground 2-5 Years	1	3	
Playground Equipment (Small)	4	3	2 Sand Diggers / 2 Spring Rockers
Playground Equipment (Swings - 2 Bay)	5	3	
Other	1	1	Pond Feature
Other	1	1	Water reservoir for water feature

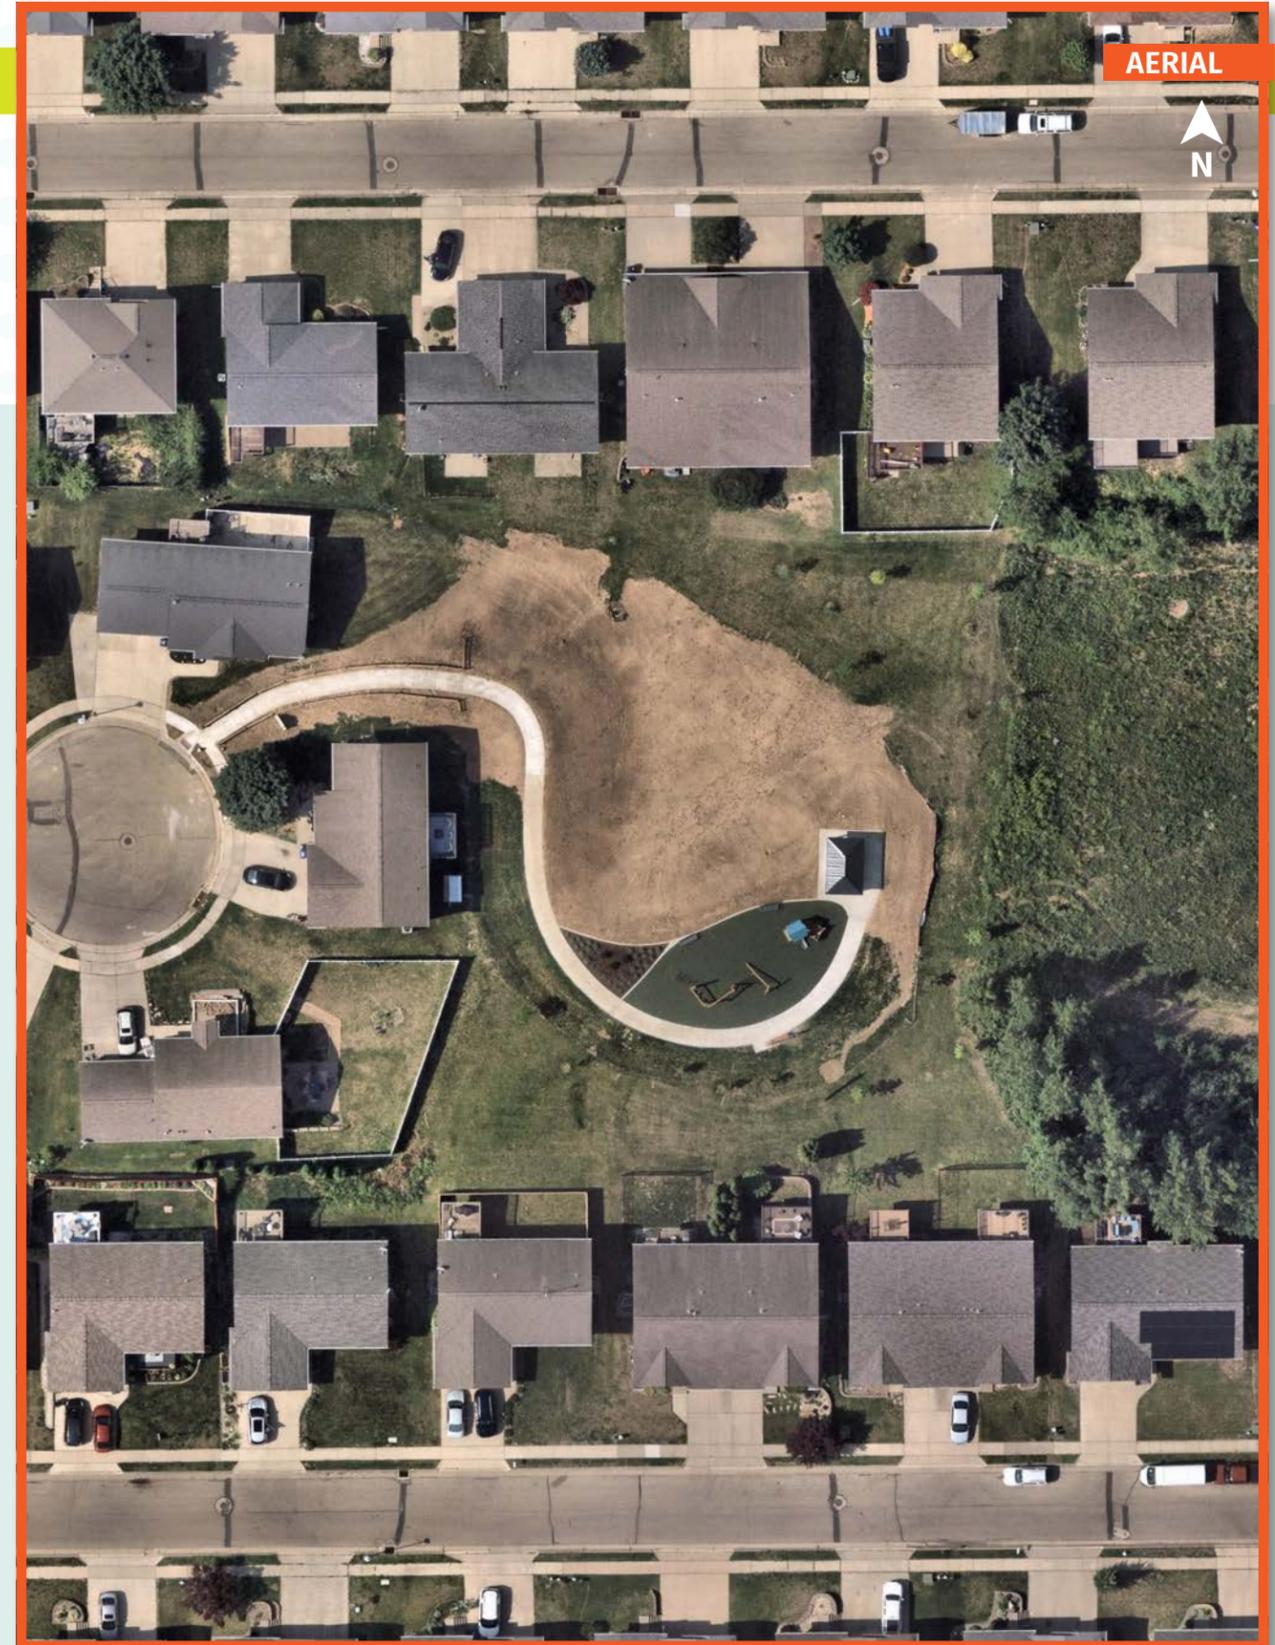
EAGLE VALLEY PARK CONTINUED

Eagle Valley Park is a mini park located adjacent to Eagle Point Park. This park, located in a residential area, has great new accessible amenities such as playgrounds, pavilions, benches, and picnic tables. There is play equipment for all ages and shaded meeting spots. The overall feel of the park is cozy and safe. The play equipment is not shaded and there is no parking, so unfortunately the park can only be enjoyed by the surrounding residents.

AMENITY TYPE	QTY	GRADE	NOTES
Bench	2	5	Great condition.
Bike Rack	1	5	Would be better located at entrance to park. Great condition.
Pavilion Open	1	5	Great condition.
Picnic Table (Metal)	2	5	New and very vibrant color. Great condition.
Playground Equipment (Large 5-12 Years)	1	5	Missing signage for age ranges, new and in great shape.
Playground Equipment (Small 2-5 Years)	1	5	
Playground Surfacing	1,900 SF	5	Brand new rubberized surface.
Playground Curb Turndown	180 LF	5	
Railing (Wooden)	185 LF	5	
Sign (Monumentation)	1	5	Great condition just missing park information.
Sidewalk (Concrete)	2,470 SF	5	
Swing Bench	1	5	Brand new.
Trash Can (Metal)	1	5	Great condition.

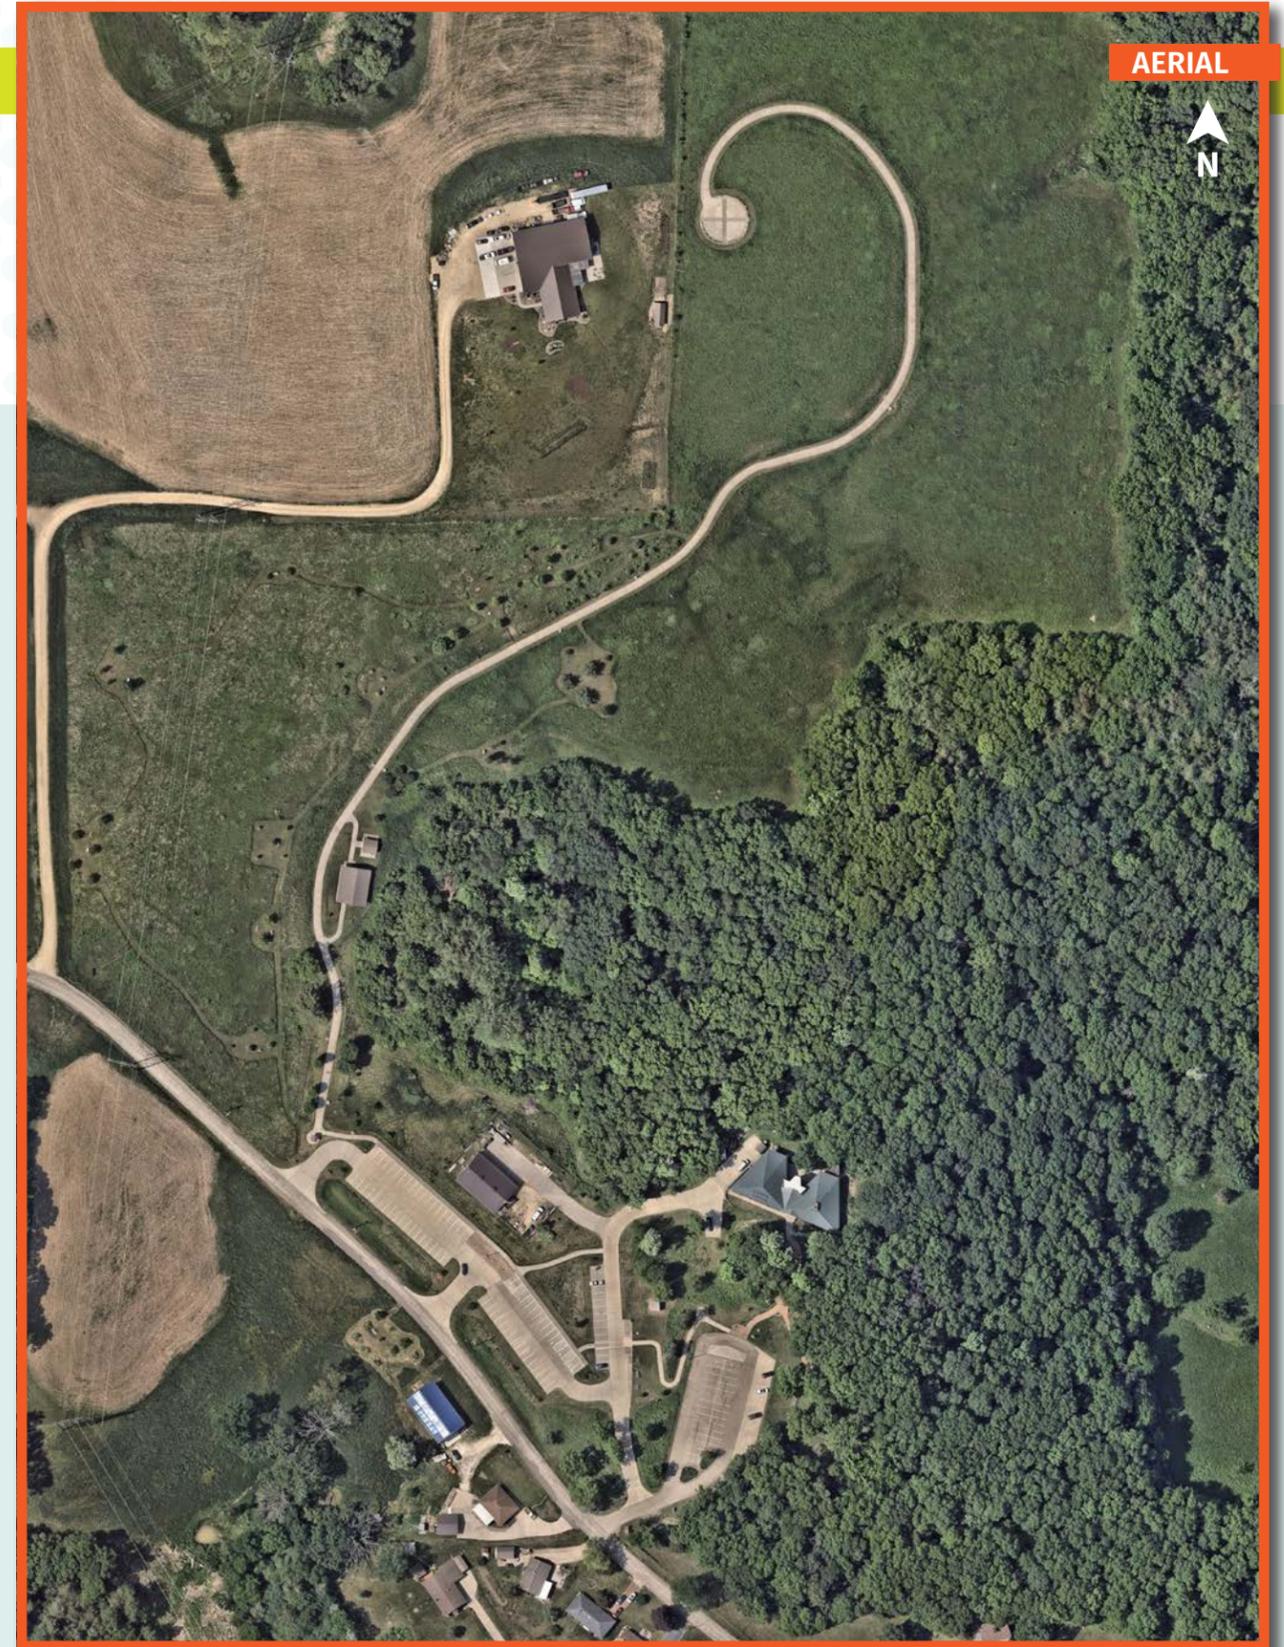
EB LYONS NATURE CENTER CONTINUED

EB Lyons Nature Preserve features an interpretative center full of exhibits on the parks history and features about the park. The preserve also features a paved trail and multiple mowed paths throughout. Multiple story boards line the paths telling the story of the area that is being traversed.

AMENITY TYPE	QTY	GRADE	NOTES
BBQ Grill	2	3	Rusting, poor condition
Bench (Limestone Blocks)	20	3	Benches Aligned around Cardinal Terminus. Good condition
Bench (Wooden with Concrete Footer)	5	3	
Bike Rack	1	2	Metal Bike Rack
Cardinal Terminus	3,365 SF	4	Terminus of Trail, Colored concrete and Lettering Denotes Cardinal Directions. Great condition
Drinking Fountain (2 Bubblers and Pet Bowl)	1	3	2 Bubblers and Dog Bowl, Good condition
EB Lyons Interpretive Center Building	8,215 SF	4	
Flag Pole	1	4	
Kiosk	1	3	Kiosk located at trail head. Contains 4 interpretive signs.
Lighting Walkway (Bollards)	3	3	Metal Bollards with Light fixtures
Water Spigot	1	3	
Pavilion Open	1	4	
Picnic Table (Metal)	10	4	Metal Picnic Tables in Pavilion
Picnic Table (Wooden)	2	3	Wooden Picnic Tables located on trail
Restroom	375 SF	4	Vault restroom. Good condition
Sidewalk (Plain Grey)	21,550 SF	4	
Sign (Dubuque Bike Map)	1	3	
Signage (Interpretive with Metal Supports)	19	3	Interpretive Signs located along trail. Most are in good condition, some are very sun faded and cracking/

Sign (Traffic style on Post)	4	3	Pet Rules Sign, Trail Marker sign
Trashcan - Metal	2	3	Metal Bins located at pavilion

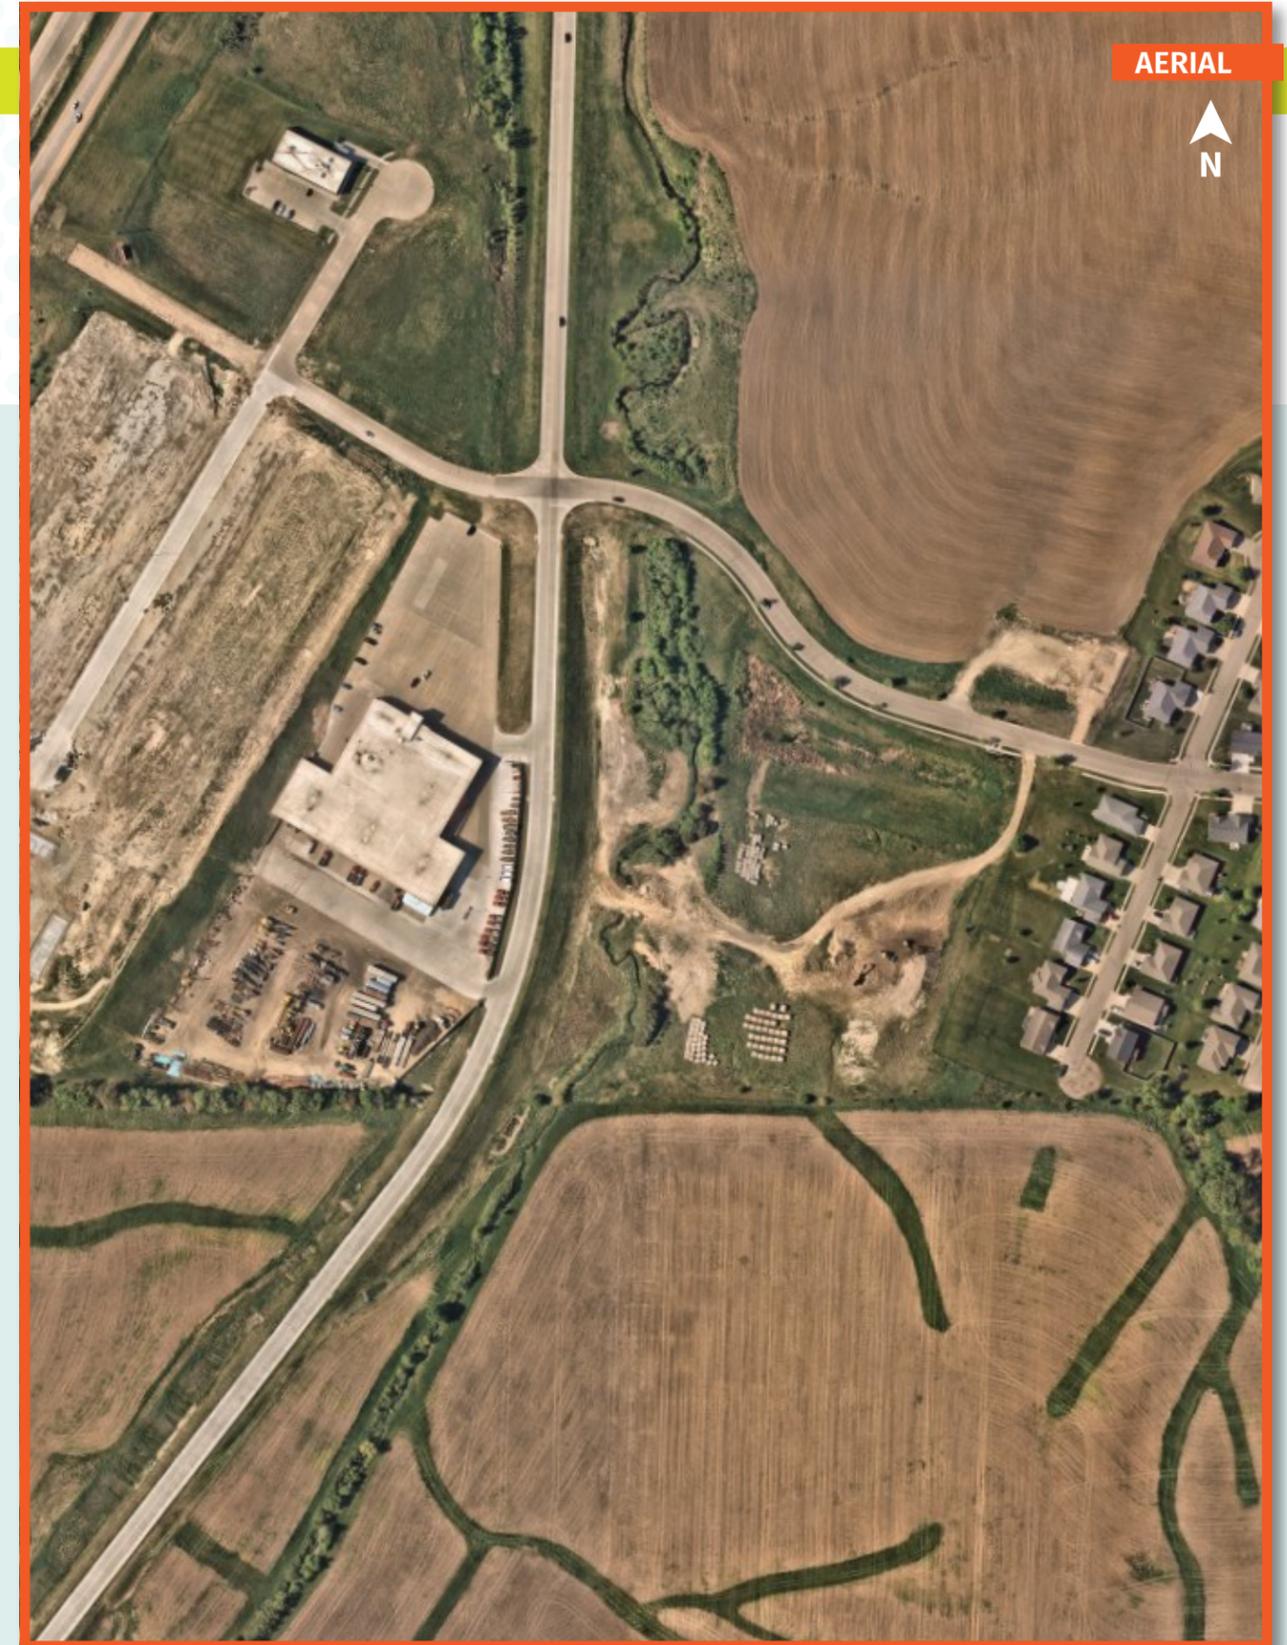
ENGLISH RIDGE PARK CONTINUED

English Ridge Park is a small cozy park serving the surrounding neighborhood. All of the equipment is new and in great shape. The ramada offers shade and seating options and is accessible to all. The park feels a little disconnected from the adjoining neighborhood and does not offer opportunities for parking.

AMENITY TYPE	QTY	GRADE	NOTES
Swing Bench	1	5	New swinging bench.
Bike Rack	2	5	Very decorative bike rack, not installed at time of inventory.
Drinking Fountain - 2 Bubblers and Pet	1	5	
Pavilion Open	1	5	New and very nice.
Picnic Table (Metal)	2	5	New and nice, ADA accessible.
Playground Equipment (Large 5-12 Years)	1	5	Very nice and new, missing regulation signage/ age descriptions.
Playground Equipment (Small)	1	5	
Playground Surfacing	1,140 SF	5	Brand new rubberized surface.
Playground Curb Turndown	130 LF	5	
Sign Monumentation	1	5	Nice new sign.
Trash (Metal)	1	5	New.
