Appendix A

Park Inventory and Assessment Report

Dubuque
Parks and Recreation
Comprehensive Plan

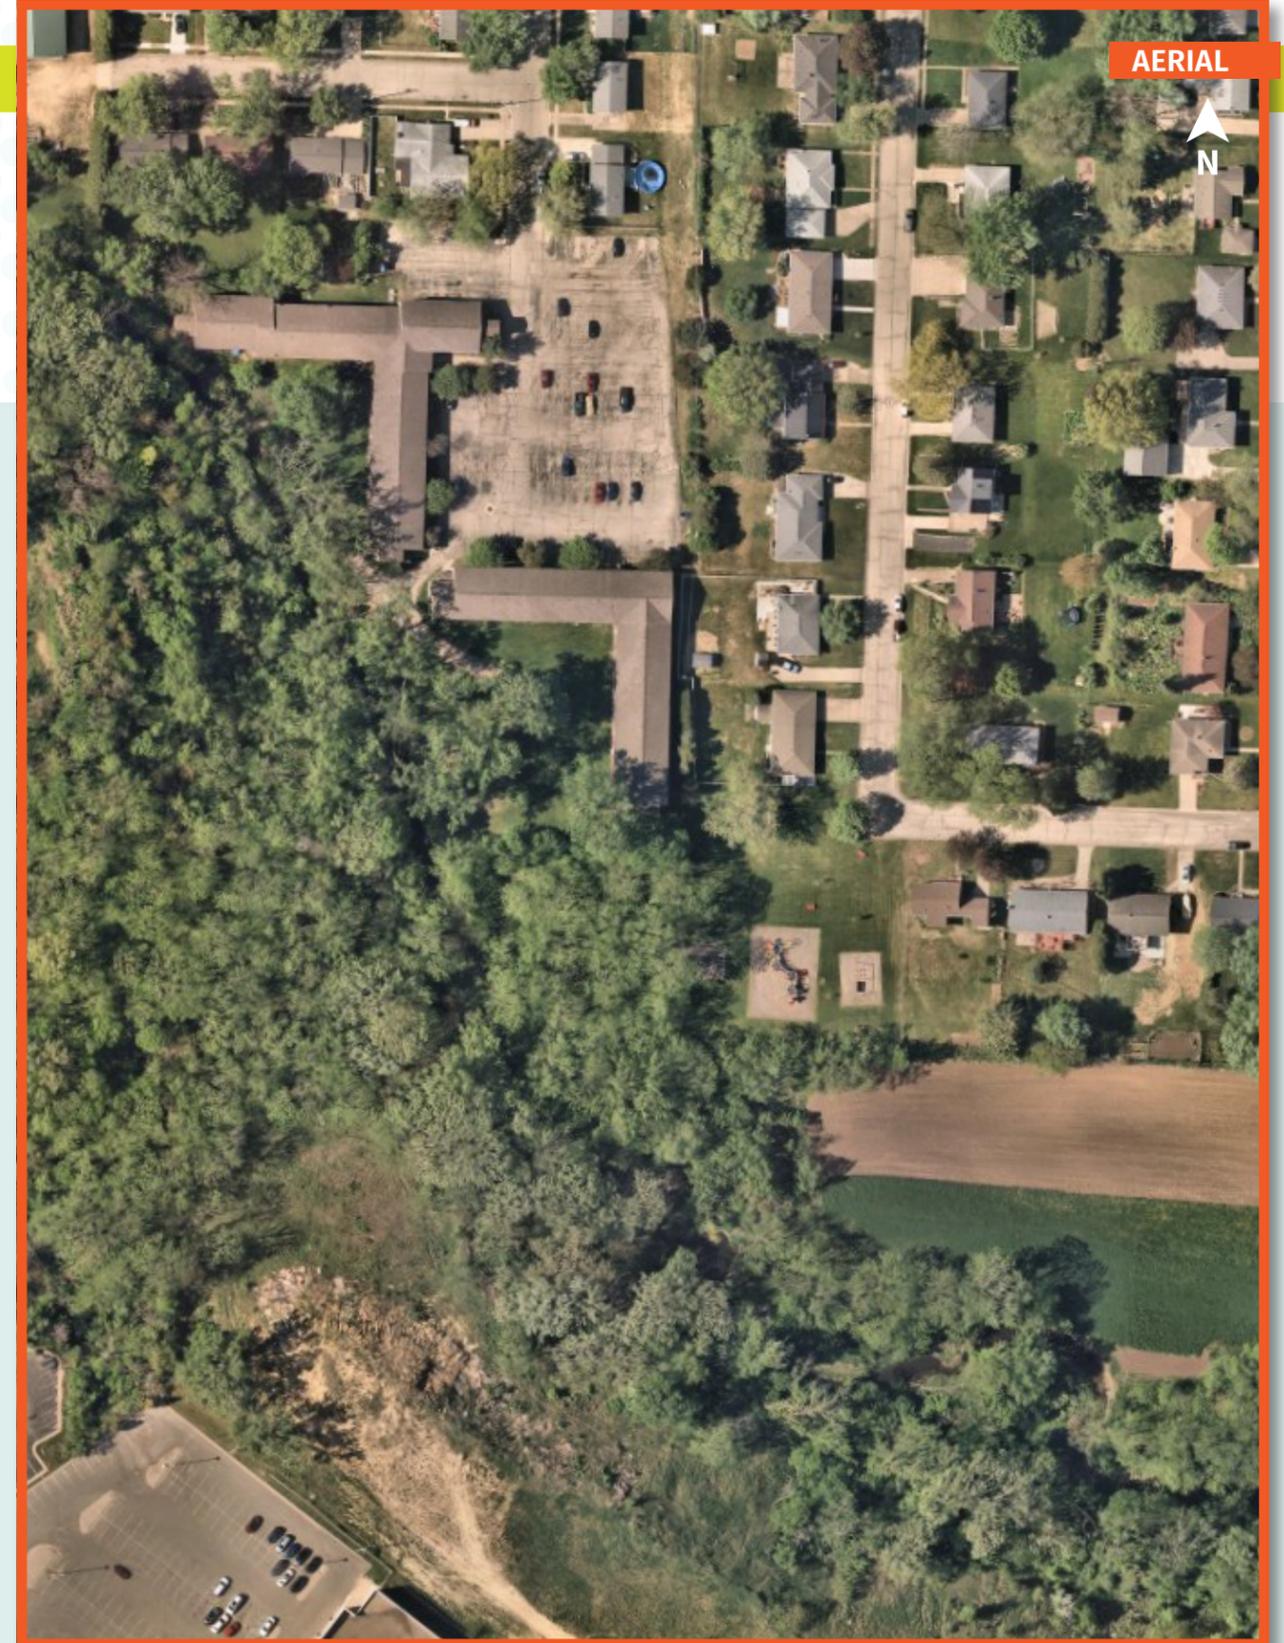
Falk Park features playground equipment, lighting, a trash receptacle, a basketball court, and signage. The playground area shows wear and rust, with faded paint and rusting chains on swings. The lighting for the playground is extremely dated with weathered wooden poles. The basketball court has an uneven asphalt surface and faded backboard with rusting metal poles. Park signage shows wear and has begun to lean. The park lies at the bottom of a hill with no ADA accessibility.

AMENITY TYPE	QTY	GRADE	NOTES
Basketball (Back Board, Rim, Net, Pole)	1	2	Rust was prevalent on hoop and pole, backboard faded.
Basketball Court Surfacing (Asphalt)	670 SF	3	Cracking , uneven surface, no border with turf.
Carsonite Property Posts	1	5	3 posts missing to determine park boundaries.
Playground Equipment (Large 5-12 Years)	1	3	No ADA access, some wear and tear. Walking surfaces are rusting.
Playground Equipment (Small)	3	2	2 sand diggers /1 rocker.
Playground Surfacing (Wood Mulch)	4,810 SF	1	
Swing (2 Bay)	1	3	Rust prevalent, decent condition.
Sign (Monumentation)	1	1	Wooden park sign at the end of its life, needs replaced with Dubuque City Monumentation standard.
Sign (Traffic Style with Post)	2	3	
Trash Container - City Roll off with post	1	2	Normal wear and tear, rust prevalent.

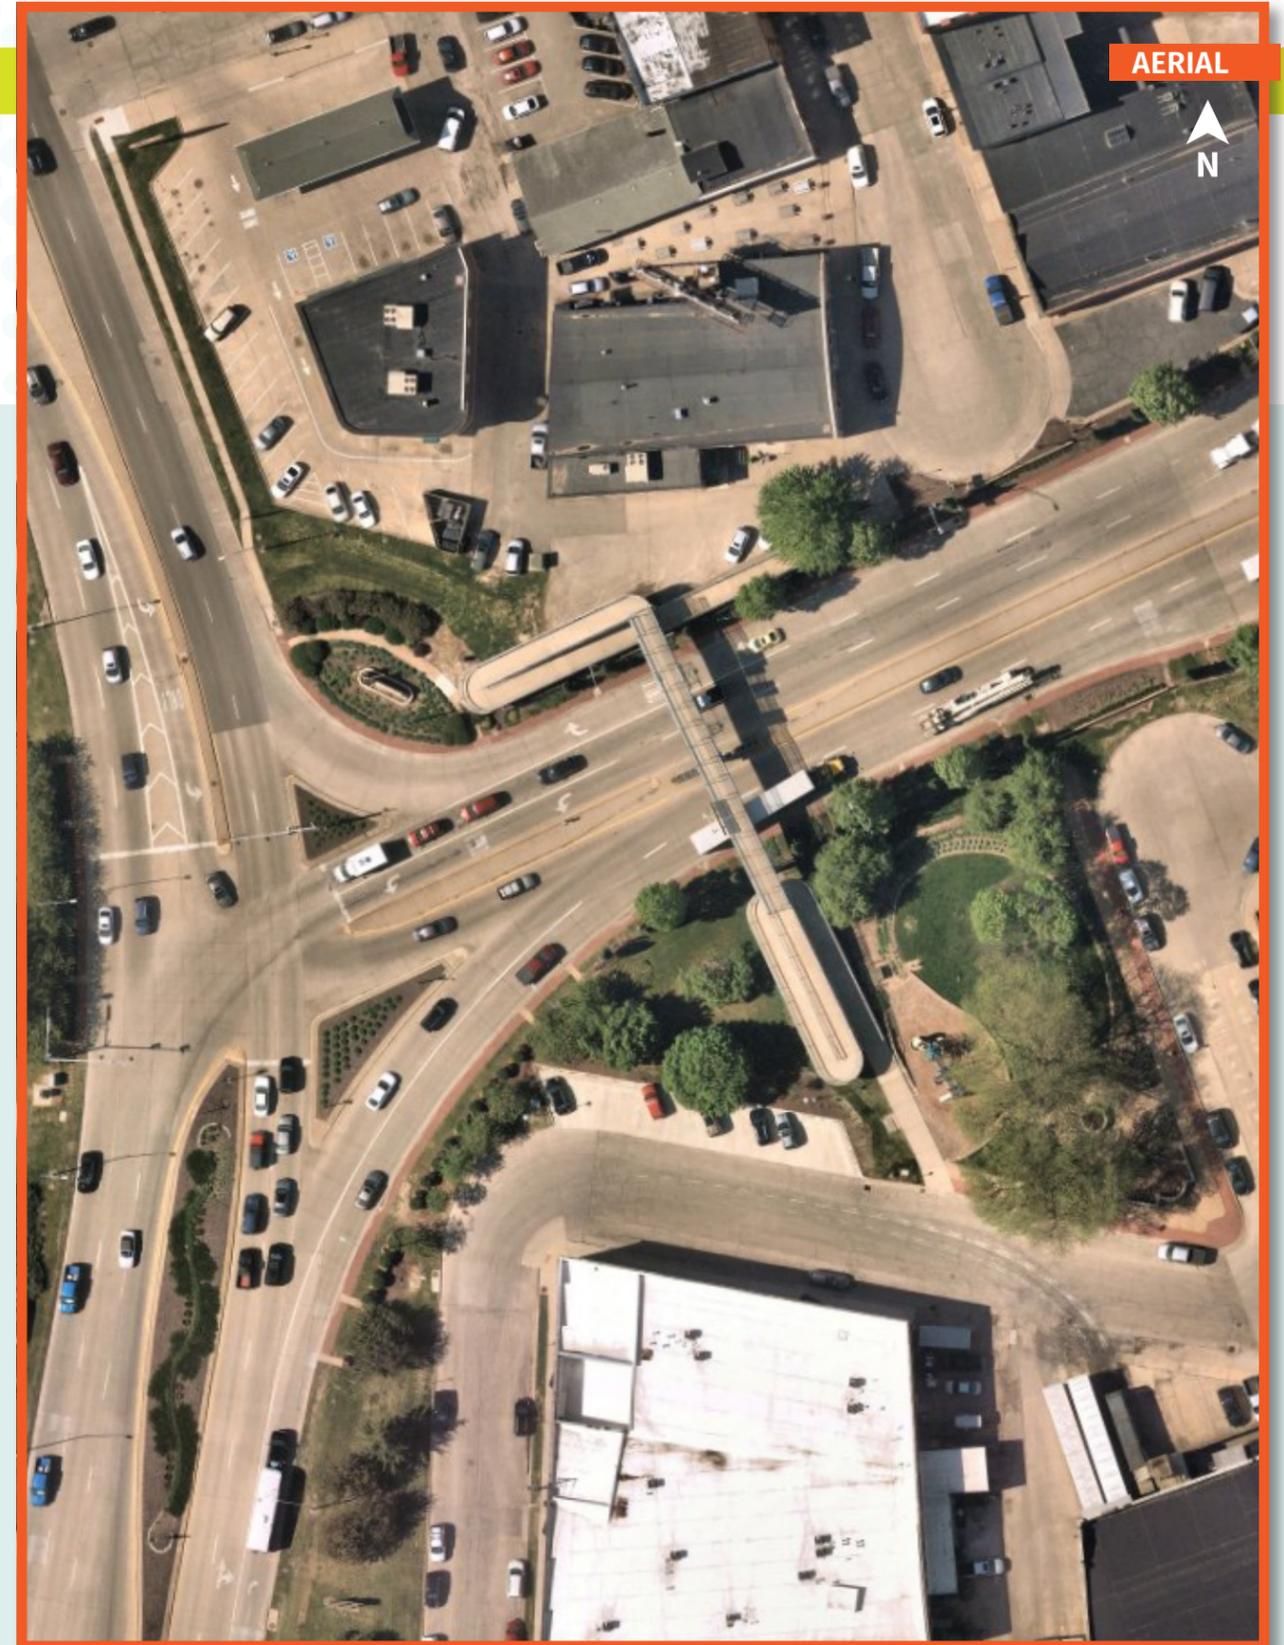
FLAT IRON PARK CONTINUED

Flat Iron Park offers amenities including a picnic table, playground equipment, a bike rack, and a drinking fountain. The playground equipment shows chipping, wear, and rust, requiring additional wood fiber coverage for safety. The picnic table and bike rack are in good condition but show signs of rust and fading. The drinking fountain needs paint and rust repairs, although current water flow is off for the season. Its location offers a cozy outdoor break for the employees from surrounding businesses and gives access to Main St. Dubuque via a pedestrian bridge.

AMENITY TYPE	QTY	GRADE	NOTES
Bike Rack	1	4	Slight wear, overall great condition.
Drinking Fountain - 1 Bubbler	1	3	Paint fading and rusting.
Electric Pedestal (50 AMP)	1	5	
Lighting Sidewalk	5	3	Worn but still good shape.
Pet Waste Station	1	3	Decent condition.
Picnic Table (Metal)	1	4	Great condition.
Planter (Raised) Type 1 (24")	20 LF	5	
Playground Equipment (Large 5-12 Years)	1	2	Aesthetic damage on all pieces, walking surface is cracking and beginning to break apart.
Playground Surfacing (Wood Mulch)	2,340 SF	1	Needs replaced, not to depth.
Sidewalk (Plain Grey)	1,745 SF	4	
Sidewalk (Pavers)	525 SF	3	Decent condition but uneven.
Sign (Specialty)	1	5	Great condition, integrated lighting.
Trash Plastic Roller Bin	2	4	Great condition.

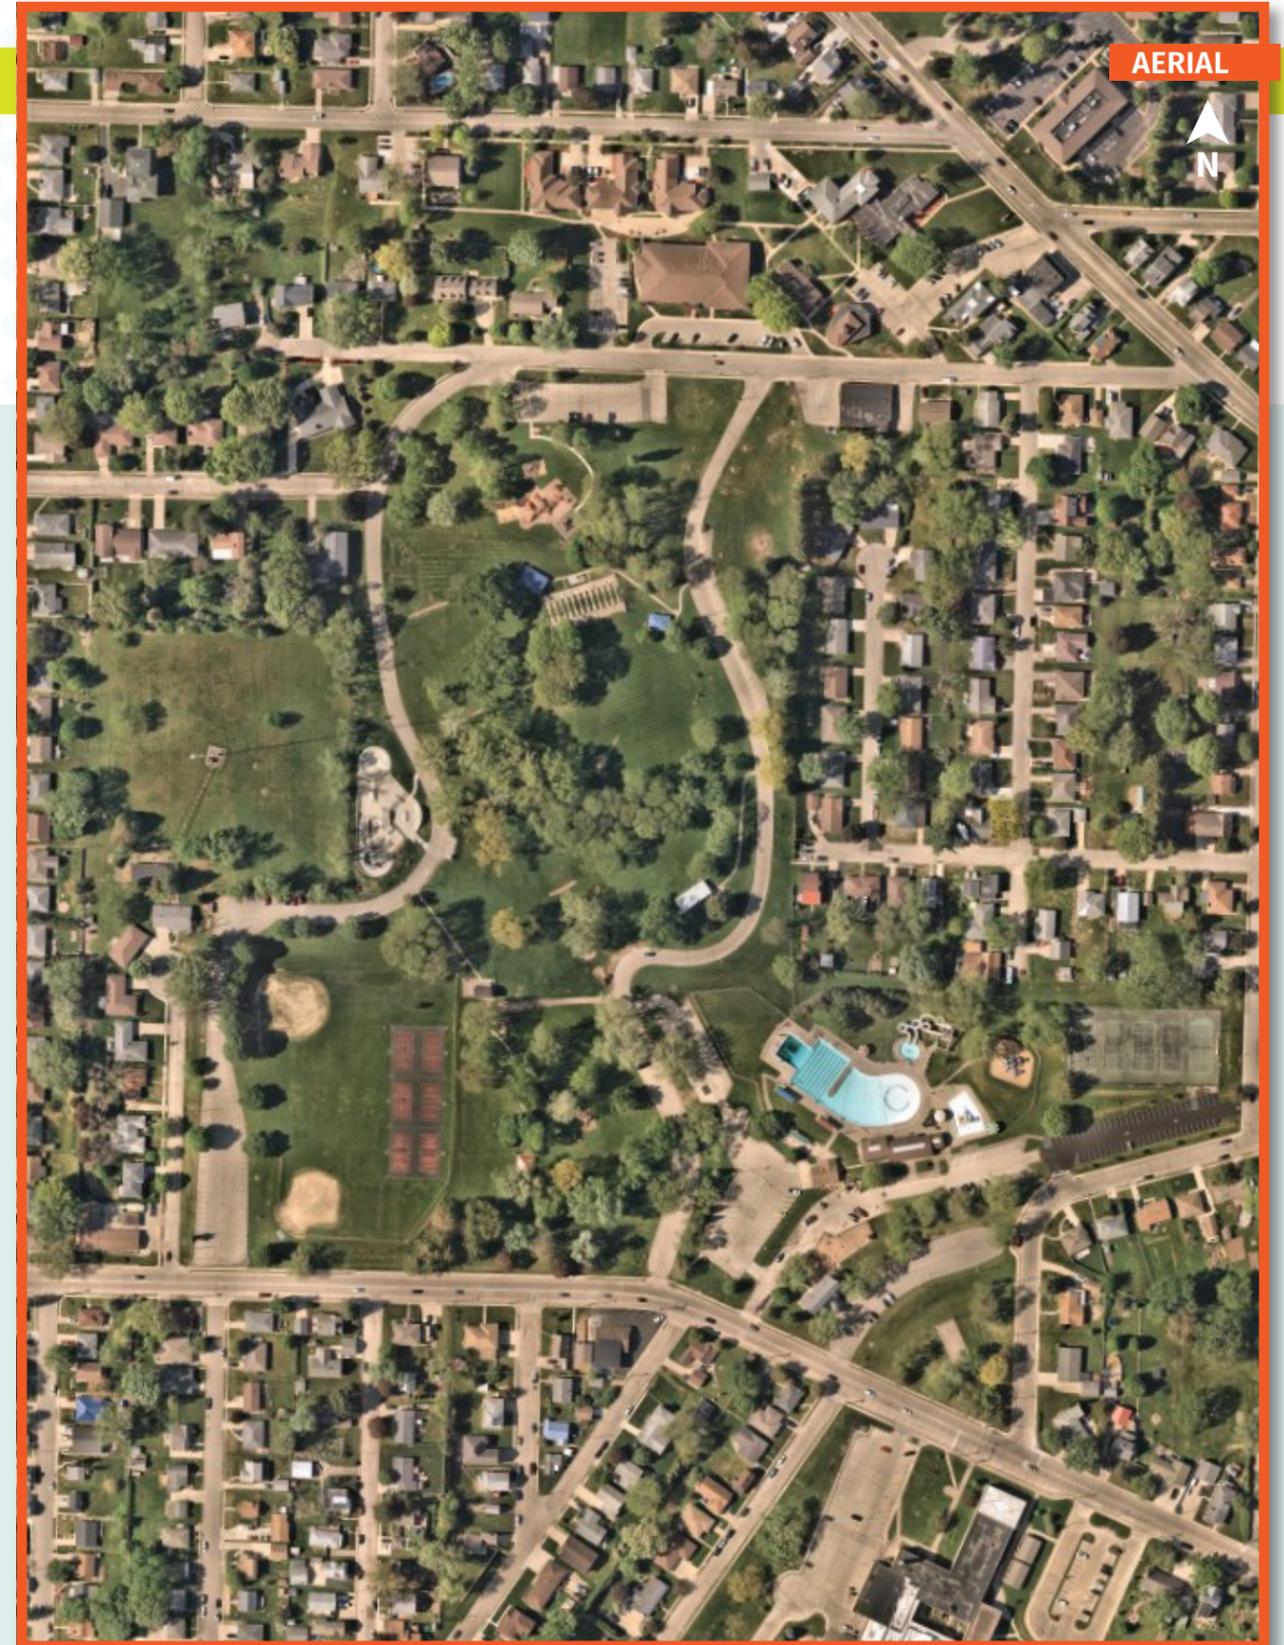
Flora Pool is one of two pools located in Dubuque, making it an important destination for residents during the summer months. A fairly large pool with various amenities such as a concession stand, diving boards, tot pool, and plenty of seating, it really feels like a destination location within Dubuque. The pool overall appears to be in a decent condition and both patrons and employees seemed happy to be there.

AMENITY TYPE	QTY	GRADE	NOTES
Aquatic Center (Pool)	45,900 SF	2	
Aquatic Slide Tower	1	1	Some wear and rust, critical condition, becoming a hazard.
Bench (Wrought Iron with Back)	4	3	Decent condition, some sun fading and cracking present.
Concession	1,520 SF	3	New roof, exterior in good condition.
Office building	1,650 SF	3	
Other	3	3	Large umbrella-shaped shade structure. Good condition, two seemed to be inoperable at time of inventory.
Other	3	2	Shade Canopies
Picnic Table (Metal)	9	3	
Playground	1	3	Decent condition, no ADA access. Some integrated shade present, equipment shows signs of wear.
Pool Building	1,500 SF	1	
Restroom / Locker Room	2,800 SF	1	Two changing/restrooms. Okay condition.
Sign (Traffic Style)	10	5	Pool rules/hours signs.
Storage Building	550 SF	1	
Trash	8	3

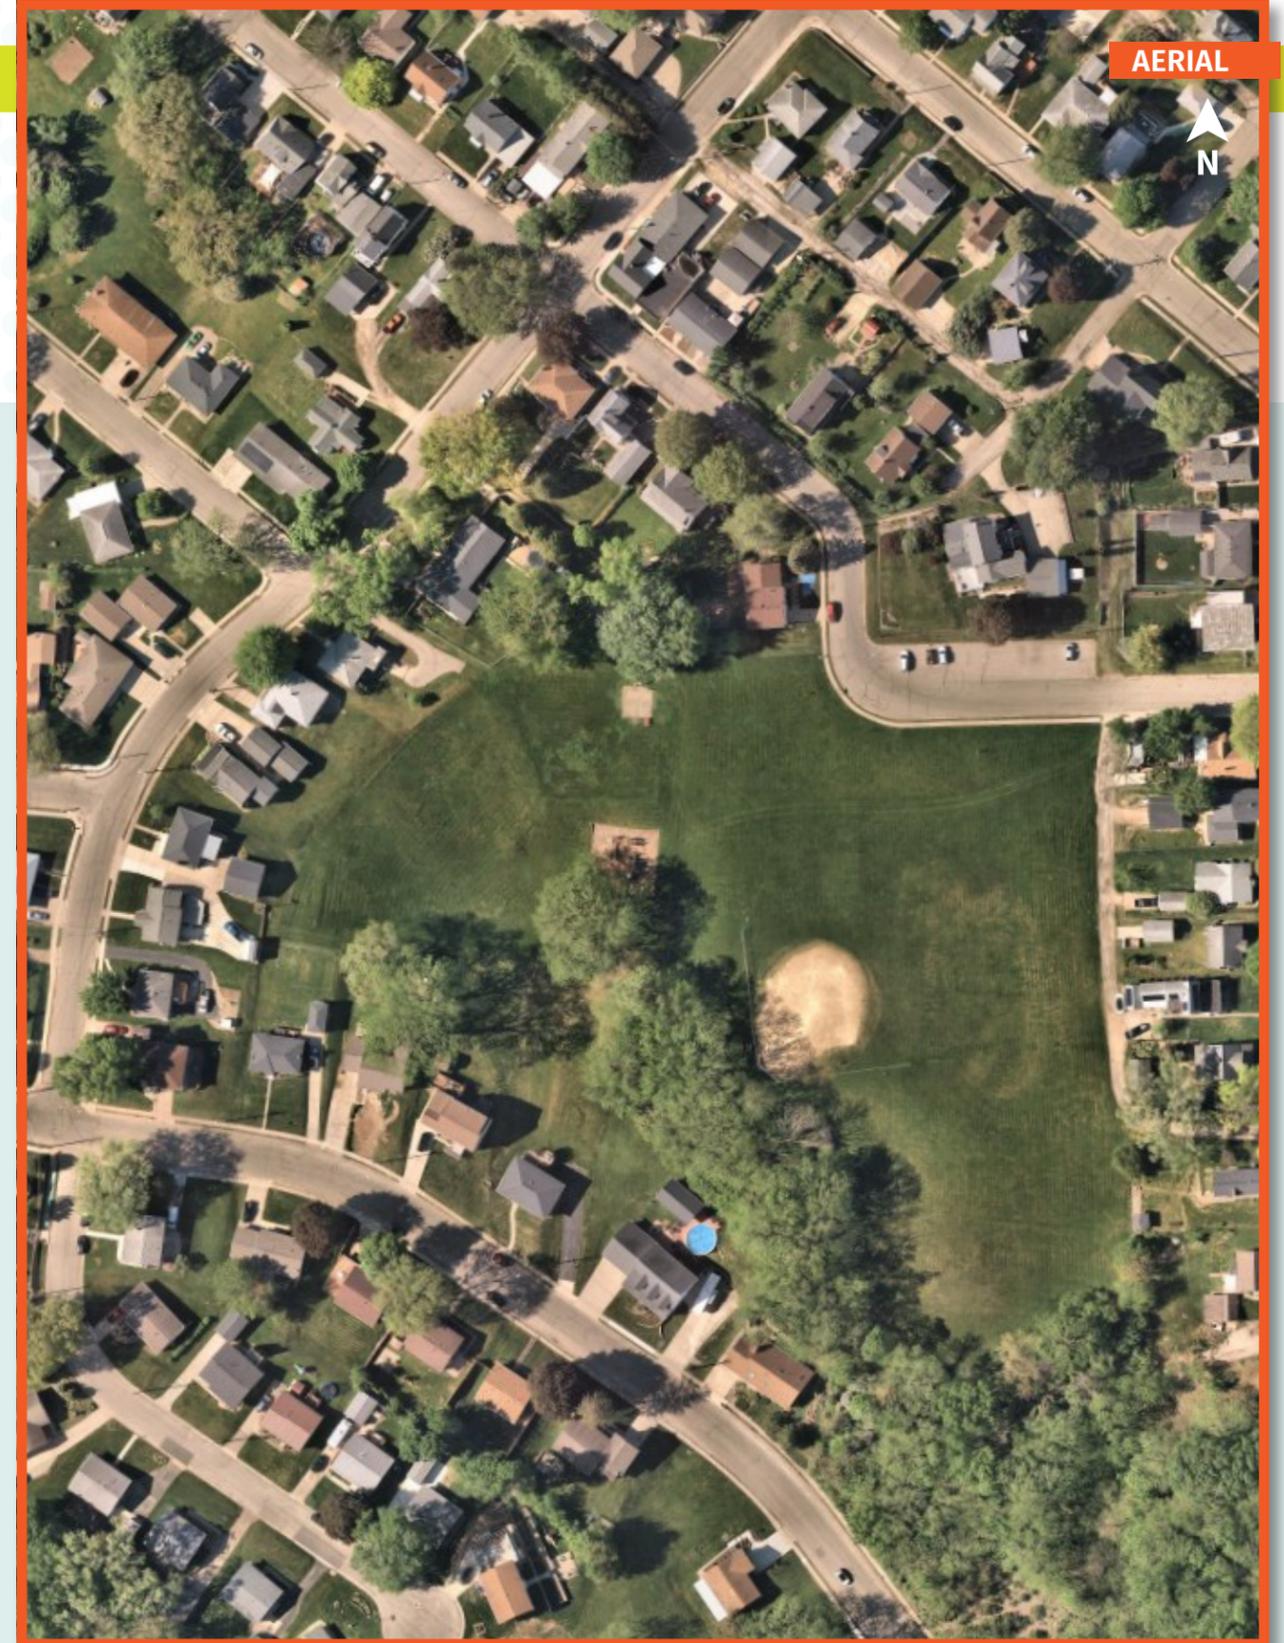
GAY PARK

Gay Park amenities include a baseball field, picnic tables, a playground, a basketball court, and trash receptacles. The baseball field features adequate base and backstop fencing but lacks walkways and seating, leading to ADA issues. Picnic tables show rusting and graffiti, while the playground equipment is significantly worn and rusted, with insufficient mulch and no ADA access. The basketball court lacks striping, has rusting backboards, and has no dedicated lighting or seating.

AMENITY TYPE	QTY	GRADE	NOTES
Baseball	1	3	Field in decent condition, no walkways or seating.
Basketball (Backboard, Rim, Net, Pole)	1	5	Great condition.
Basketball Surfacing (Asphalt)	570 SF	3	Not true half court size, no ADA, chipping and cracking present.
Picnic Table (Metal)	1	2	Rusting.
Picnic Table (Wood)	1	3	
Playground Equipment (Large 5-12 Years)	1	2	No ADA access, paint faded and cracking. Rust prevalent.
Playground Surfacing (Wood Mulch)	2,750 SF	1	Needs refreshed.
Trash Plastic Roller Bin	2	4	Permanent post and removable plastic trash bin.

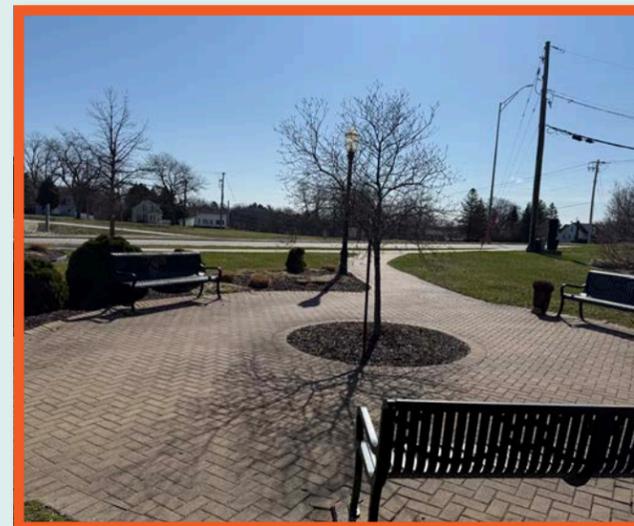
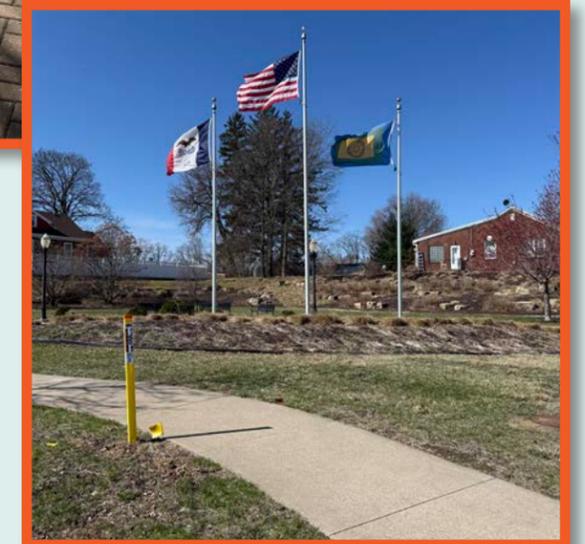
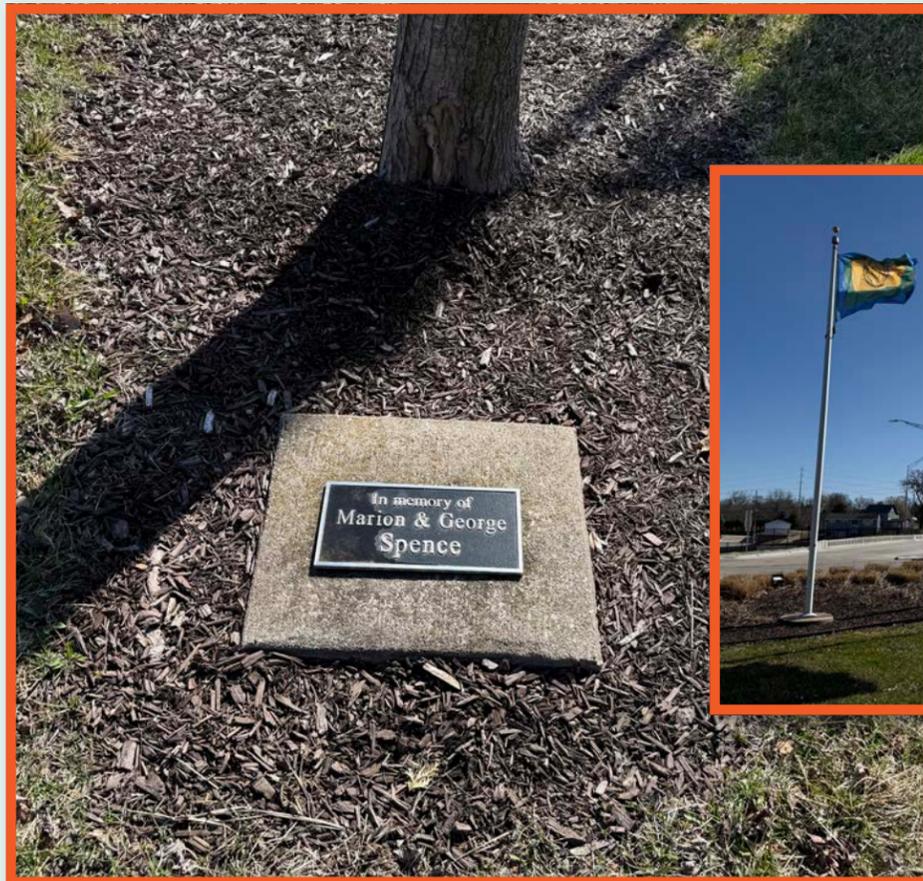
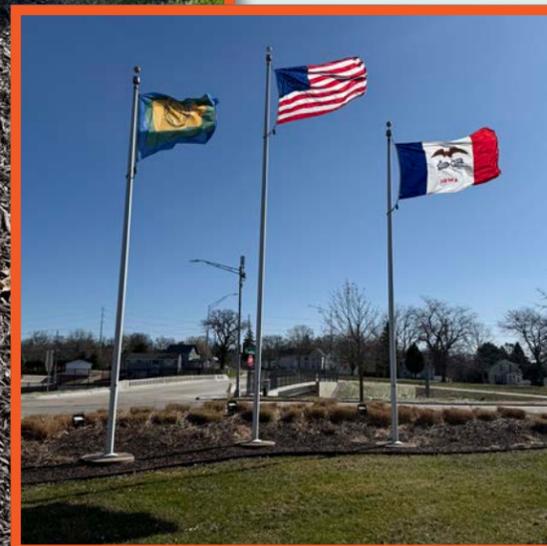
Grandview Green Space is a nice area that offers seating and a potential reprieve for those walking the sidewalk along Grandview Avenue. The area does not offer many amenities but it is a nice, well kept green space with attractive landscaping.

AMENITY TYPE	QTY	GRADE	NOTES
Bench	4	3	Paint/enamel covering cracked and peeling.
Drinking Fountain (2 Bubblers - 1 Pet Bowl)	1	4	Great condition, slightly dirty.
Electric Power Pedestal (50 Amp)	1	5	
Flag Pole	3	5	Great condition.
Lighting Sidewalk	2	4	Paint slightly faded, great condition overall.
Pet Waste Station	1	5	
Sidewalk (Brick)	1,630 SF	4	Good condition, some unevenness.
Sign (Plaque)	5	5	
Trash Container - City Roll Off with Post	1	5	Great condition overall.

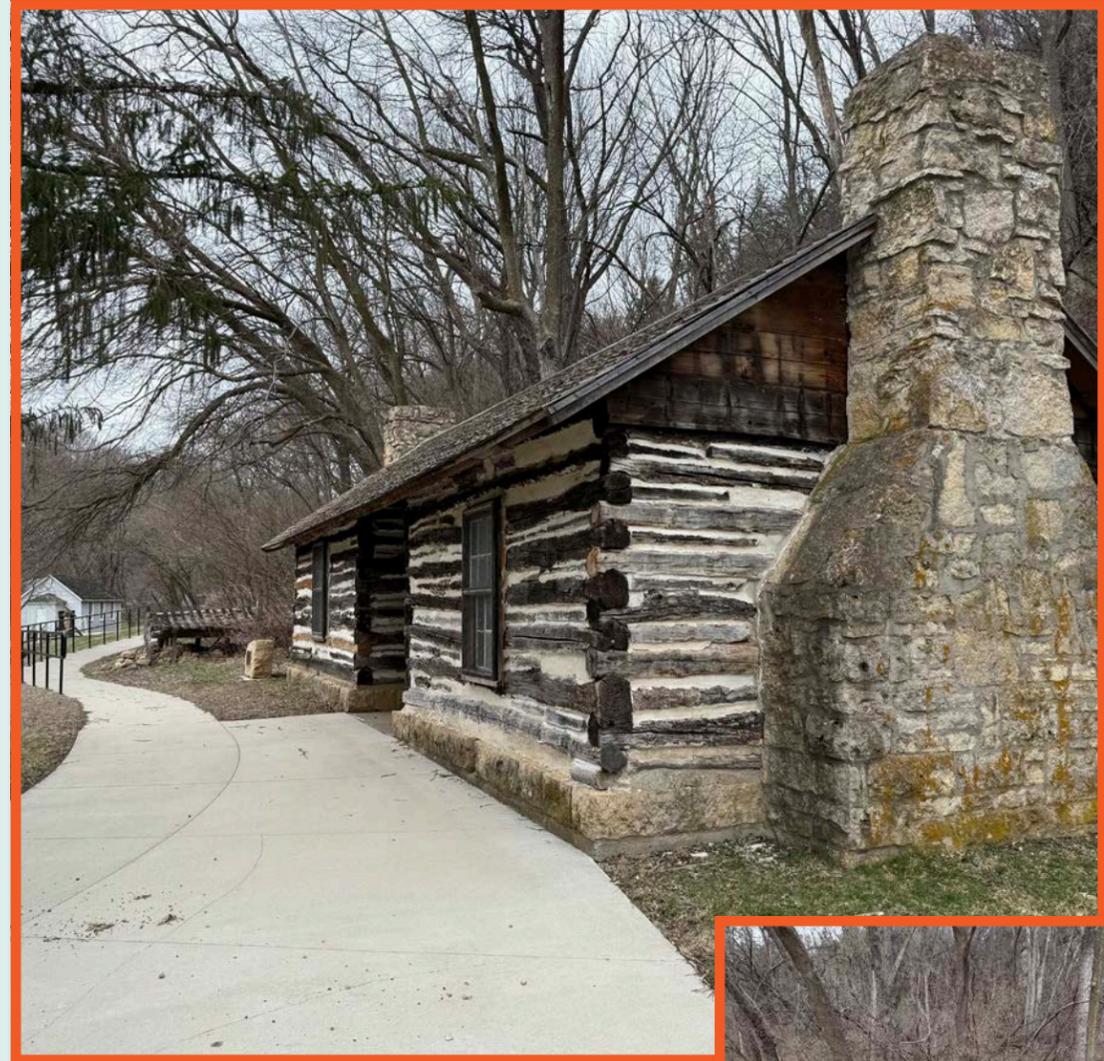
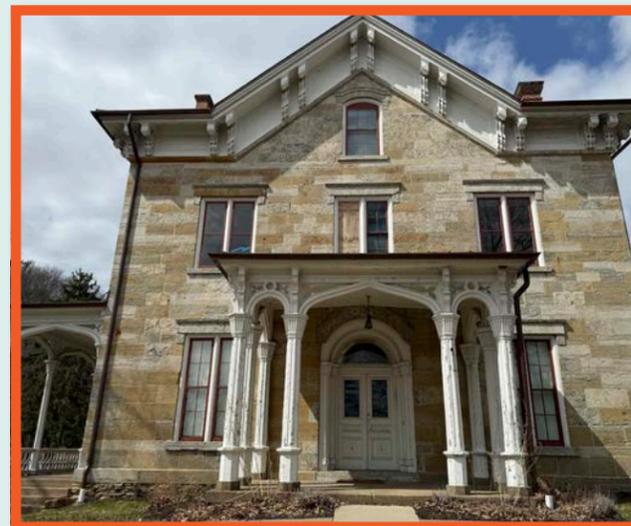
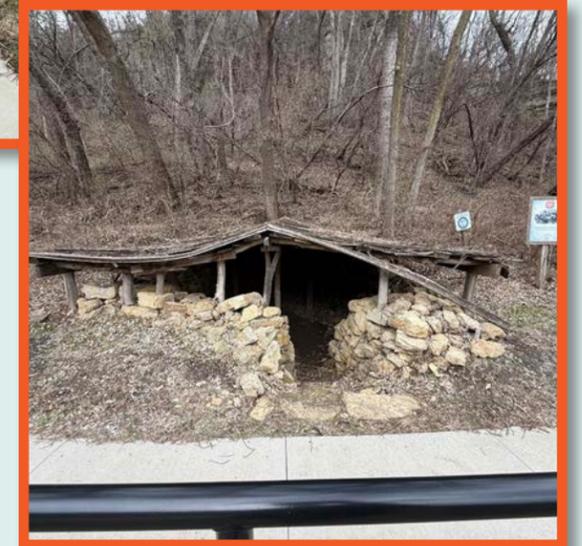
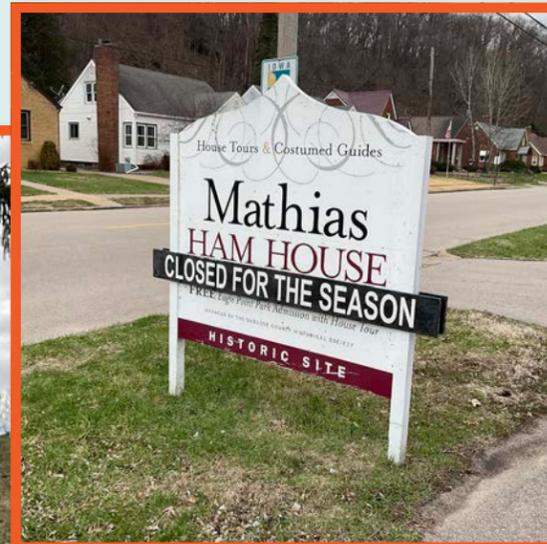
Ham House Historic site is a nice historical site with opportunities to glimpse and learn about Dubuque's past. Parking is adequate and the connectivity to Eagle Point Park only adds to the historical factor of this site.

AMENITY TYPE	QTY	GRADE	NOTES
Lighting Parking	1	3	LED light on wooden pole, wood is worn but decent.
Lighting Pathway	2	3	Flood-style light on metal pole, some rusting present.
Other	1	N/A	Historical Site
Parking (Asphalt Paving w/ Striping)	6,600 SF	4	Great condition of surface and striping.
Sign (Interpretive Display with Post)	6	4	Ham House signage and info boards.

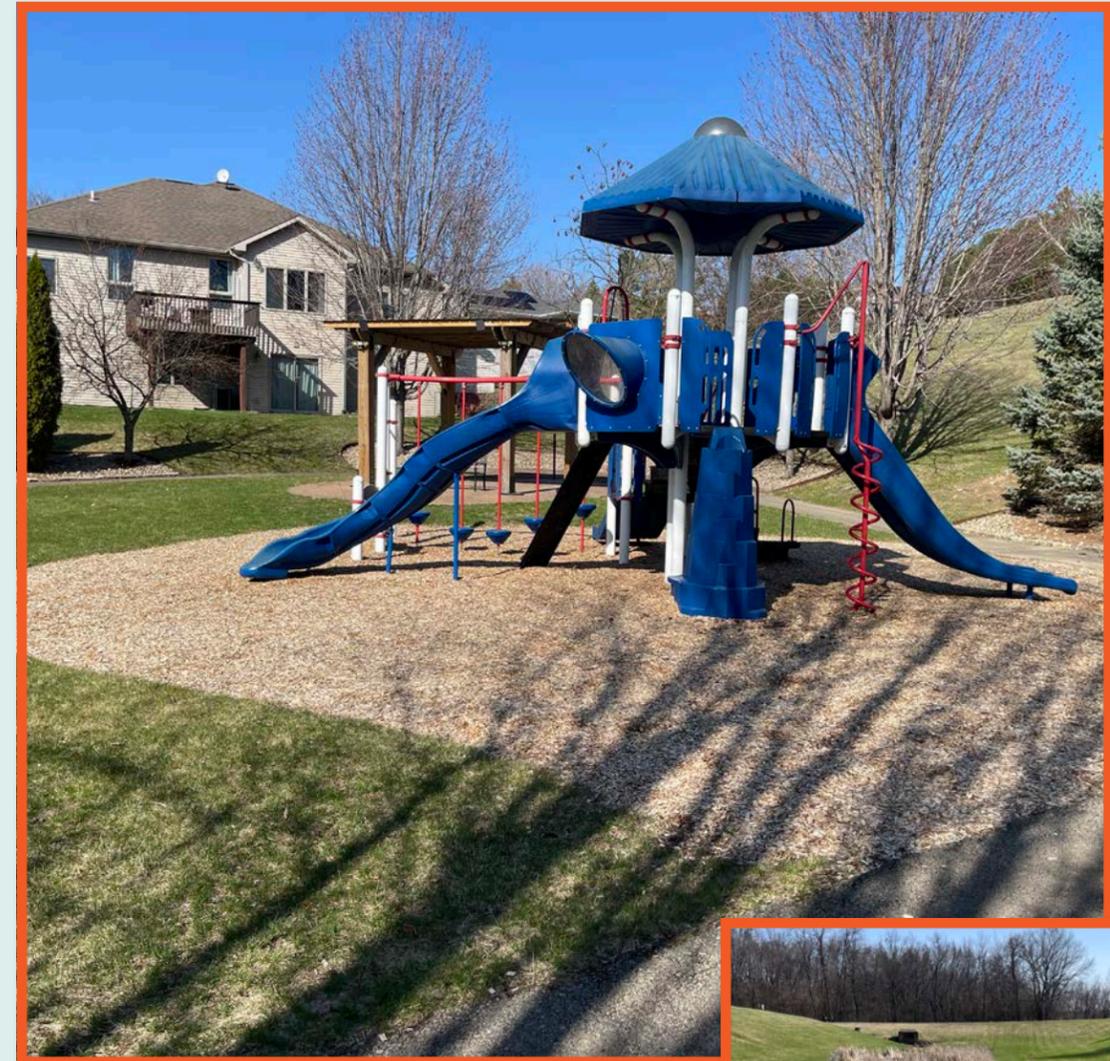
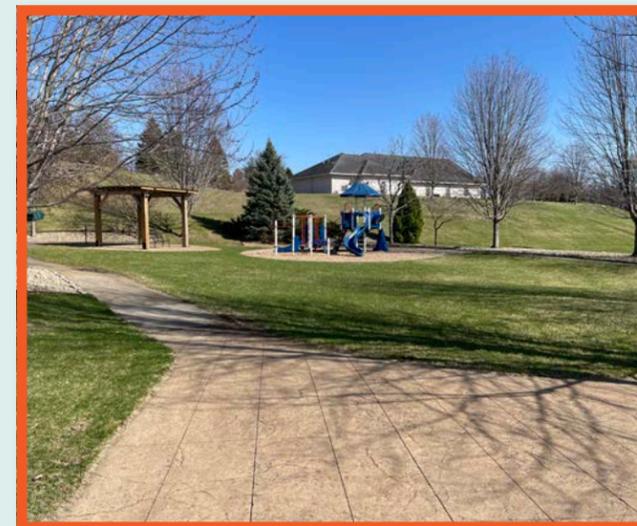
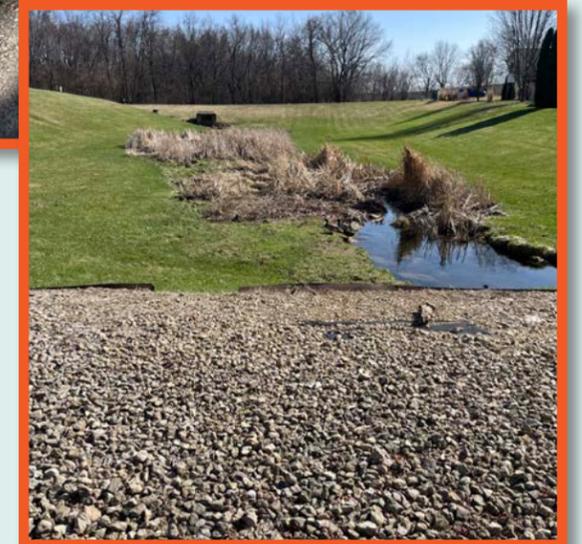
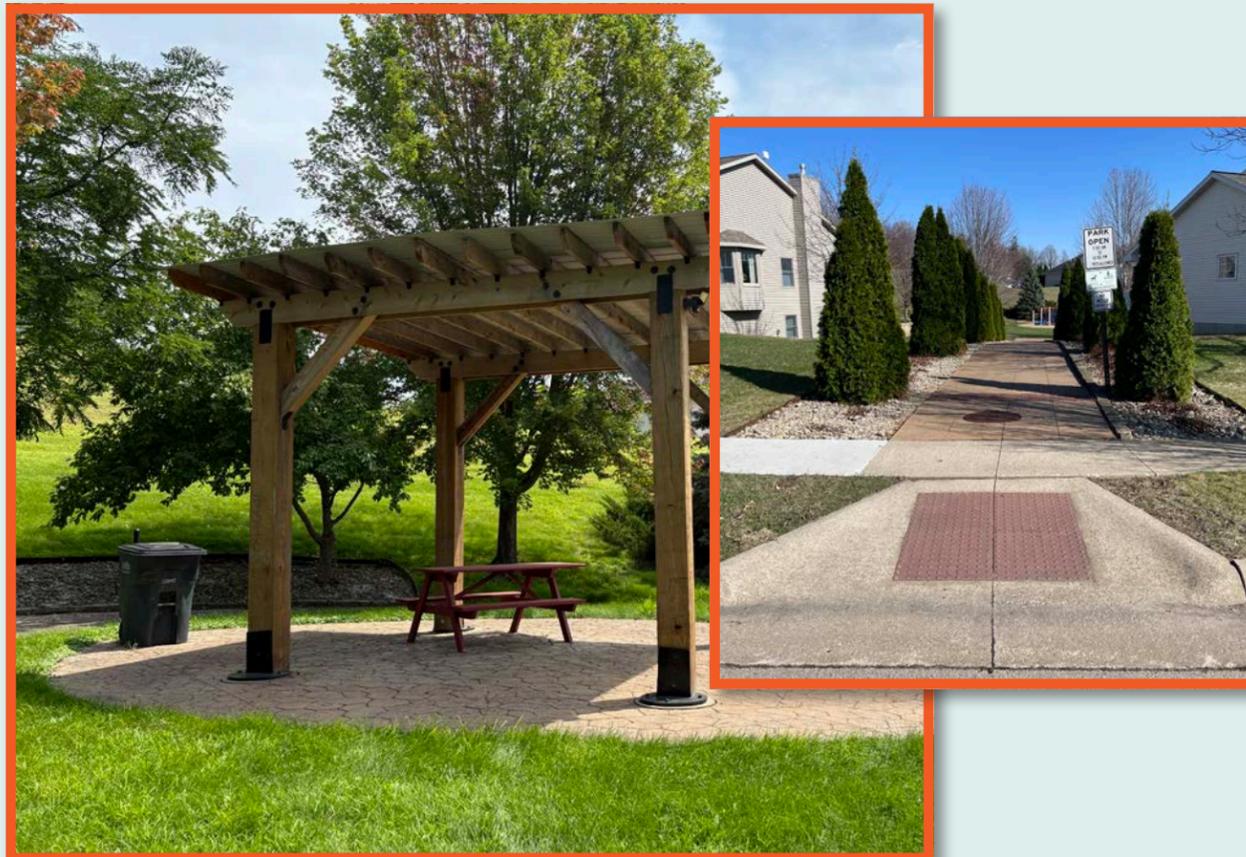
Harvest View Park is a quaint park situated on the outskirts of a neighborhood. Although it is located at the bottom of a hill, it offers ADA access to its amenities which are all in great condition. Its proximity to the surrounding homes makes it a great resource to the surrounding neighborhood.

AMENITY TYPE	QTY	GRADE	NOTES
Bench	1	3	Decent metal bench.
Pavilion Open	1	4	Wooden pergola , overall great condition.
Picnic Table (Wood)	2	3	Decent condition, wooden tables.
Playground Equipment (Large 5-12 Years)	1	3	Surface rust on metal elements. Shade on structure is not adequate. Decent condition overall.
Playground Surfacing (Wood Mulch)	1,650 SF	1	Does not appear to be at depth, needs refreshed.
Sidewalk (Asphalt)	1,750 SF	3	Cracks and spalling present.
Sidewalk (Integral Color Concrete)	1,800 SF	4	Great condition integral color and stamped concrete.
Trash Plastic Roller Bin	1	3

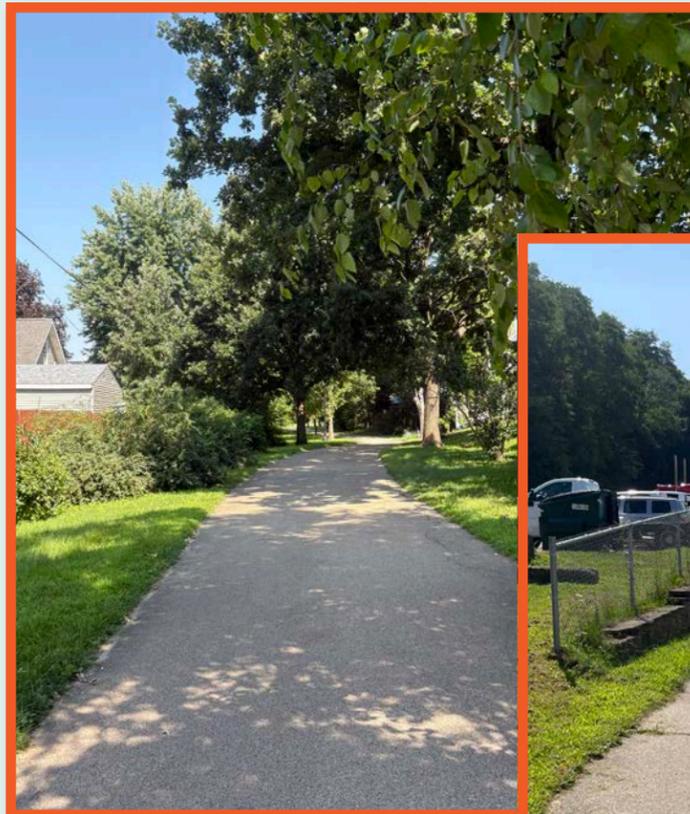
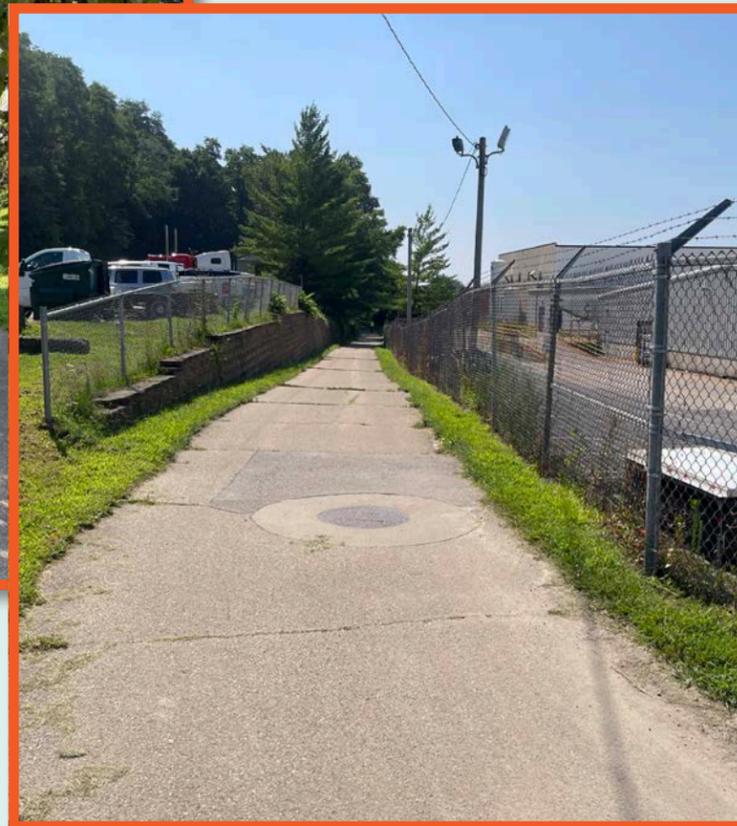
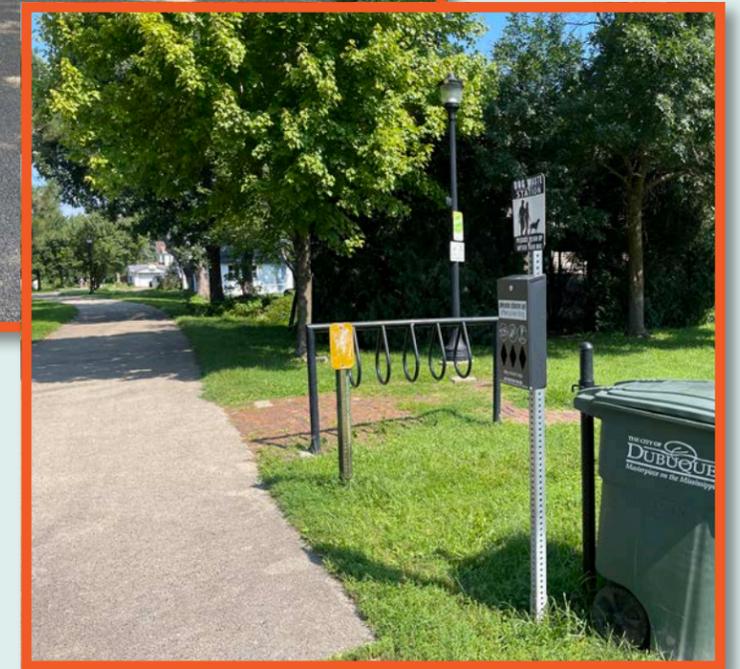
Heritage Trail is a 26-mile long multi-use trail connecting the Dubuque area with Dyersville, Iowa. It features benches, bike racks, picnic tables, signage, trash cans, and access to nearby parks. The trail surface is mostly compacted crushed limestone, with only the urban access portion in Dubuque paved.

AMENITY TYPE	QTY	GRADE	NOTES
Bench	2	5	Some scratches but looks new.
Bike Rack	1	3	
Parking (Asphalt with Striping)	6,500 SF	3	
Picnic Table (Metal)	1	4	With roof, on concrete pad, ADA accessible.
Sign (Traffic Style)	3	3	ADA parking space sign, pet waste station sign, park sign.
Trash Plastic Roller Bin	2	2	Rusted, some on concrete pads some not.

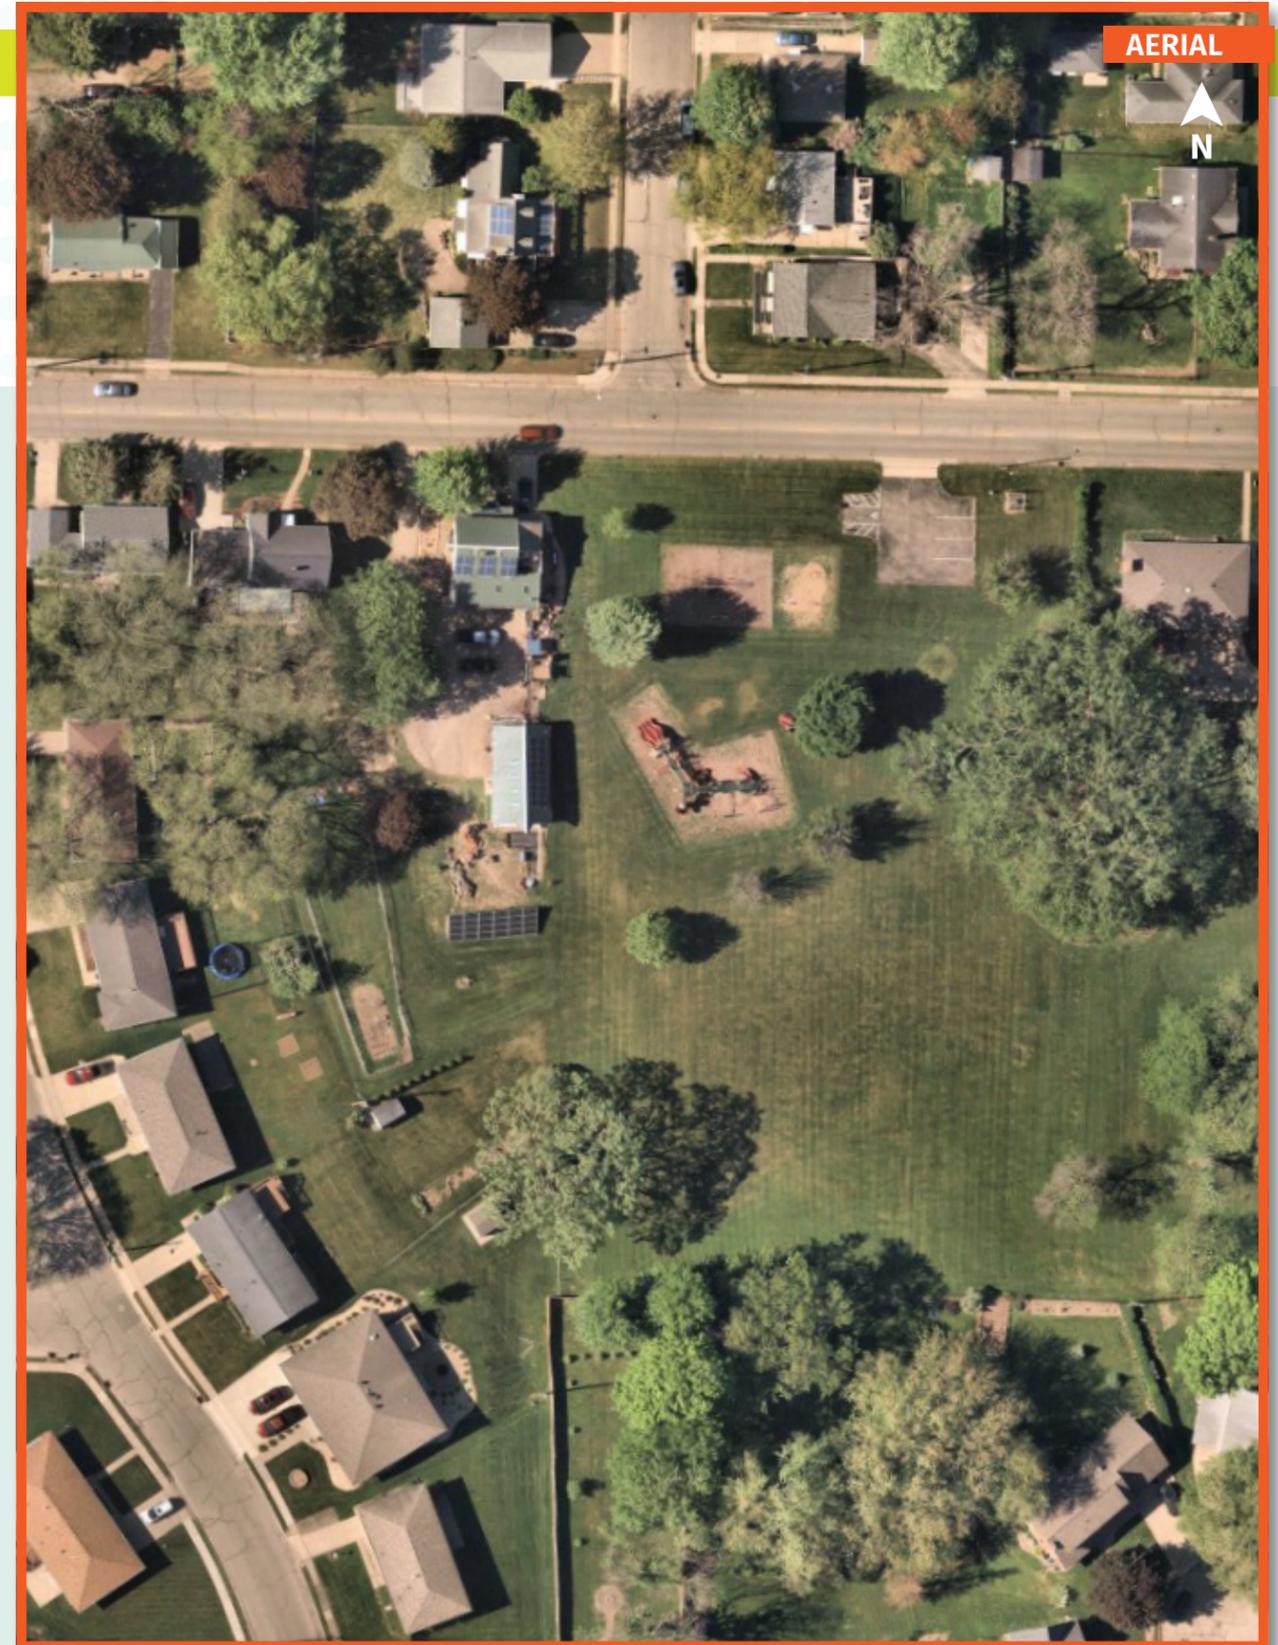
Hillcrest Park is a conveniently located park along the western side of Dubuque. It offers parking and is in close proximity to the surrounding neighborhood. Unfortunately, most of the amenities present are in a poor state of repair, some to the point they might pose a safety issue to the public.

AMENITY TYPE	QTY	GRADE	NOTES
BBQ Grill	1	2	Extremely rusted, no ADA access.
Parking (Asphalt Pavement w/Striping)	2,040 SF	2	Asphalt and striping are very faded.
Picnic Table (Wood)	2	3	
Playground Equipment (Large 5-12 Years)	1	1	Major rusting prevalent, no shade or seating. No ADA access. Wood chips in decent condition but no edging present.
Playground Surface (Wood Mulch)	4,810 SF	1	Mulch needs refreshed.
Playground Equipment (Small)	3	2	2 sand diggers/1 spring rocker.
Playground Equipment (Swings - 2 Bay)	1	2	
Trash Plastic Roller Bin	1	3	No ADA access.
