Appendix A

Park Inventory and Assessment Report

Dubuque
Parks and Recreation
Comprehensive Plan

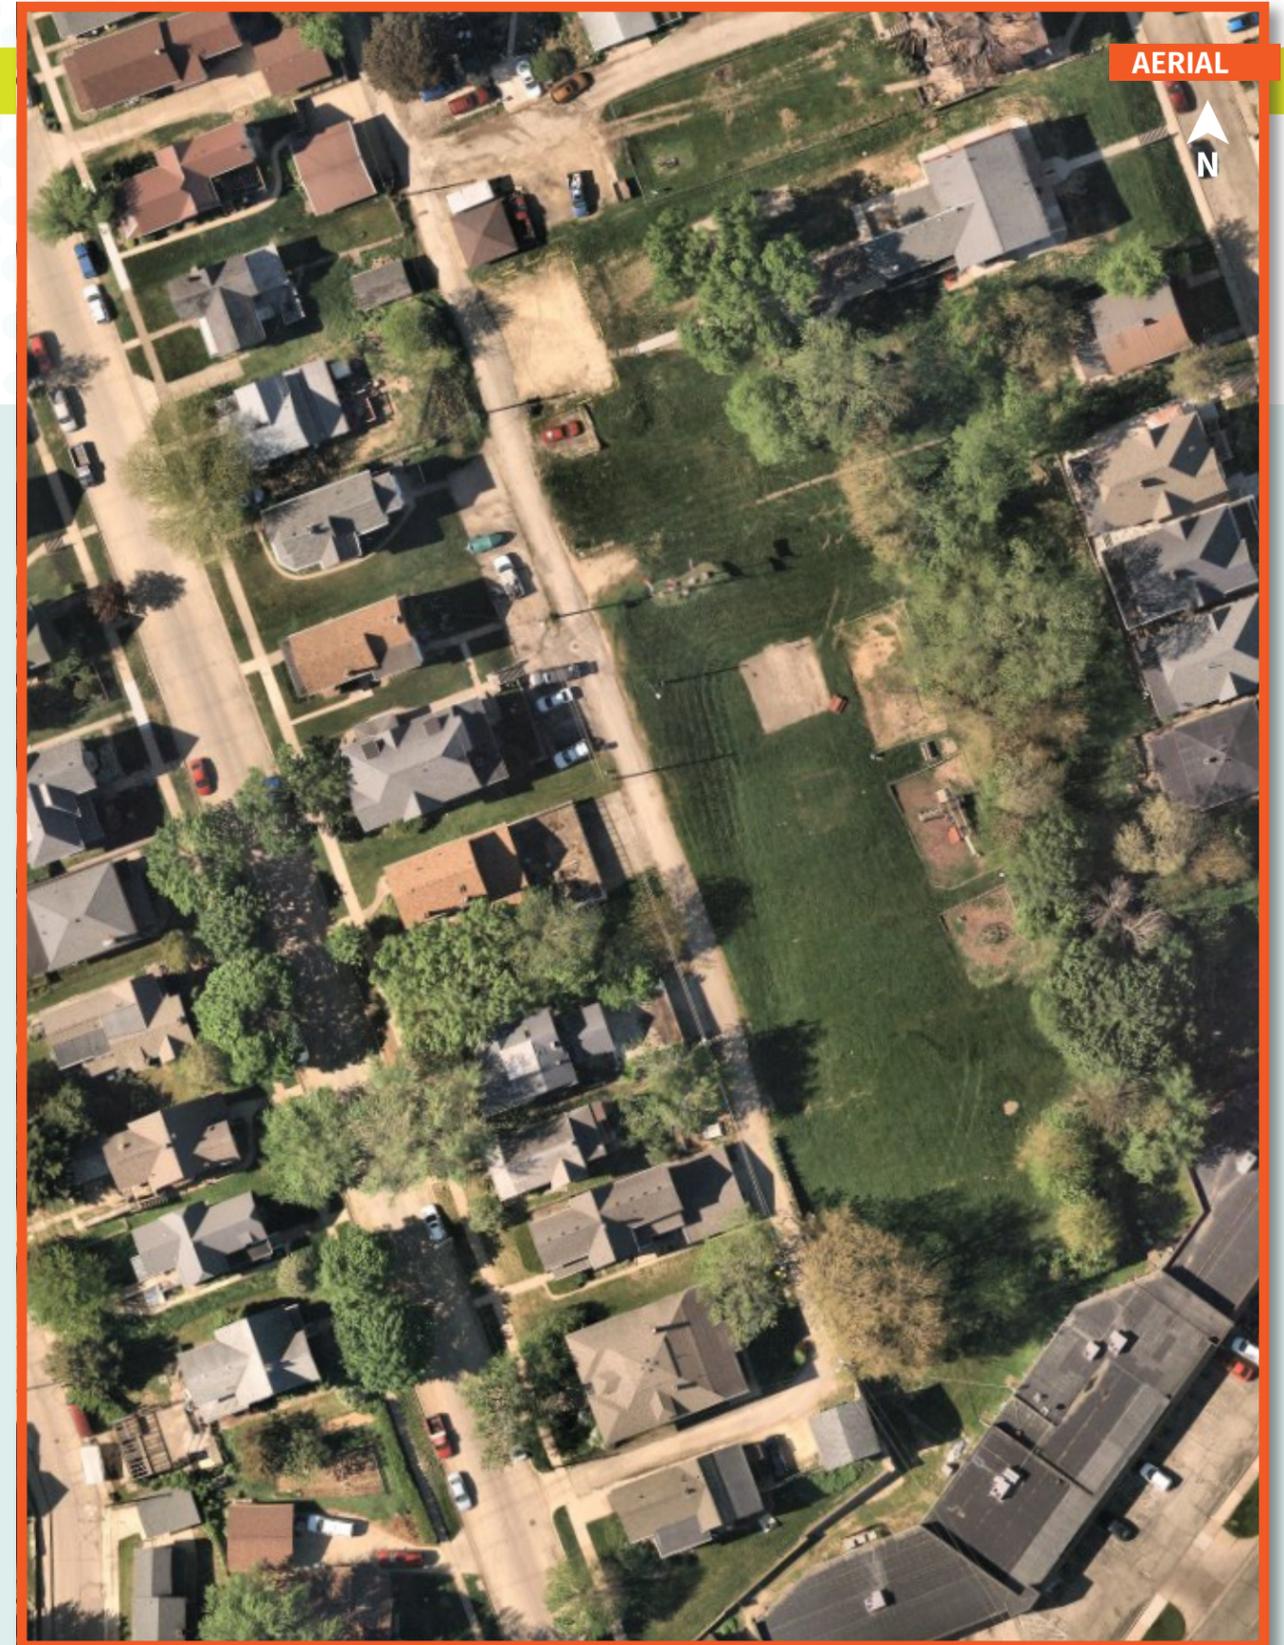
Hilltop Park includes a basketball court, swing set, playground equipment, and flag poles. The basketball court shows major cracking, lacks defined borders, and has no striping. The swing set and playground equipment exhibit rust and wear, needing additional wood fiber and lacking ADA access. The amenities are shaded by the surrounding wood line during certain parts of the day. There is plenty of open lawn space which provides lots of opportunities for play and provides a great resource to the surrounding neighborhood.

AMENITY TYPE	QTY	GRADE	NOTES
Basketball Goal (Backboard, Rim, Net, Pole)	1	2	Equipment is dated, rest prevalent.
Basketball Surface (Asphalt)	905 SF	2	Cracking, spalling present.
Flag Pole	3	4	Decent condition.
Parking	1	1	Only 1 space available, not ADA or paved.
Picnic Table (Wood)	2	2	Marked ADA but not accessible, wear and on slope.
Playground Equipment (Large 5-12 Years)	1	3	Very aged equipment, no shade, rusted and no ADA access.
Playground Equipment (Small)	2	2	Old jungle gym/spring rocker.
Playground Surface (Wood Mulch)	4,090 SF	1	Mulch needs refreshed.
Retaining Wall (Railroad Tie)	55 LF	2	
Sign (Traffic with Post)	1	3	
Playground Equipment (Swings - 2 Bay)	2	2	Poor condition.
Trash Plastic Roller Bin	1	3

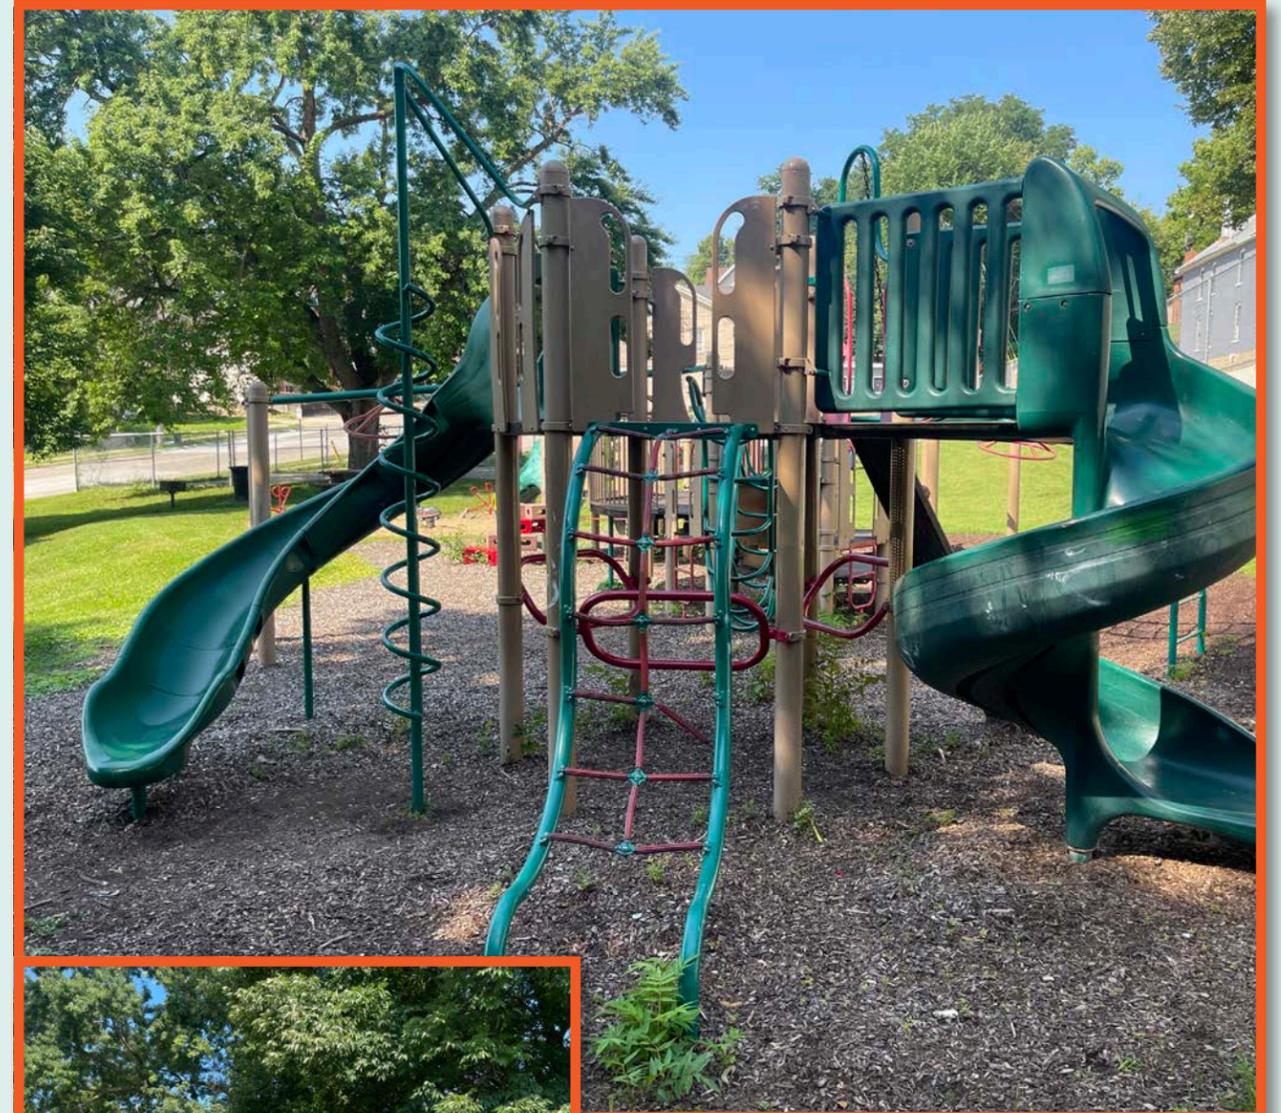
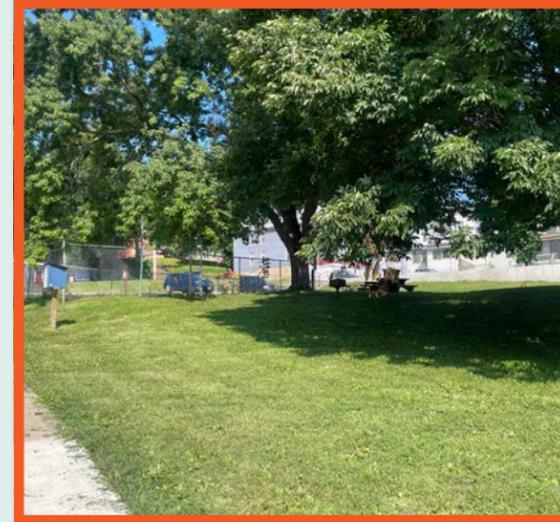
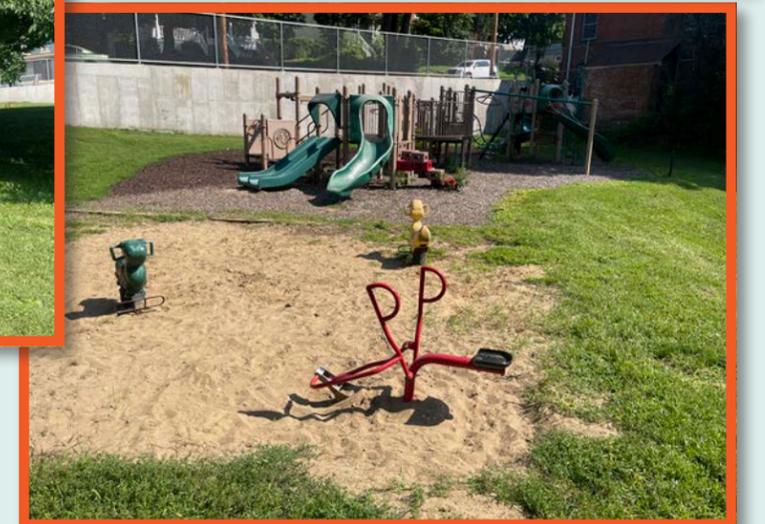
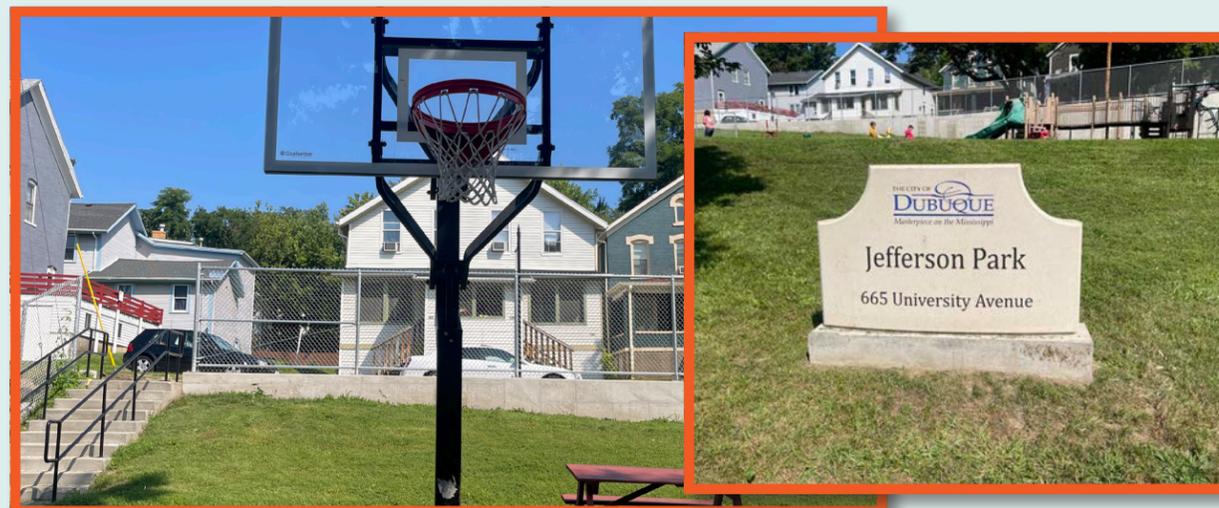
JOHN G BERGFELD RECREATION AREA

John G Bergfeld Recreation Area features amenities such as restrooms, drinking fountains, parking, a playground, pavilion, flag poles, benches, pedestrian bridges, and a lake. Playground equipment shows light rusting. The parking area and restrooms exhibit surface cracking and spalling. The area is beautiful and offers a long biking path as a part of Dubuque's trail system; however, this path does not connect to the larger trail network.

AMENITY TYPE	QTY	GRADE	NOTES
Bench	9	3	Most in good condition, three benches are rusting and severely faded.
Drinking Fountain - 2 Bubblers and Pet	2	4	Slight wear, includes a dog drinking fountain.
Flag Pole	3	4	Good condition.
Lake	9 AC	4	
Lighting (Parking)	2	3	
Pedestrian Bridge	2	3	Wood fading and some cracking, structural evaluation not performed.
Parking (Asphalt Pavement w/ Striping)	16,875 SF	3	Some cracking and spalling, decent striping.
Pavilion Closed	1	3	Wood is weathered, decent condition.
Picnic Table (Metal)	2	2	Severely faded, warping.
Playground Equipment (Large 5-12 Years)	1	2	Rusting at welds, surfacing starting to break.
Playground Surfacing (Mulch)	2,040 SF	1	Needs refreshed.
Railing	150 LF	3	
Restroom	890 SF	4	Light wear on roof, exterior evaluation only.
Retaining Wall, Type 3 - Stone (>3 ft)	125 LF	4	
Sidewalk (Plain Grey)	126,150 SF	3	Decent condition, cracks present.
Sign (Monumentation)	1	1	Wooden park sign at the end of its life, needs replaced with Dubuque City Monumentation standard.

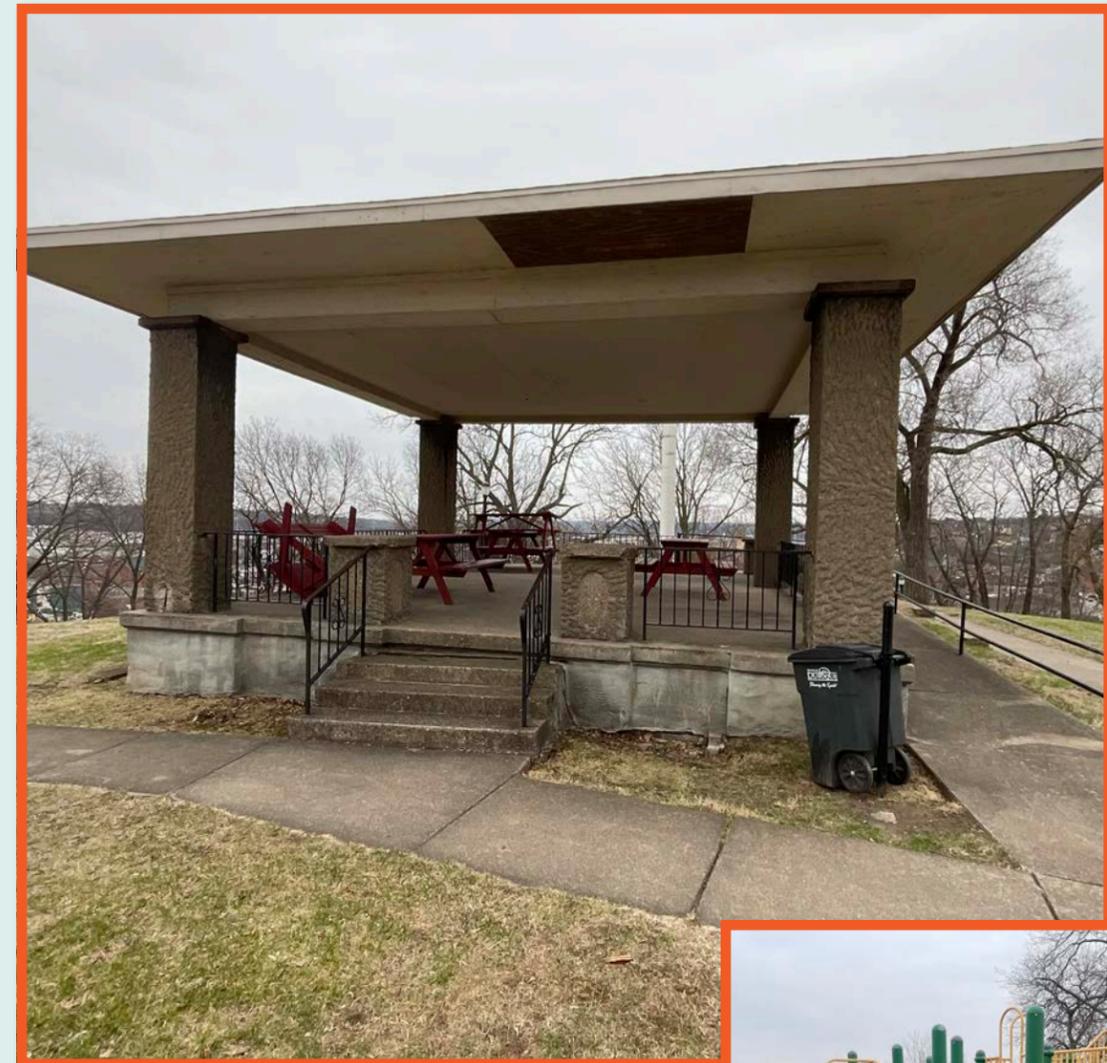
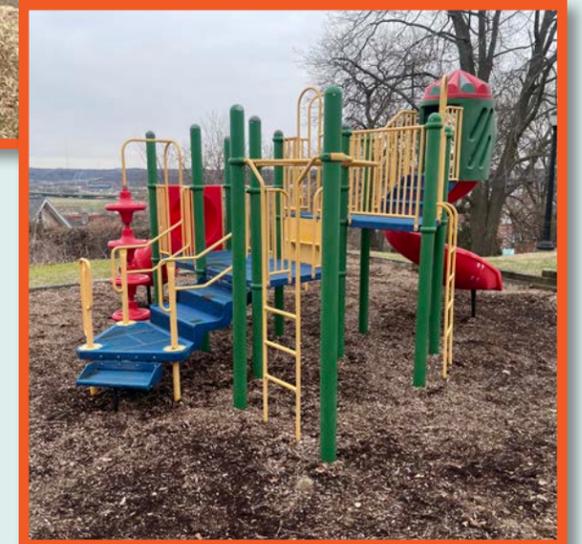
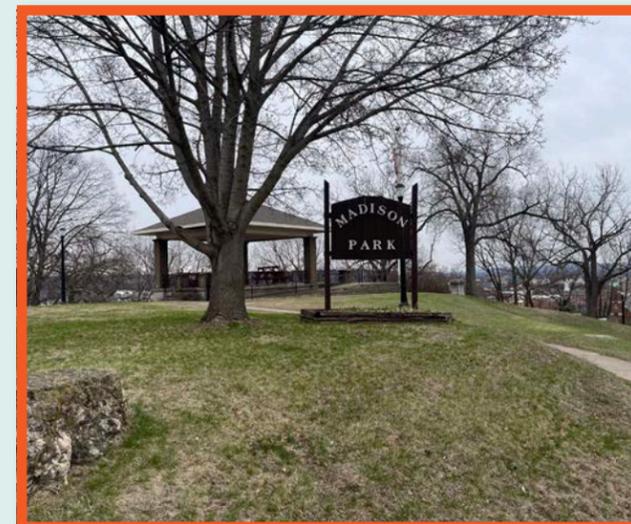
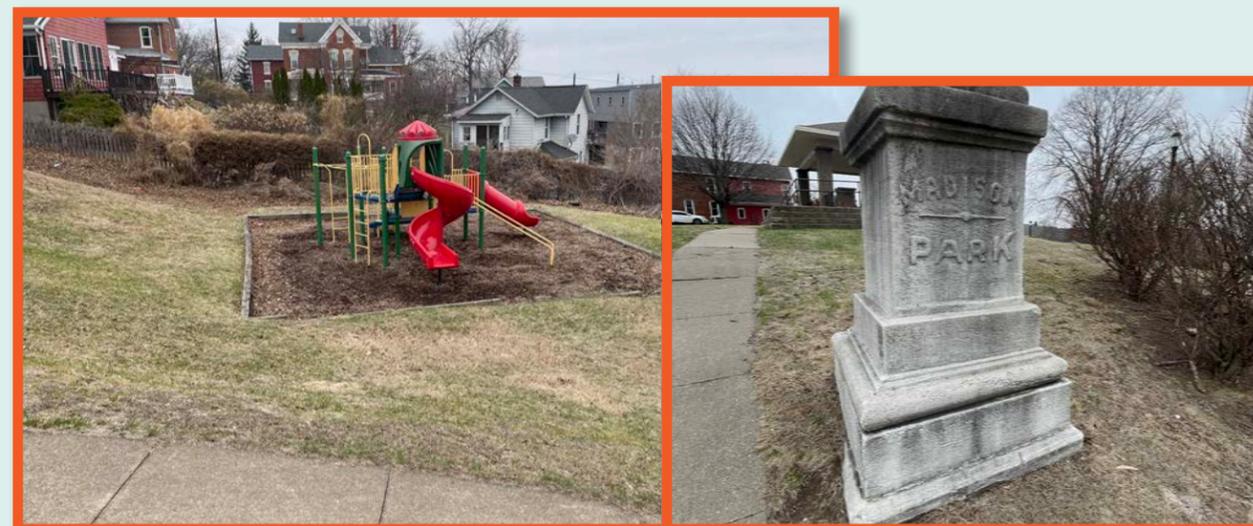
MARSHALL PARK/DUBUQUE ARBORETUM & BOTANICAL GARDEN

Marshall Park features extensive amenities including benches, trash receptacles, pavilions, picnic tables, and playgrounds. Benches show significant wear, degradation, and bird droppings. Pavilions and picnic tables are generally in good condition, with some requiring minor maintenance due to weathering. Playground equipment displays signs of wear, sun fading, and inadequate mulch coverage. Many of the amenities do not offer ADA access, but the park feels inviting and is in close proximity to the Arboretum.

AMENITY TYPE	QTY	GRADE	NOTES
BBQ Grill	2	3	
Bench	9	4	Missing uplights, trees encroaching.
Swing (3 Bay)	1	3	Good condition.
Other	5	4	Trellis Structure.
Pavilion Open	2	4	Desert Storm Bell Memorial.
Picnic Table (Metal)	2	3	Water feature. Was not operational at time of assessment, Veterans Memorial.
Picnic Table (Wood)	4	3	
Playground Equipment (Large 5-12 Years)	1	3	Mulch not to depth, very faded.
Playground Equipment (Small)	7	3	2 Sand Diggers, 1 Sand Funnel, 3 Spring Rockers, 1 Sensory Wall
Playground Surfacing (Wood Mulch)	3,525 SF	1	
Swings	2	3	Decent condition.
Restroom	1,710 SF	4	
Sidewalk (Concrete)	1,150	3	
Sign	3	4	All in good condition.
Sign (Dubuque Bike Map)	1	3	
Trash Container - City Roll Off with Post	4	3	Good condition.

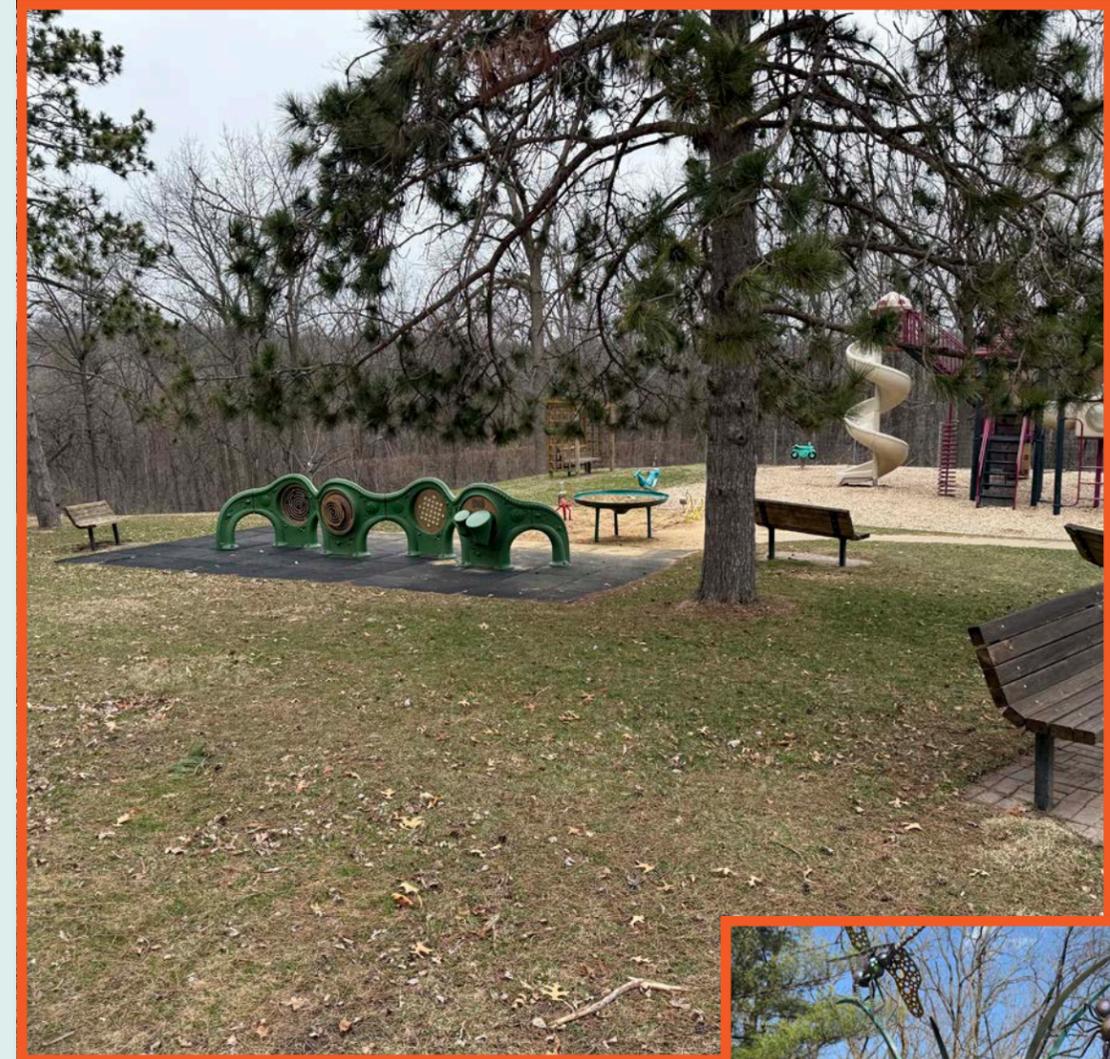
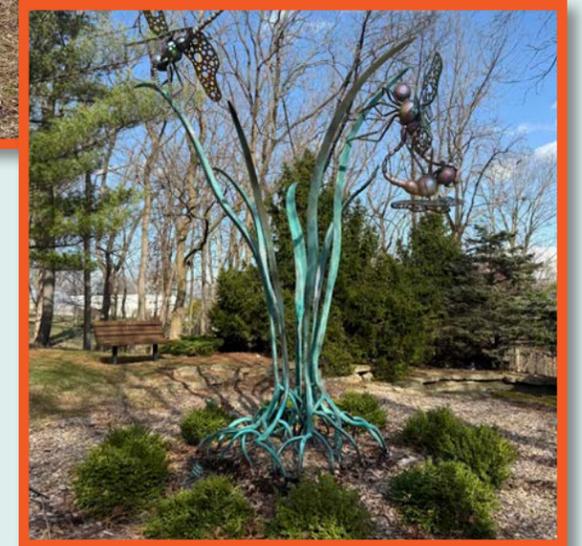
MAUS PARK

Maus Park includes signage, parking, trails, and a lake. Signage is hand painted and fading, with wooden structures deteriorating. The parking and trail areas are dirt/gravel with no ADA access, presenting uneven surfaces. The lake area is littered with trash and lacks seating or proper access.

AMENITY TYPE	QTY	GRADE	NOTES
Lake	17 AC	2	Lots of trash present, no ADA access anywhere.
Sidewalk (Asphalt)	2,700 SF	2	Cracked and uneven.
Sign (Monumentation)	1	1	
Sign (Traffic Style with Post)	2	4	Park signs on Existing Monument Sign
Trail (Unpaved)	1,400 LF	2	Uneven dirt and gravel path.

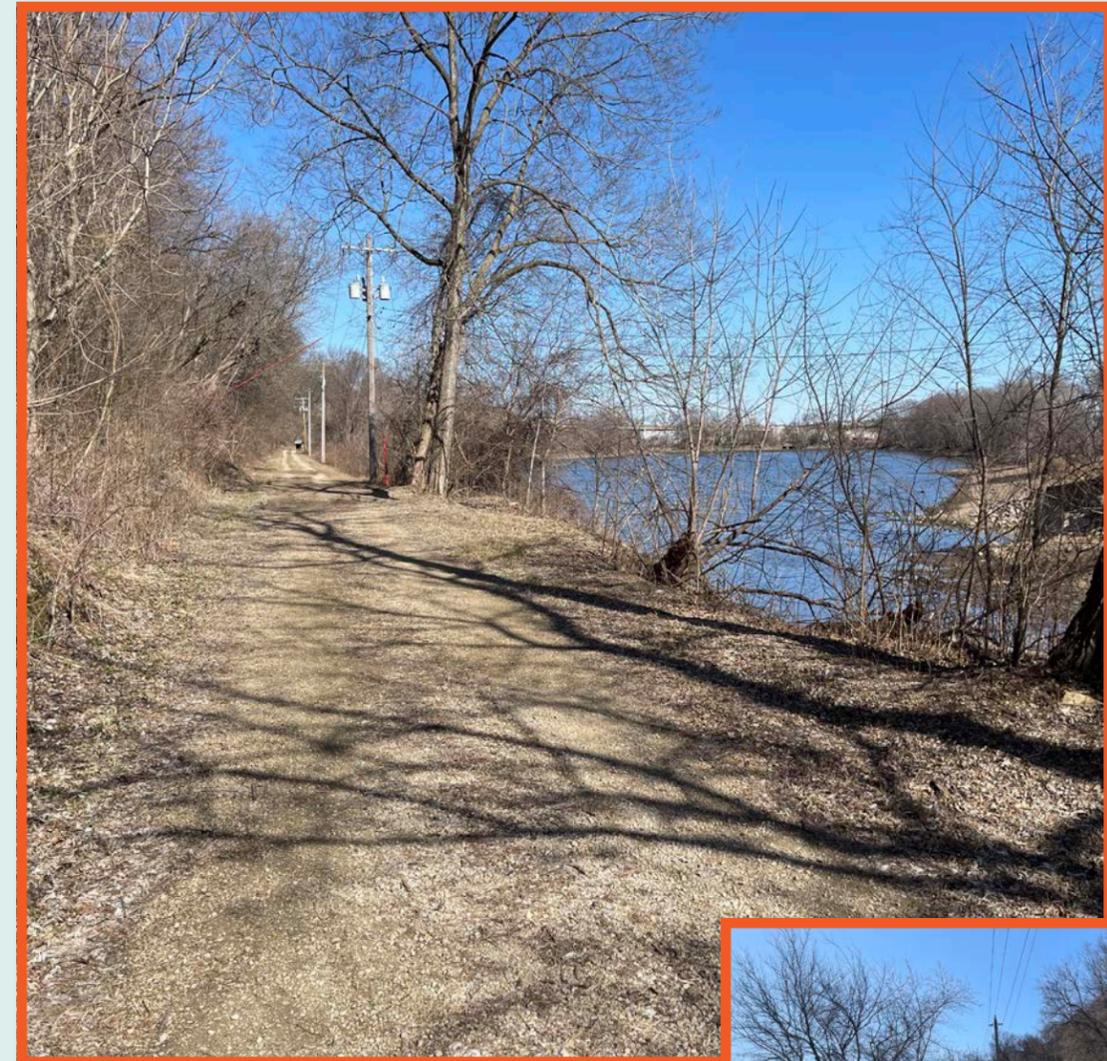
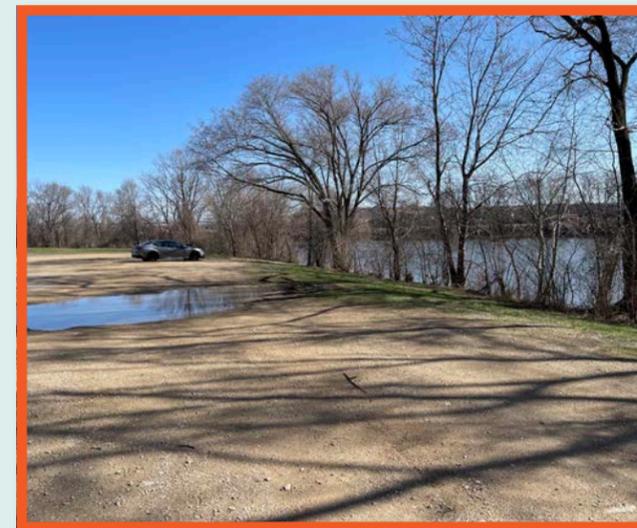
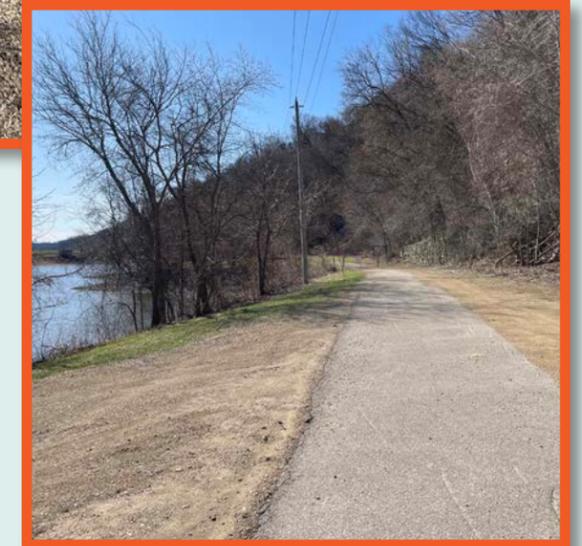
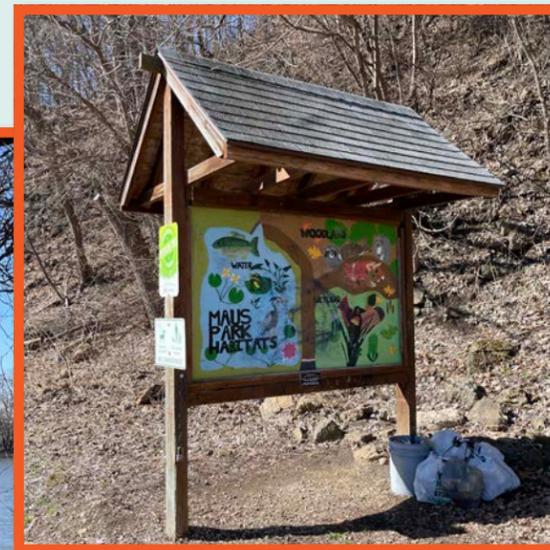
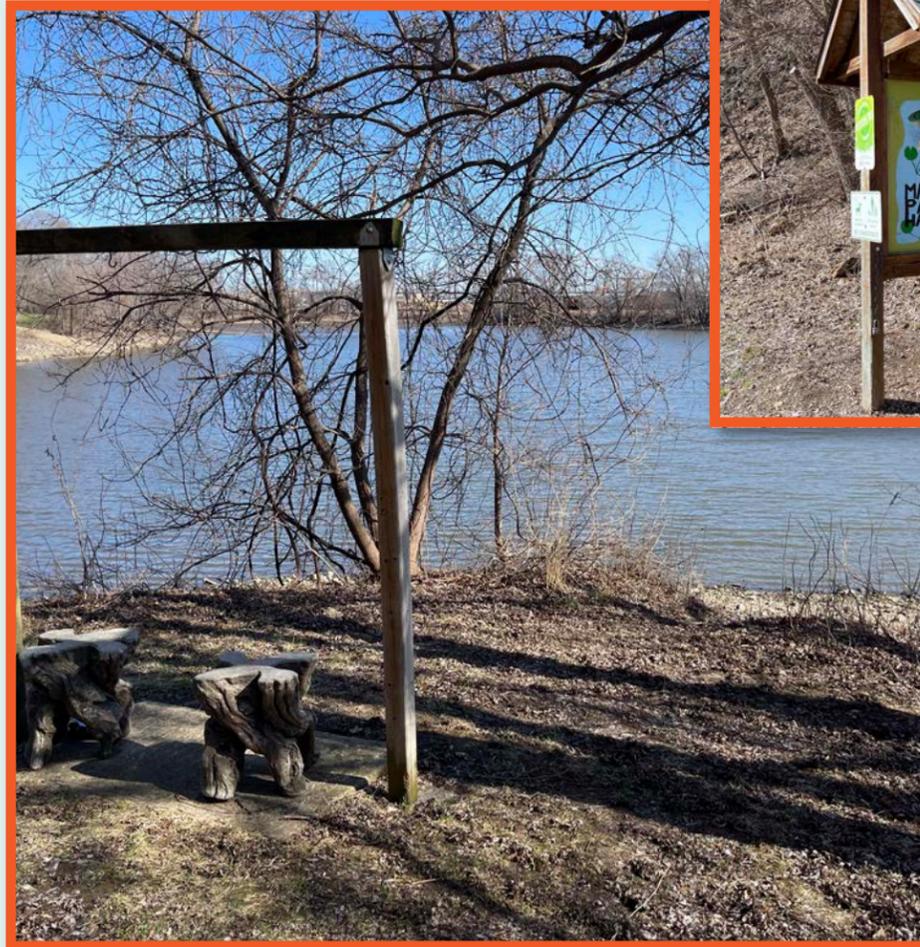
MCALEECE PARK AND RECREATION COMPLEX

McAleece Park and Recreation Complex provides various amenities including sufficient parking, a pavilion, skate park, lighting, benches, playgrounds, and baseball/softball fields. The parking lot shows faded striping and cracks, while the pavilion needs rust treatment and wood restoration. The skate park exhibits some rusting panels, and the playground has mulch needing replenishment. The baseball/softball complex feels grand and has a nice layout. Unfortunately, ADA access is limited within the facility. The adjoining Veterans Memorial is immaculate and pristine and offers many intimate moments for admiration and reflection.

AMENITY TYPE	QTY	GRADE	NOTES
Baseball Field	1	5	New field is in great shape.
BBQ Grill	1	3	Some rusting on base. Good overall.
Bench	4	2	Rusted, sitting at angle. Inside locked playground.
Concession	3,750 SF	3	Exterior only, everything in decent shape. No ADA access anywhere to concessions or bathroom.
Drinking Fountain w/ Bottle Filler	1	5	
Flag Pole	1	4	
Lighting Parking	8	5	
Sports Lighting	12	3	Stadium lighting for fields. Dated but decent condition.
Maintenance Yard	4,320 SF	4	
Other	1	4	Bike track, needs signage.
Other	1	4	Softball Hall of Fame Memorial.
Parking (Asphalt Pavement w/ Striping)	188,795 SF	3	Decent condition. Striping okay, spalling and cracking present.
Pavilion Open	1	2	Very dated, wood faded. Rust covers most metal.
Playground Equipment (Large 5-12 Years)	1	3	Decent condition.
Playground Surfacing (Wood Mulch)	3,500 SF	1	
Picnic Table (Wood)	4	3	
Sidewalk (Concrete)	23,712 SF	4	Great condition.

Sign (Traffic Style)	15	4	Park hours, rules, ADA signs.
Skate Park	15,015 SF	2	Rusting present, good condition.
Softball Field	3	2	Overall decent field. Dugouts have no overhead shade. Metal fences a little weathered and dated. Netting for fly balls ripped in multiple places
Trash Plastic Roller Bin	2	4	Decent

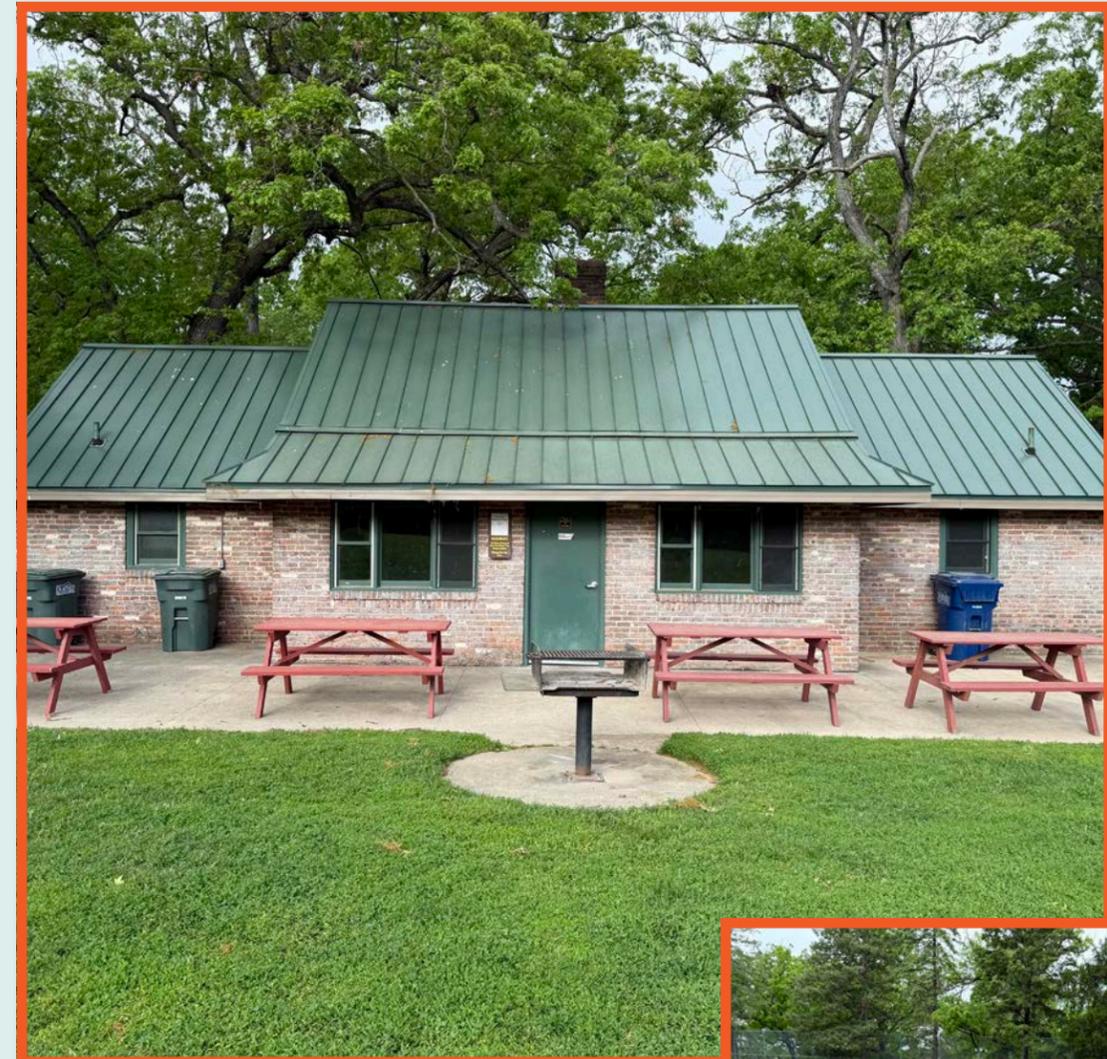
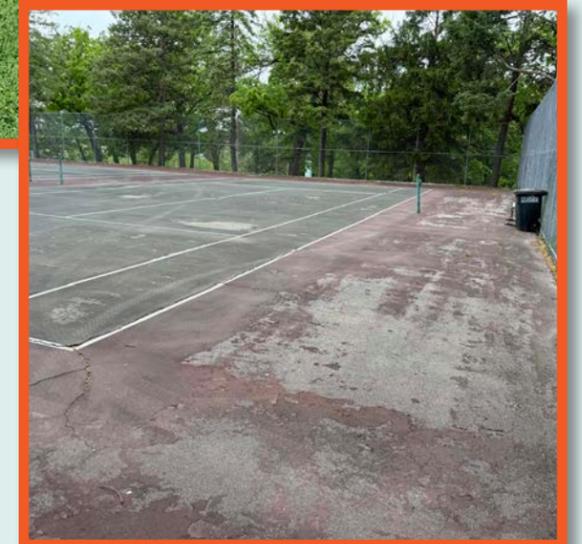
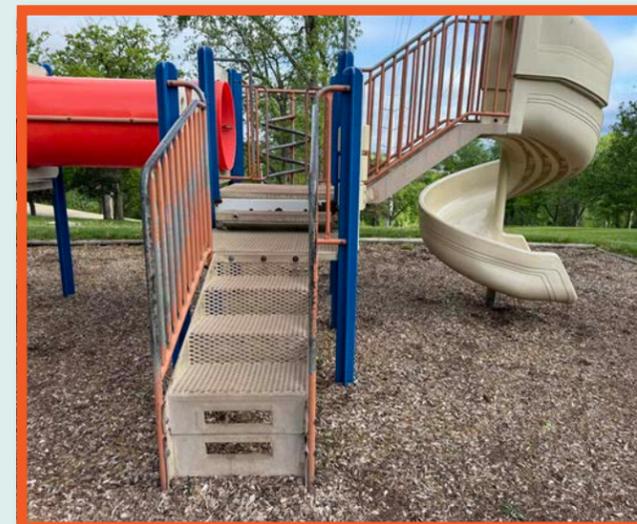
ORANGE PARK

Orange Park is centrally located and offers amenities such as playgrounds, benches, and an open green space for the surrounding neighborhood.

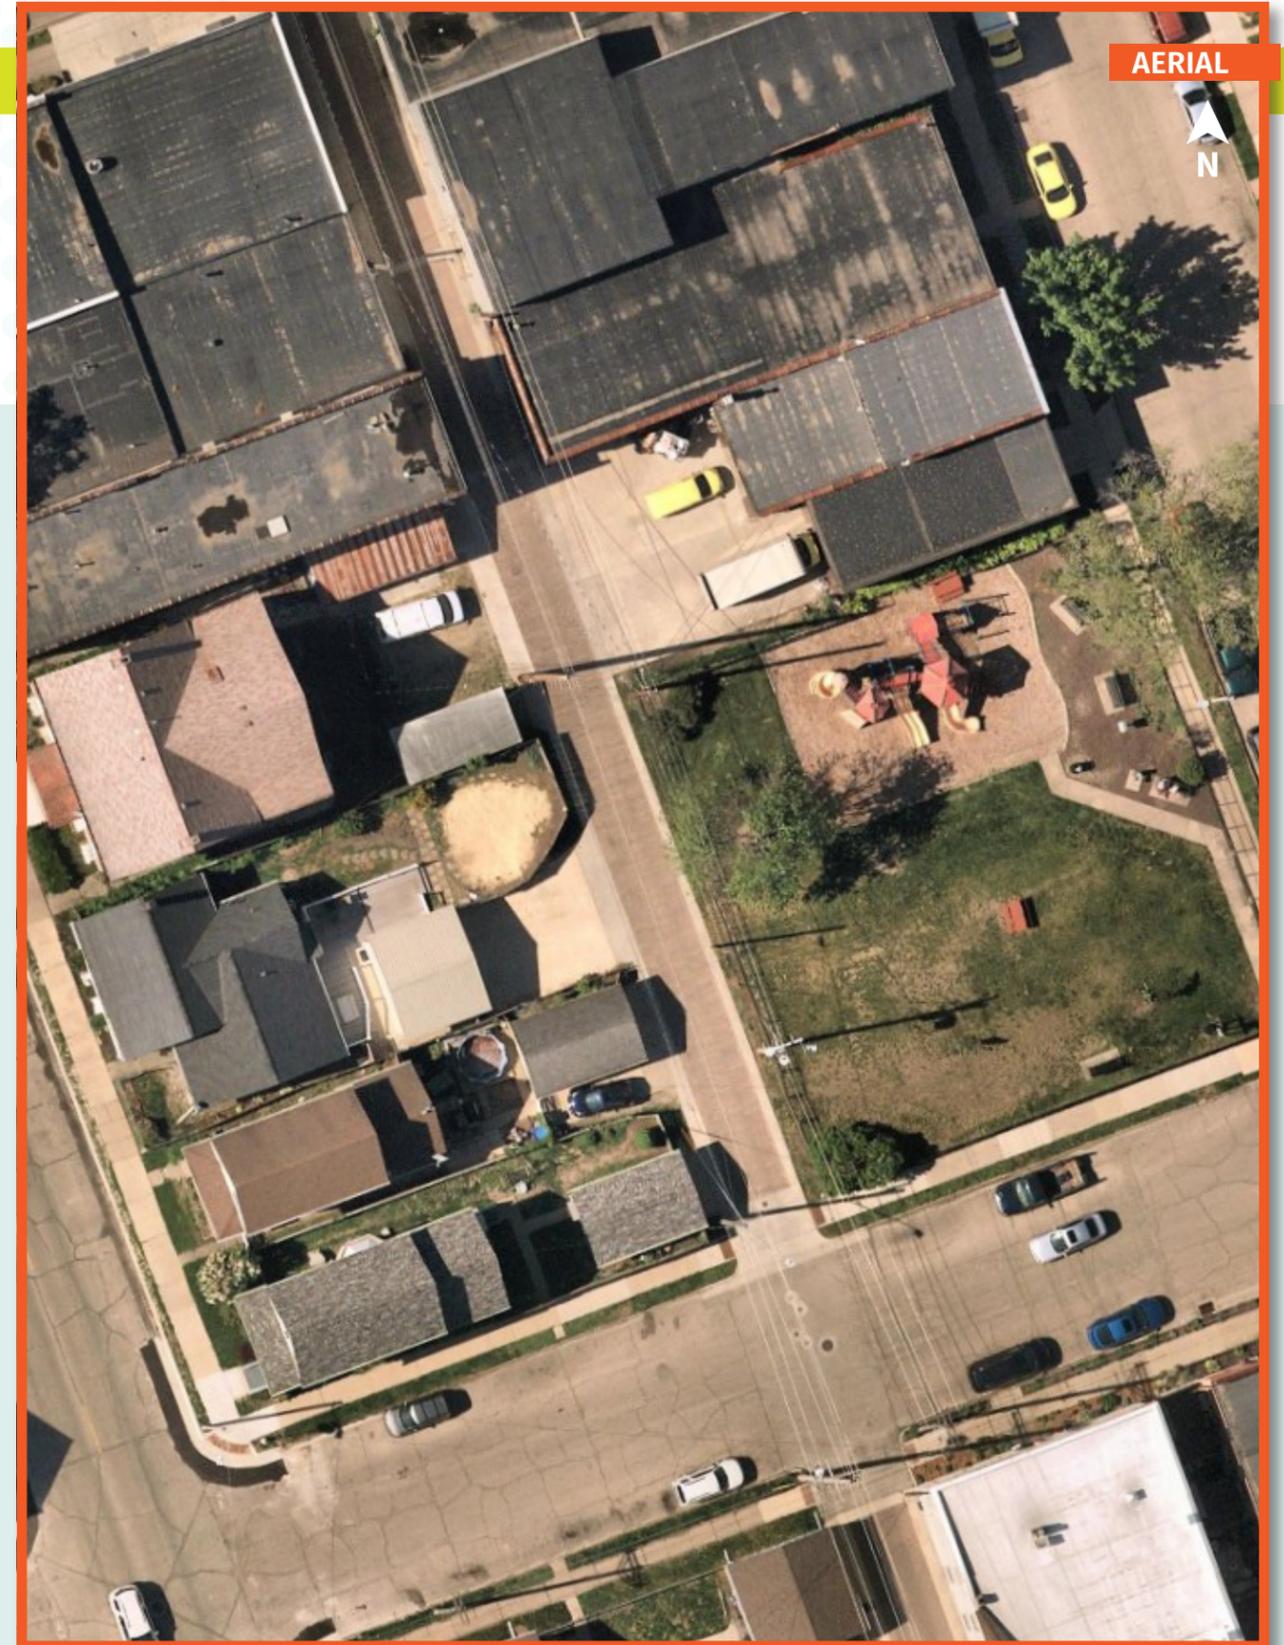
ORANGE PARK CONTINUED

AMENITY TYPE	QTY	GRADE	NOTES
Bench	4	2	Major wear and rusting present.
Drinking Fountain - 2 Bubblers	1	2	Rust and superficial damage prevalent.
Kiosk	1	1	Missing top.
Playground Equipment (Large 5-12 Years)	1	1	Multiple spots with heavy rust, plastic coverings on climbing chains are dry rotting and falling apart. Equipment height too tall for current mulch surface. No ADA access.
Picnic Table (Wood)	1	3	
Playground Surfacing (Wood Mulch)	2,035 SF	2	Wood mulch needs refreshed.
Sidewalk (Concrete)	320 SF	3	Decent condition.
Sign (Traffic Style with Post)	2	3	Park hours sign and park rules sign.
Sign (Monumentation)	1	1	Wooden park sign at the end of its life, needs replaced with Dubuque City Monumentation standard.
Trash Plastic Roller Bin	1	3	Not on concrete pad. Decent condition.
Wrought-Iron Fence	410 LF	3	Decent condition.

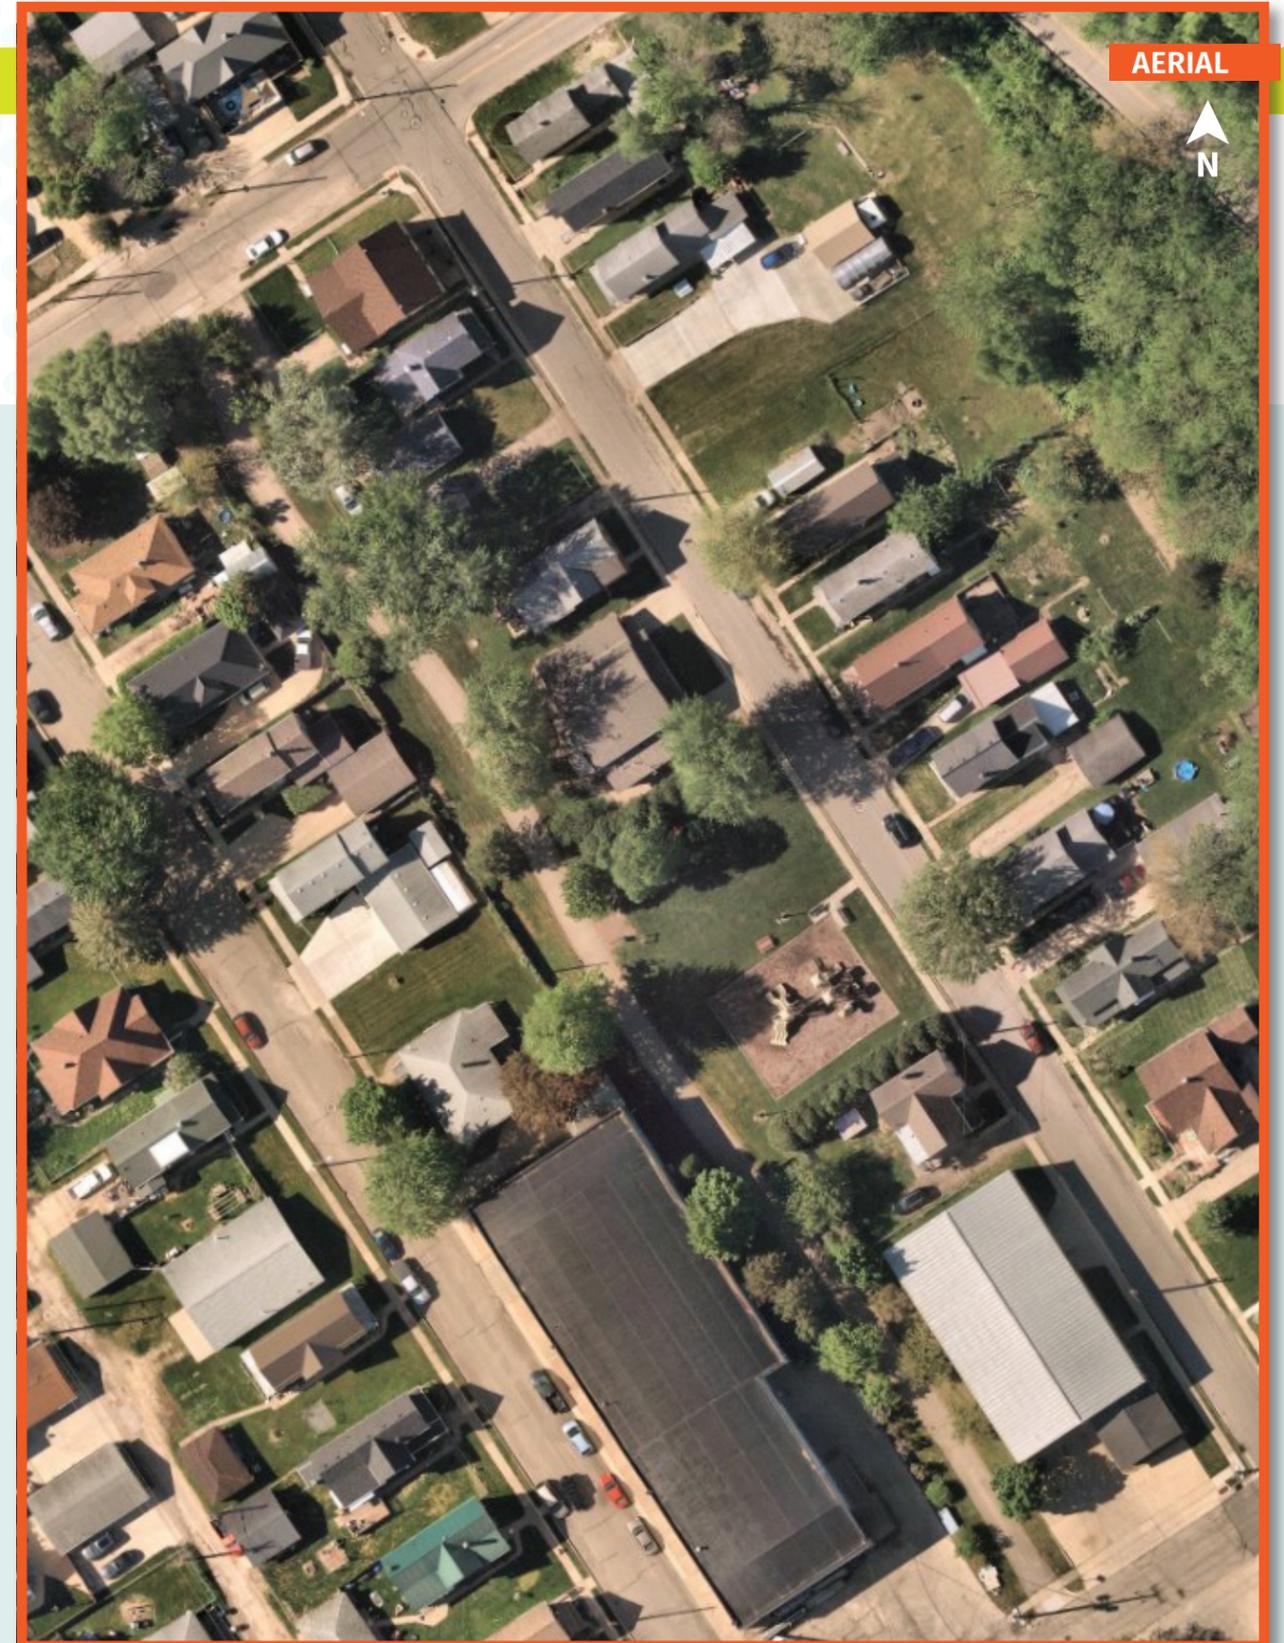
PINARD PARK CONTINUED

AMENITY TYPE	QTY	GRADE	NOTES
Bench	2	3	Minor wear and tear, ADA compliant.
Bike Rack	1	3	Minor superficial damage.
Lighting Pathway	3	4	Great condition.
Pet Waste Station	1	4	
Picnic Table (Wood)	1	3	
Playground Equipment (Large 5-12 Years)	1	2	Wear and tear present, decent condition.
Playground Surface (Wood Mulch)	2,917 SF	1	Wood Mulch needs Refreshed, does not appear to be to depth.
Sidewalk (Concrete)	160 SF	3	
Sign (Monumentation)	1	1	The existing park wooden monument sign is at the end of its lifecycle and needs to be replaced with the City's current park Monumentation standard.
Signage (Traffic Style w/ post)	2	4	Park signage, missing playground rules.
Trash Plastic Roller Bin	1	4	City trash bin on new post. Dog waste station attached.

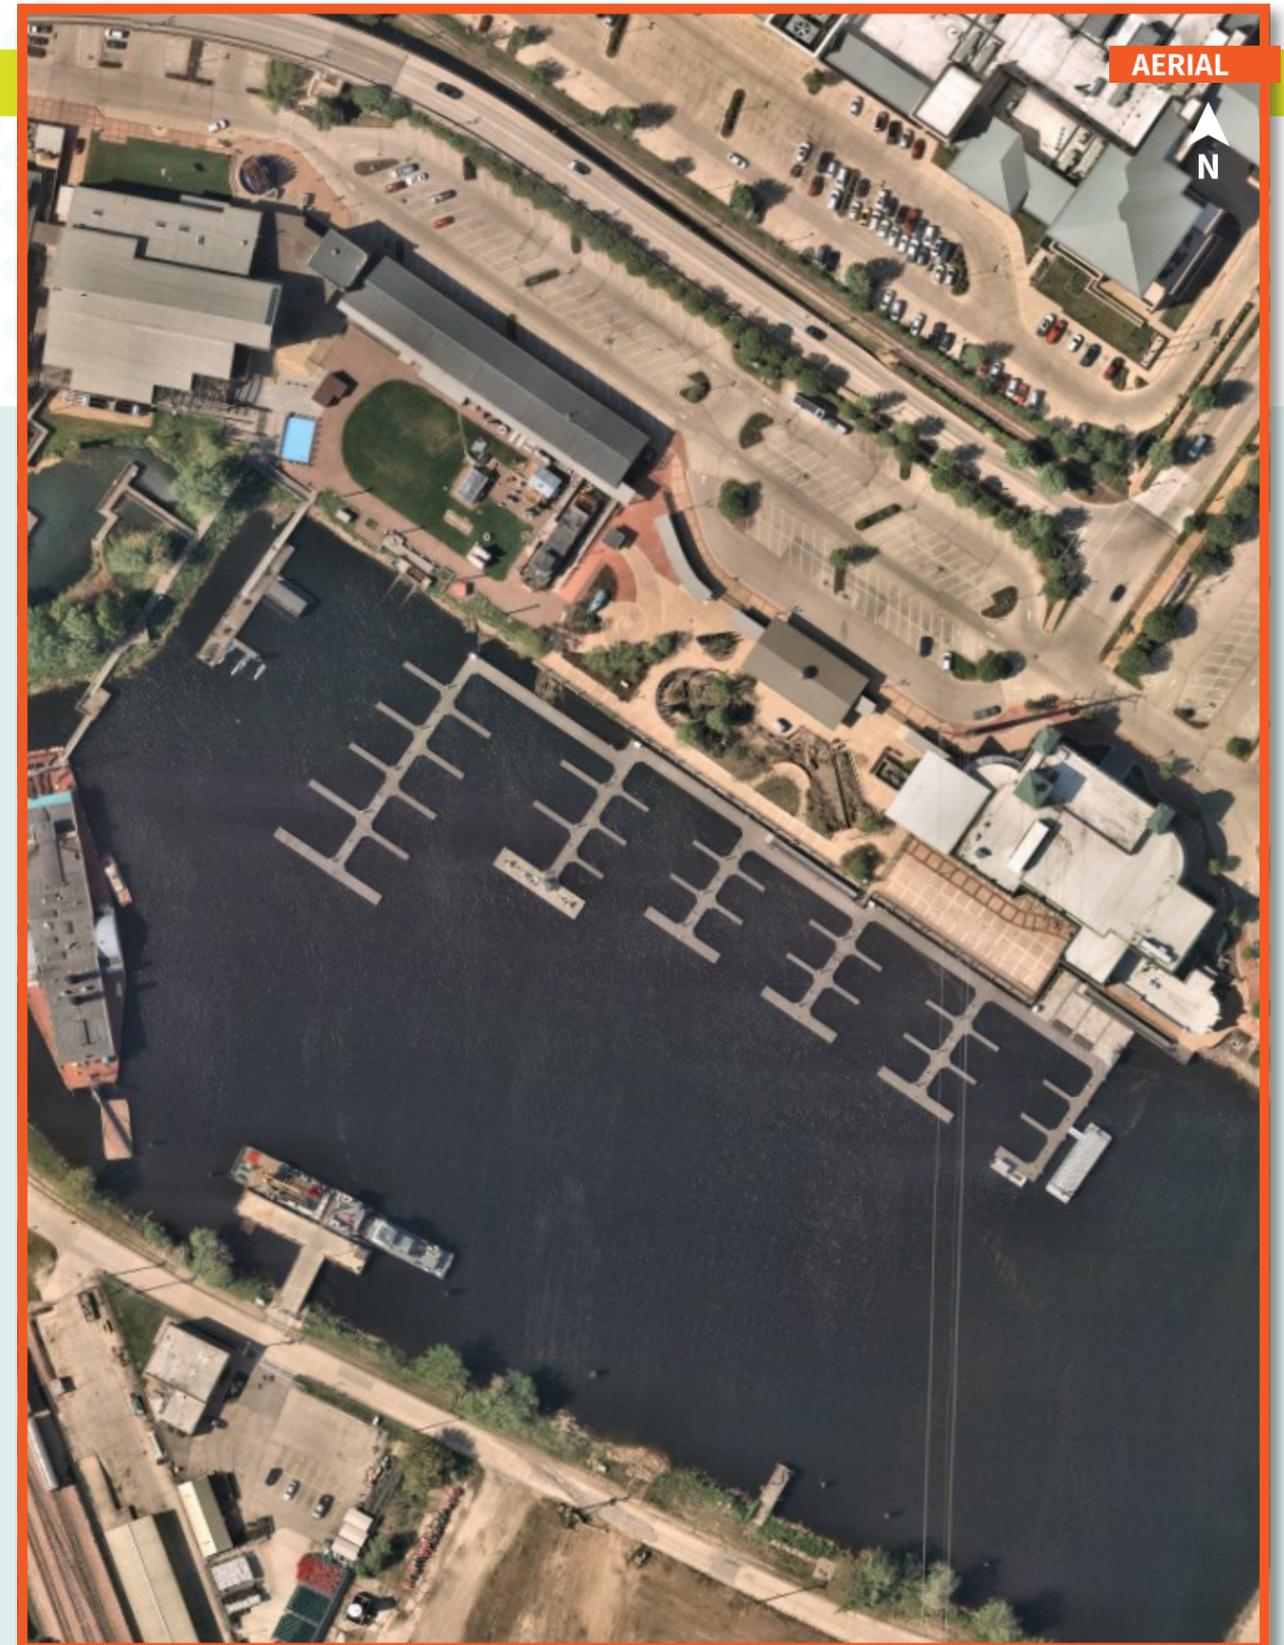
PORT OF DUBUQUE MARINA CONTINUED

AMENITY TYPE	QTY	GRADE	NOTES
Bench	2	5	Great condition.
Marina Shop	34,950 SF	5	Marina Shop.
Pier Dock	22,005 SF	5	New, great condition.
Planter (Raised) Type 2 (36")	220 LF	5
