Appendix A

Park Inventory and Assessment Report

Dubuque
Parks and Recreation
Comprehensive Plan

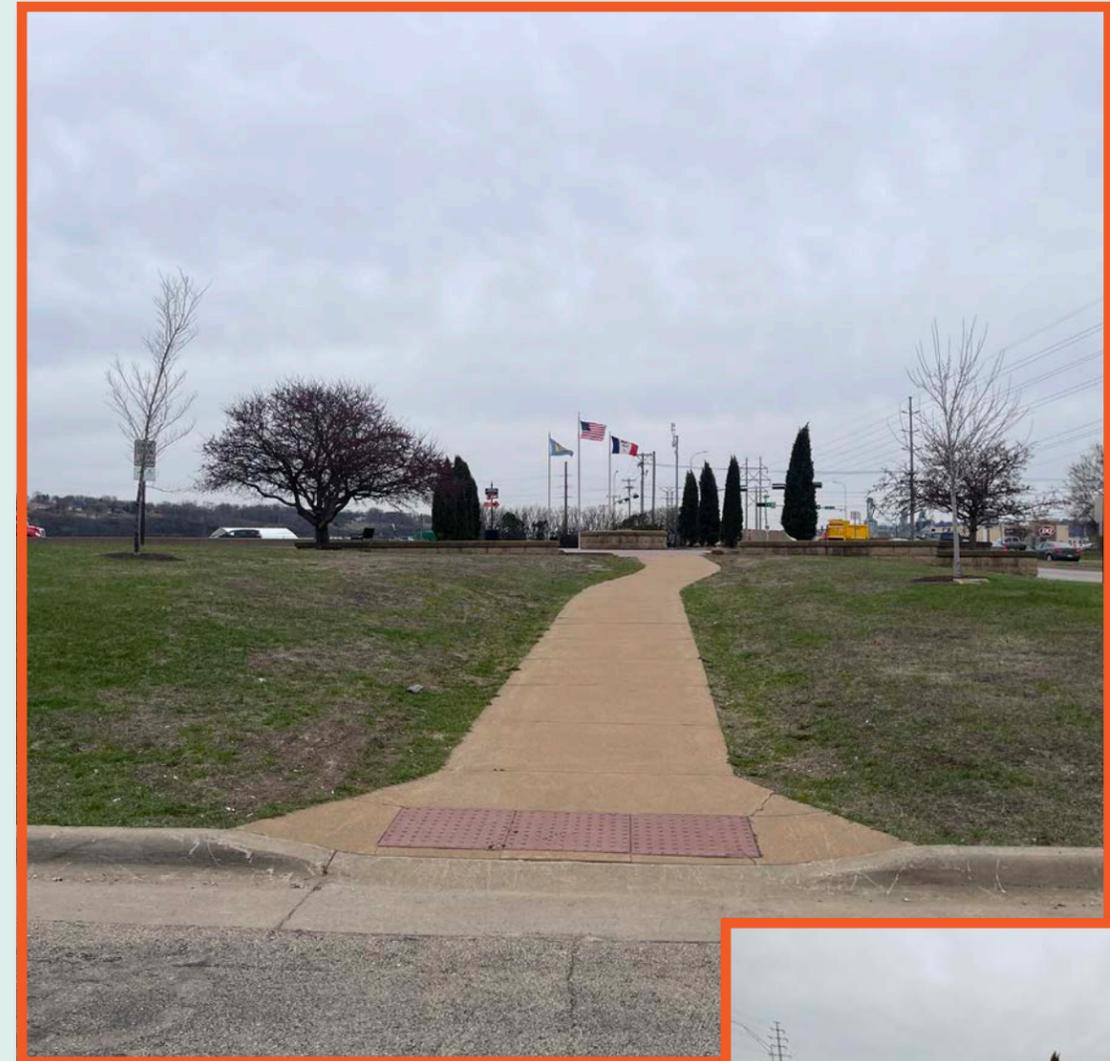
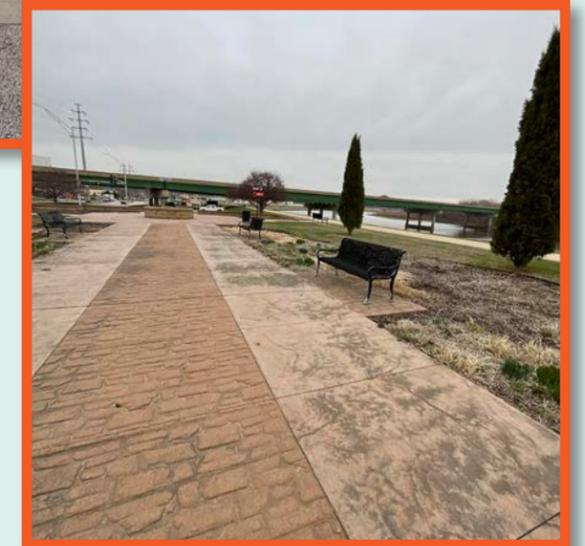
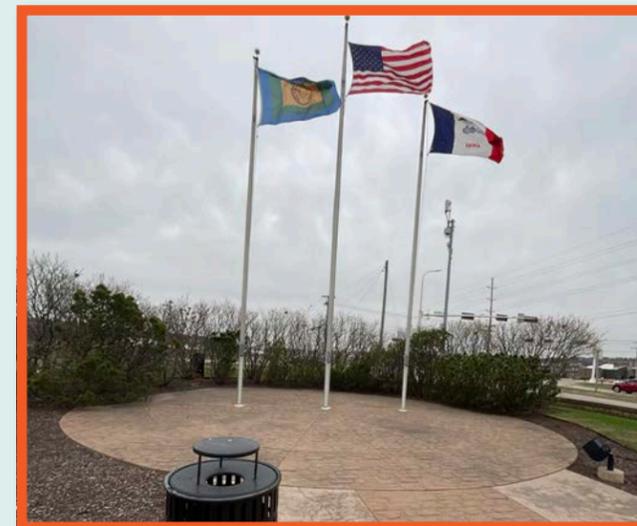
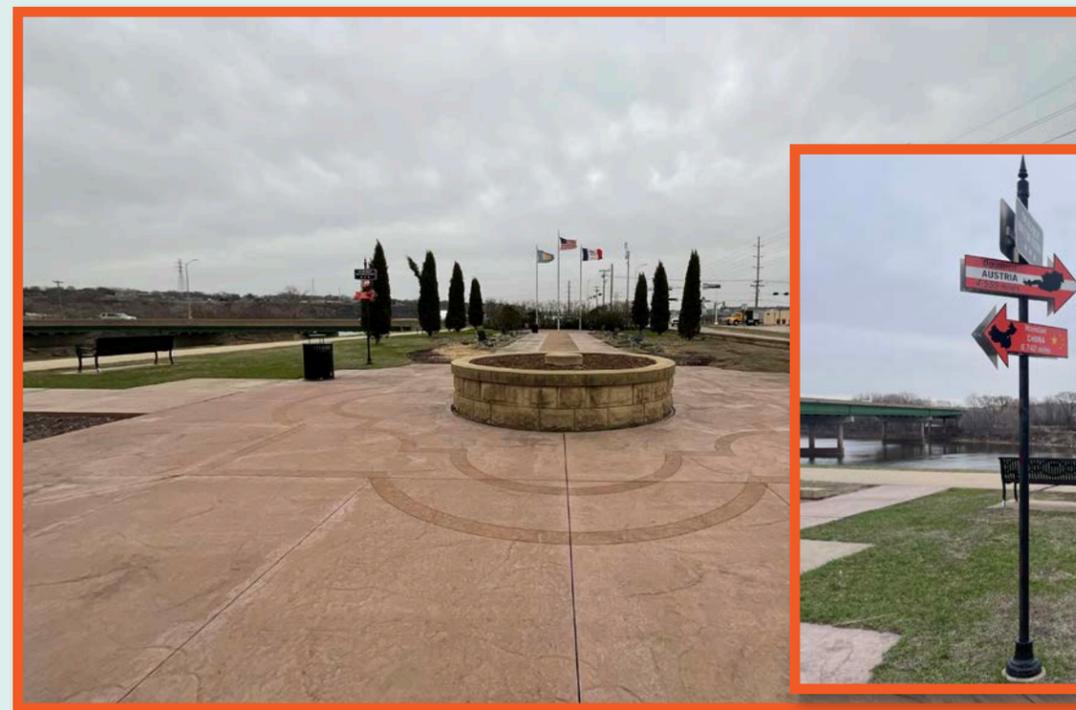
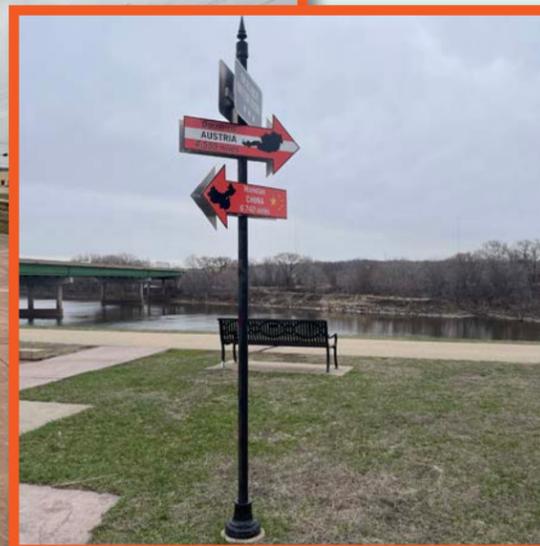
SOUTHERN PARK

Southern Park offers one small climbing structure surrounded by open green space. The equipment is very nice and appears new; however, the park almost feels out of place. There are only a few homes in the direct vicinity and no parking spaces to serve patrons. ADA access is also lacking to the site.

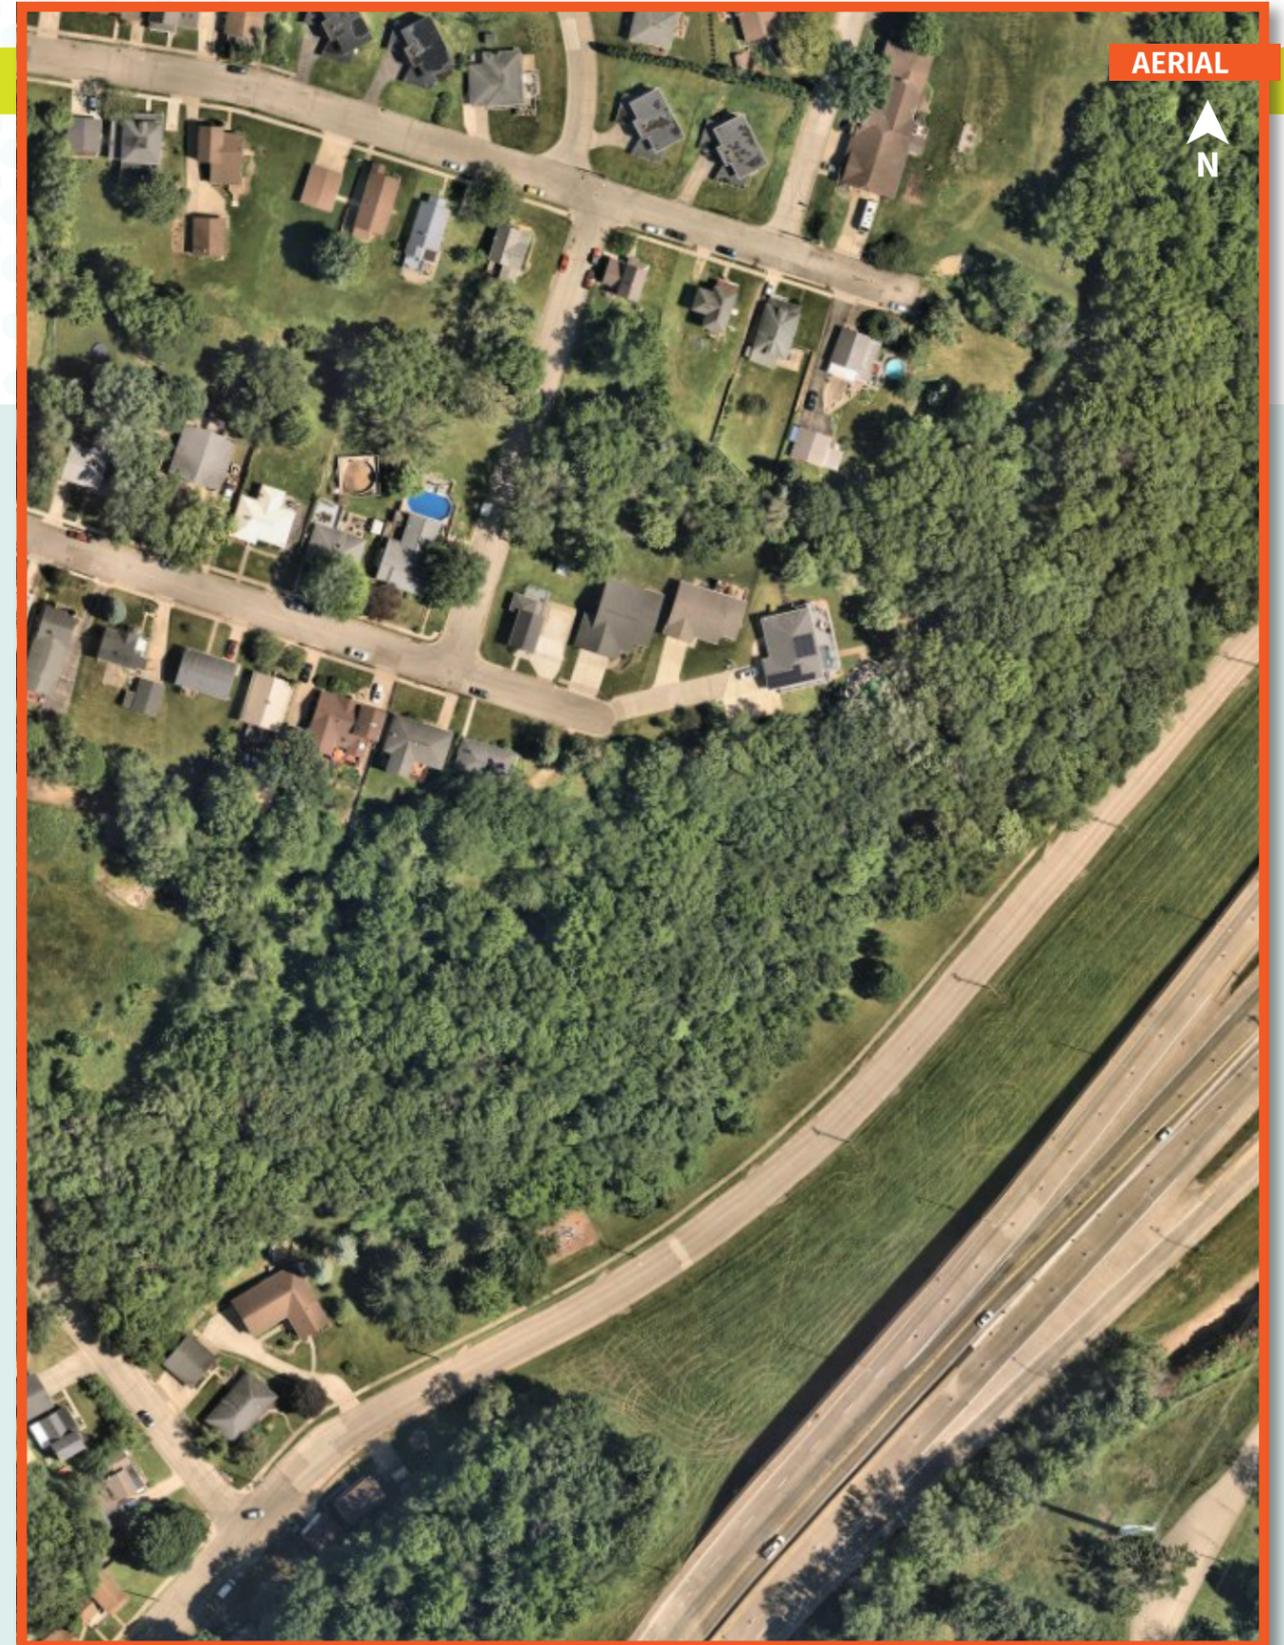
SOUTHERN PARK CONTINUED

AMENITY TYPE	QTY	GRADE	NOTES
Picnic Table (Wood)	1	3	
Playground	1	5	Great condition.
Playground Equipment (Large 5-12 Years)	1	5	1 rocker/2 balance beams.
Playground Equipment (Small)	3	5	Rocker / 2 Balance Beams
Playground Surfacing (Wood Mulch)	2,365 SF	1	Good condition overall, not ADA and wood chips need refreshed.
Sign (Traffic Style w/ Post)	3	4	Park information signs.
Trash plastic Roller Bin	1	4	Permanent post with City bin attached.

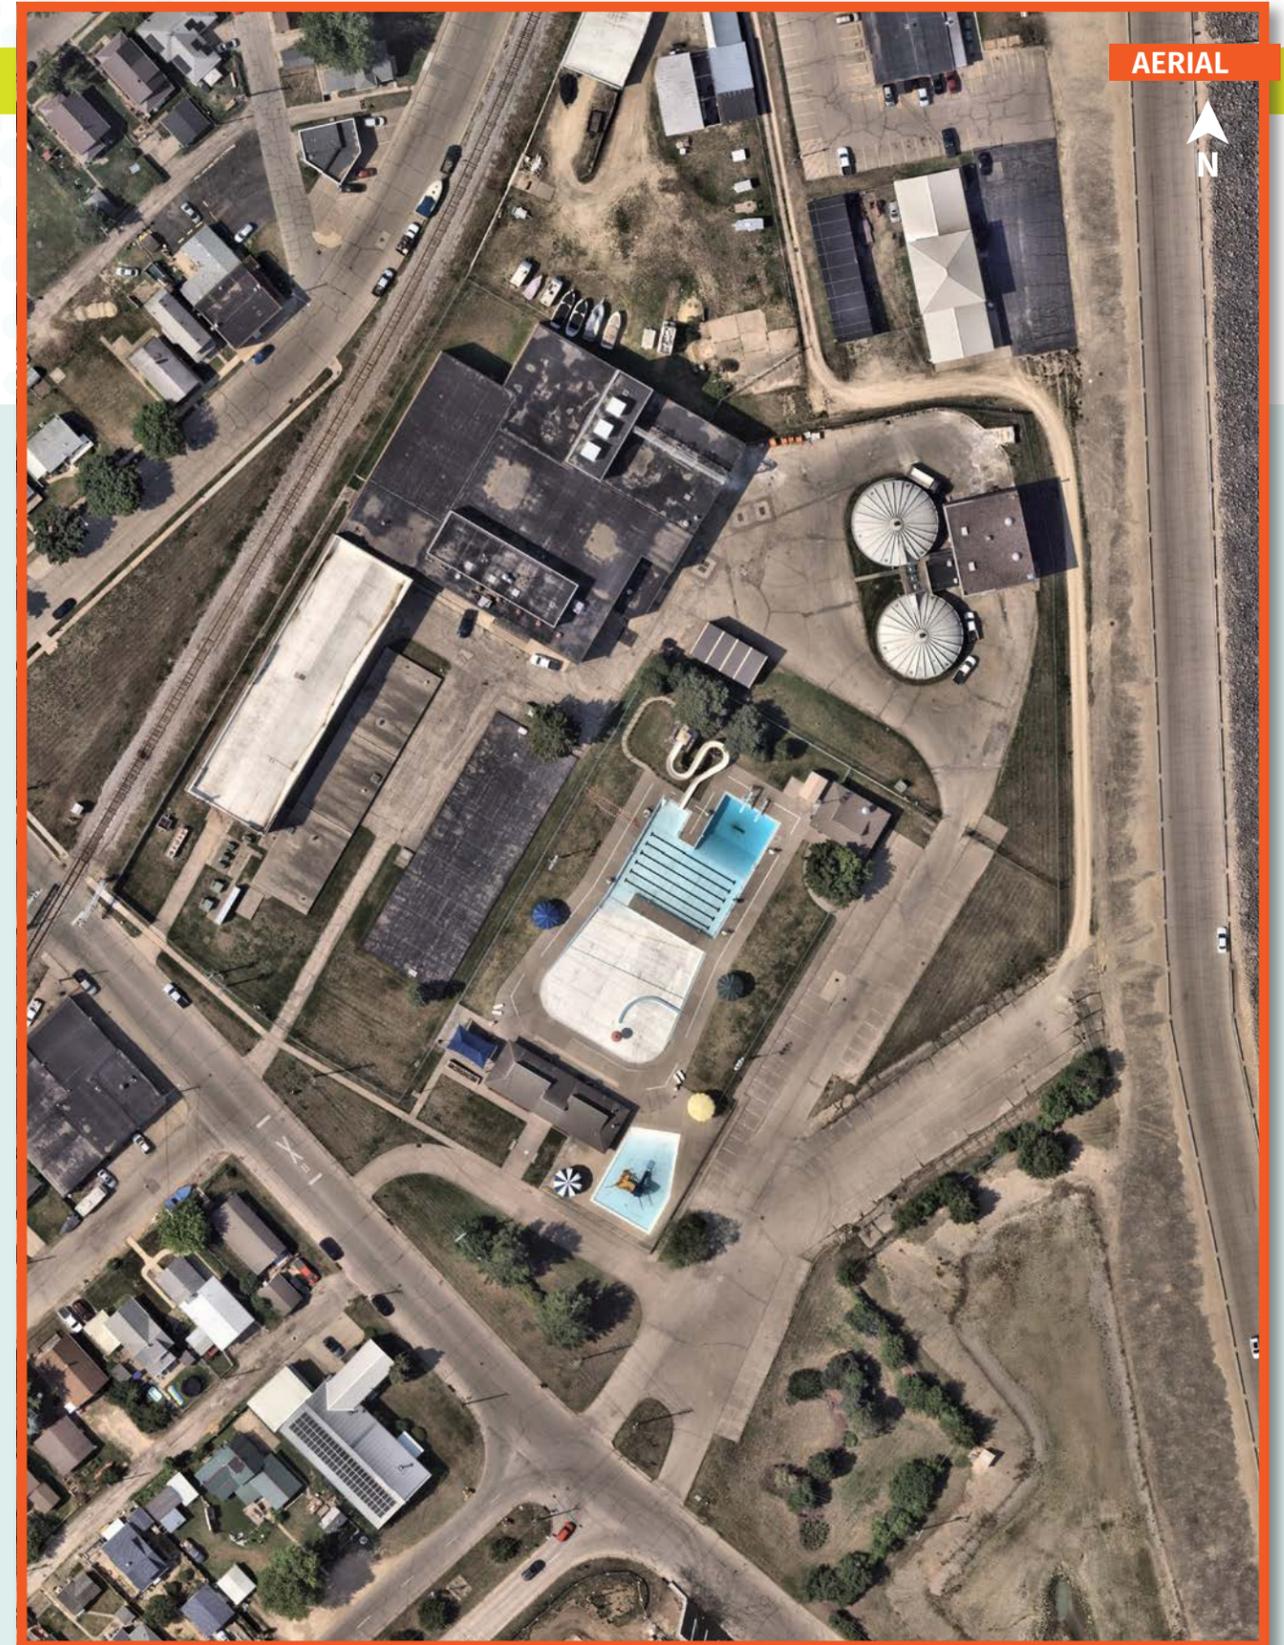
SUTTON POOL CONTINUED

AMENITY TYPE	QTY	GRADE	NOTES
Aquatic Center (Pool)	38,750 SF	2	Some rusting and wear on pool surface, splash pad equipment looks solid. Pool slides inoperable.
Aquatic Slide Tower	1	1	Rusty stairs, railing. Slide was not operational at time of inventory, potential safety concern.
Bench (Stone)	2	3	Decent condition, ADA accessible.
Bench (Metal)	1	3	
Drinking Fountain - 1 Bubbler	1	3	Decent condition, works.
Maintenance	1,810 SF	3	Houses pool equipment, looks decent.
Other	530 SF	3	Fabric Shade Structure
Other	3	3	Umbrella-style shade structure. Slightly rusted. Good condition.
Parking - Concrete	15,550	2	
Picnic Table (Metal)	6	4	Looks new, great condition.
Picnic Table (Wood)	1	3	Lifeguard station, decent condition.
Pool Building (Locker Rooms, Concessions, Etc)	3,325 SF	2	
Restroom	2	3	Dated, but all looks decent. New paint as well.
Sidewalk - concrete	4,500 SF	3	
Sign (Traffic Style with Post)	2	3	Pool signs, decent condition.

Storage Shed	300 SF	3	In Maint. Area, Houses pool Equipment
Trash Plastic Roller Bin	3	3	Average wear present, decent condition.

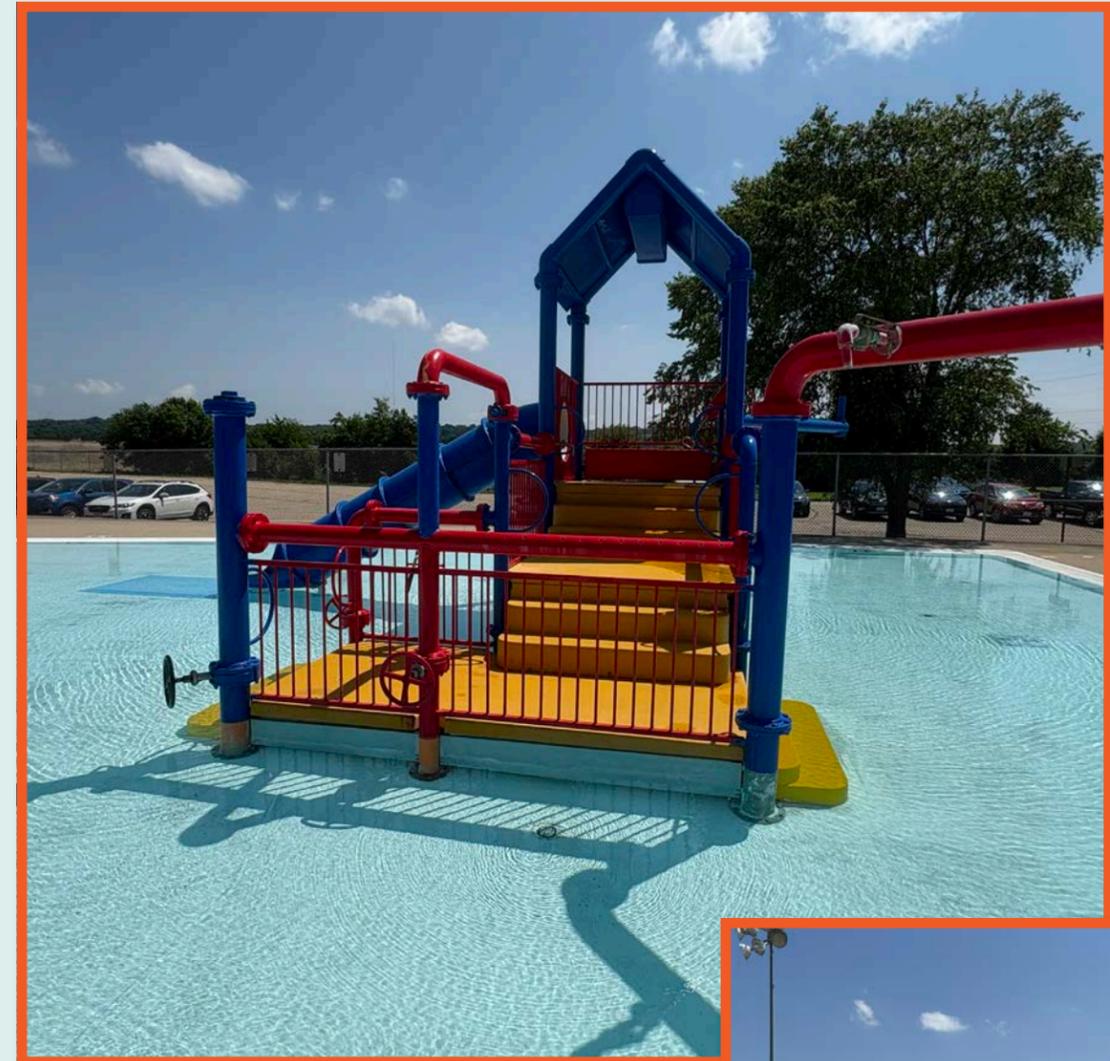
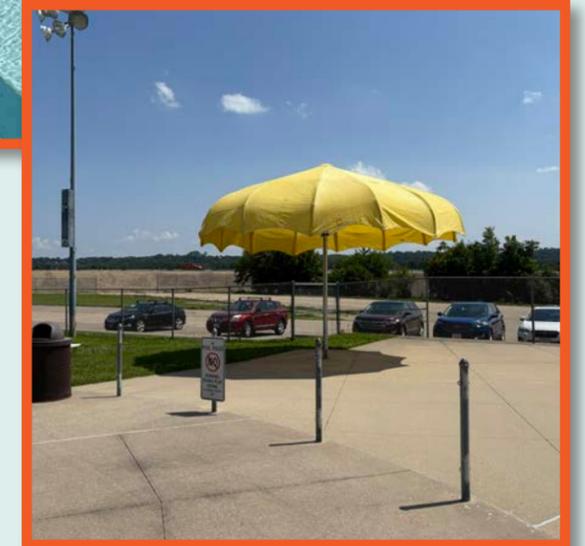
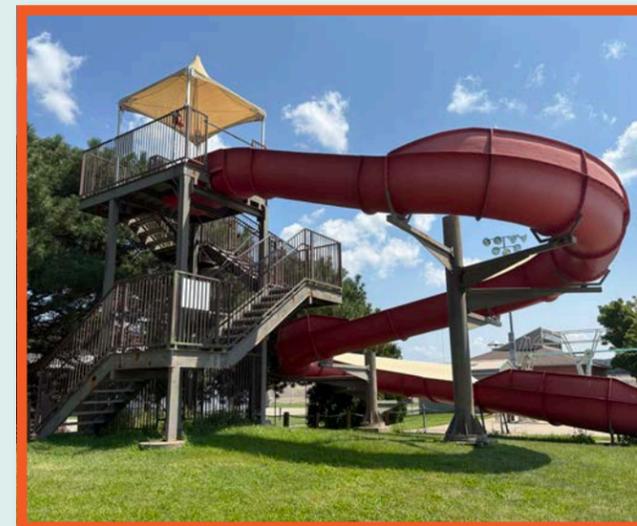
TEDDY BEAR PARK

Teddy Bear Park features playground equipment, including swings and sand diggers. The playground equipment exhibits fading paint and rust. Mulch is overgrown with grass and weeds in some areas, and the playground lacks ADA access. The park is very open with plenty of green space for patrons to run and play. Although there is no dedicated parking lot, street parking is possible, allowing this park to serve more than just the immediate neighborhood.

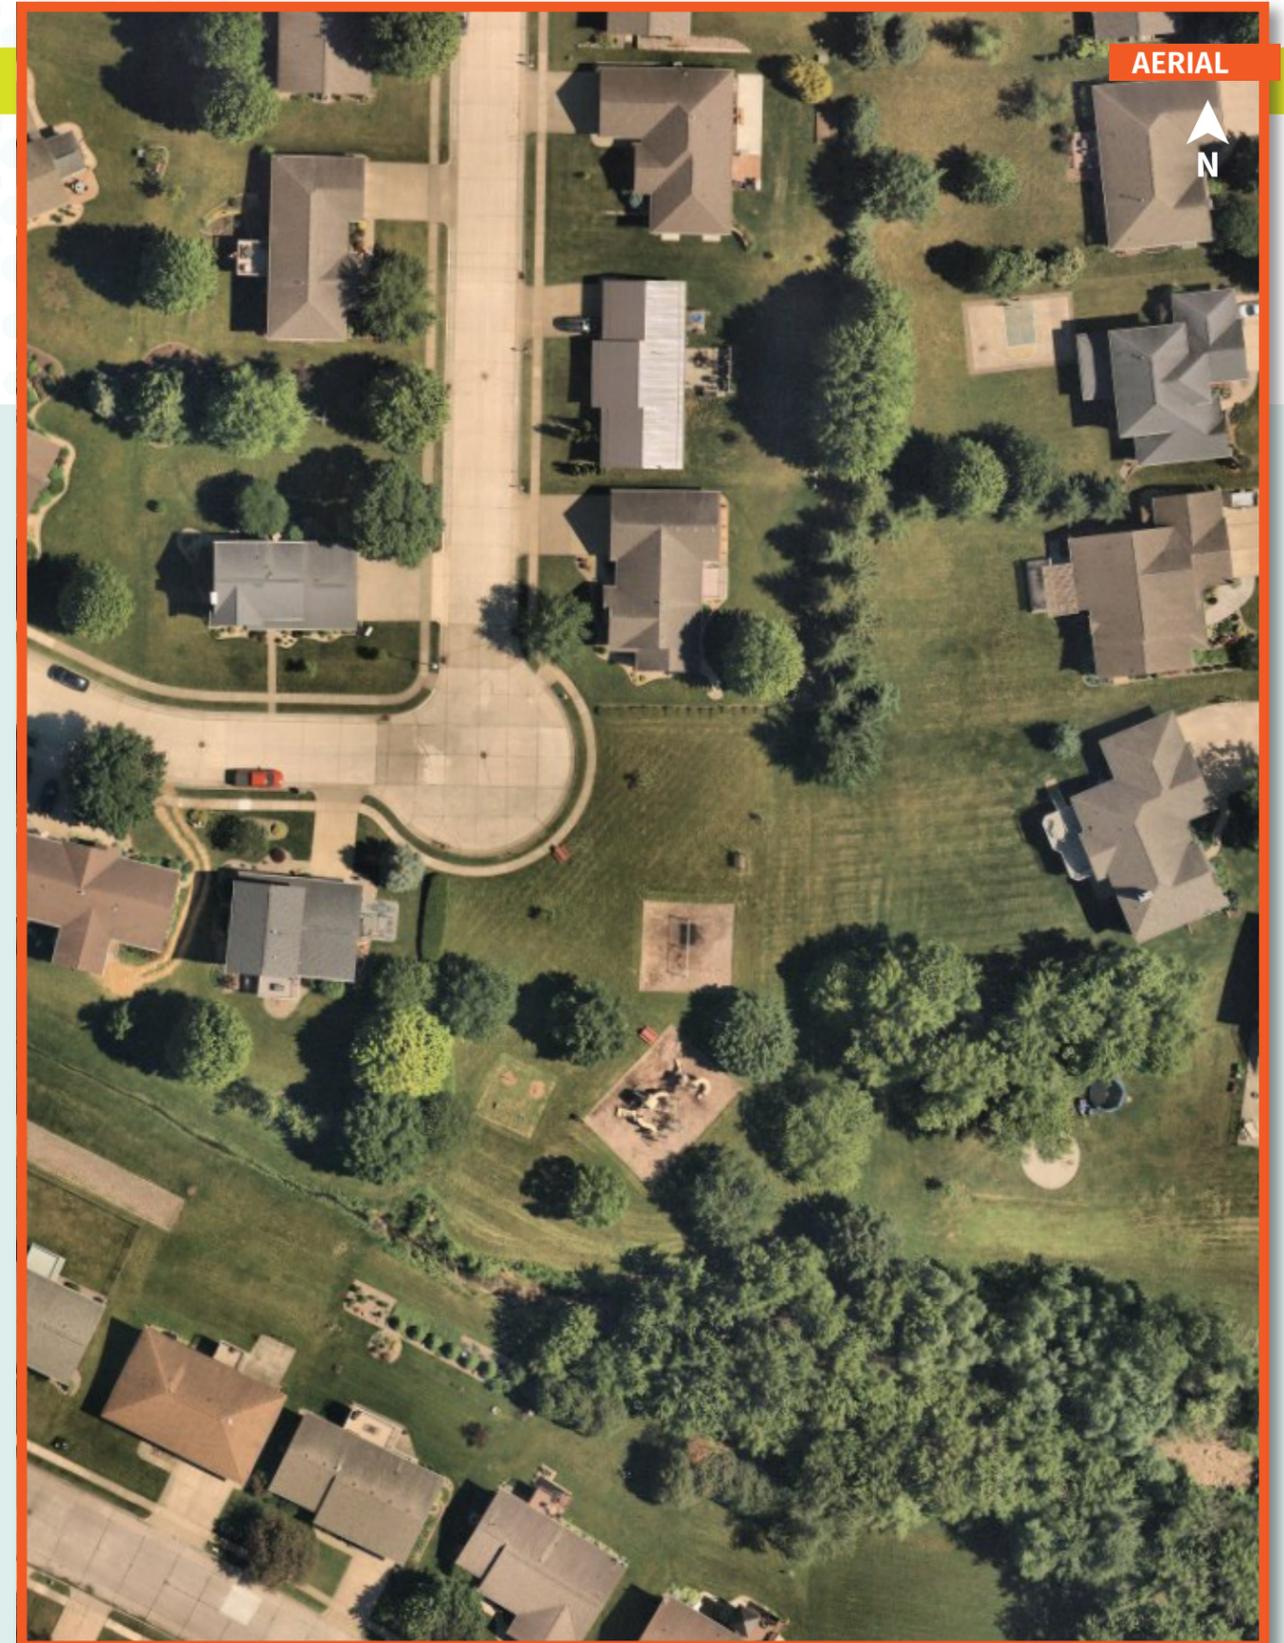
TEDDY BEAR PARK CONTINUED

AMENITY TYPE	QTY	GRADE	NOTES
Bench (Memorial)	1	3	Stone bench.
Picnic Table (Wood)	2	3	
Playground Equipment (Large 5-12 Years)	1	2	Paint is faded and starting to chip away. Rust prevalent, no ADA access.
Playground Surface (Mulch)	3,475 SF	2	Mulch does not appear to be to depth, needs refreshed.
Playground Equipment (Small)	4	2	2 spring rockers/2 diggers. All elements show signs of rust and weathering. Mulch and sand need refreshed in these areas.
Playground Equipment (Swings 2 - Bay)	1	3	
Sign (Monumentation)	1	1	Existing wooden sign is at the end of its lifecycle, needs updated with City's current Monumentation standard.
Sign (Traffic style with Post)	3	3	Park hours and info sign, good condition.
Swings (2 Bay)	1	3	
Trash Plastic Roller Bin	1	3

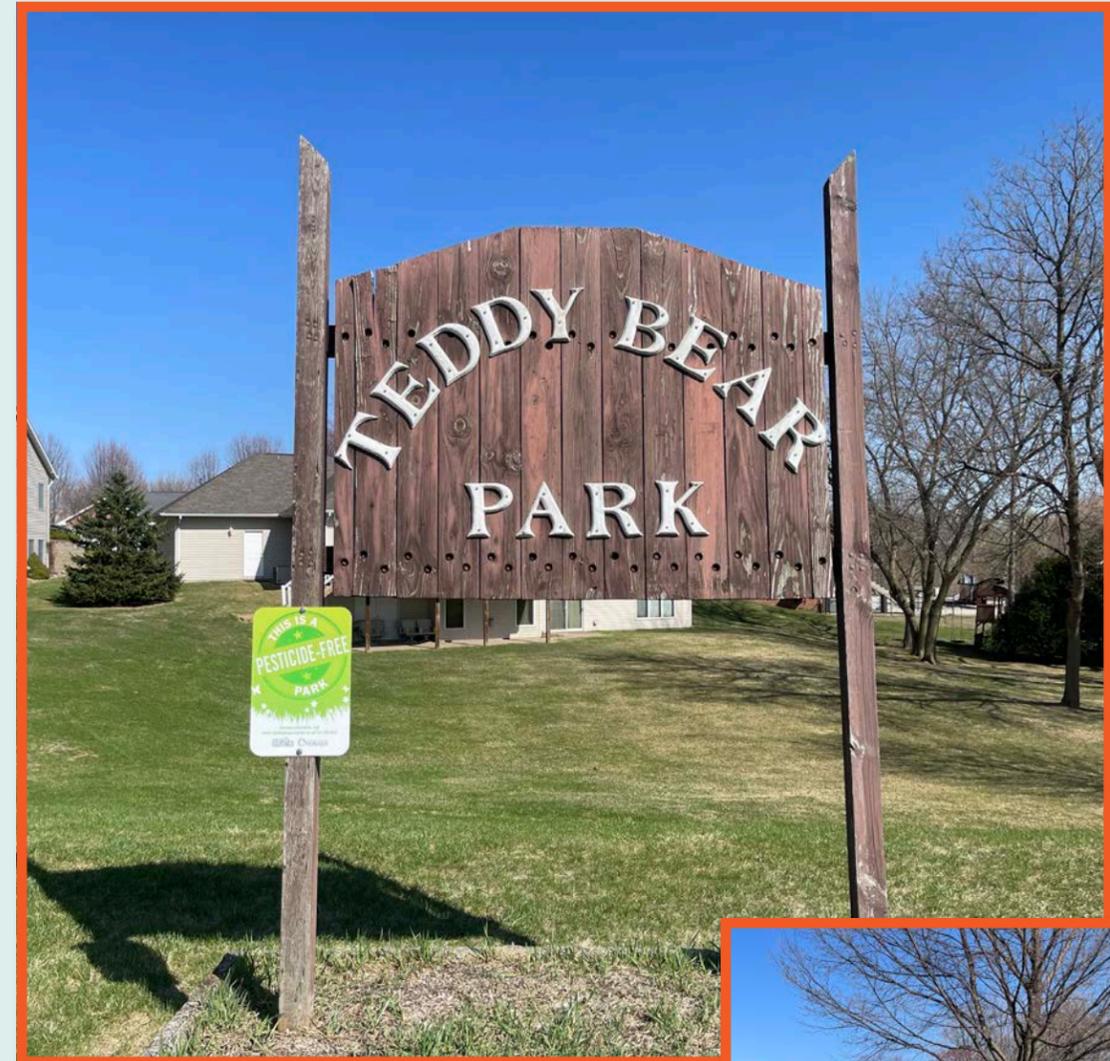
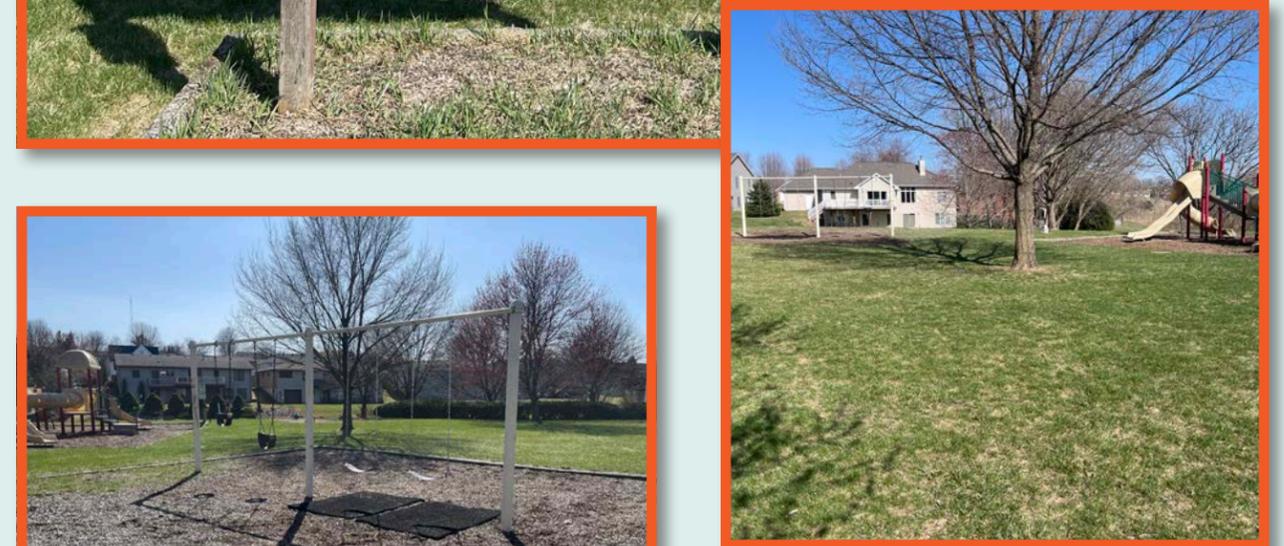
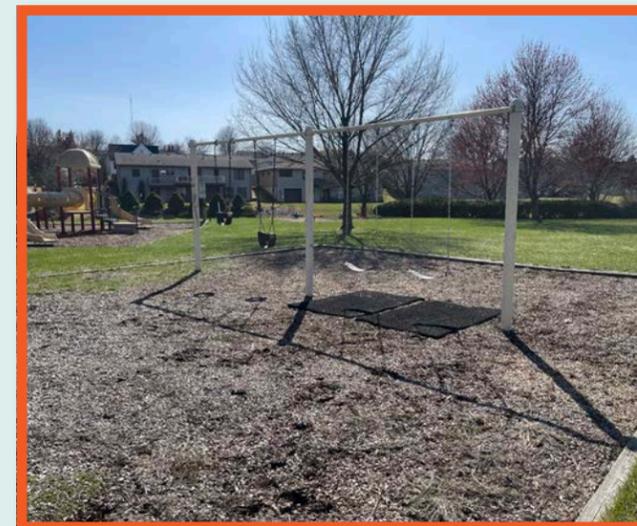
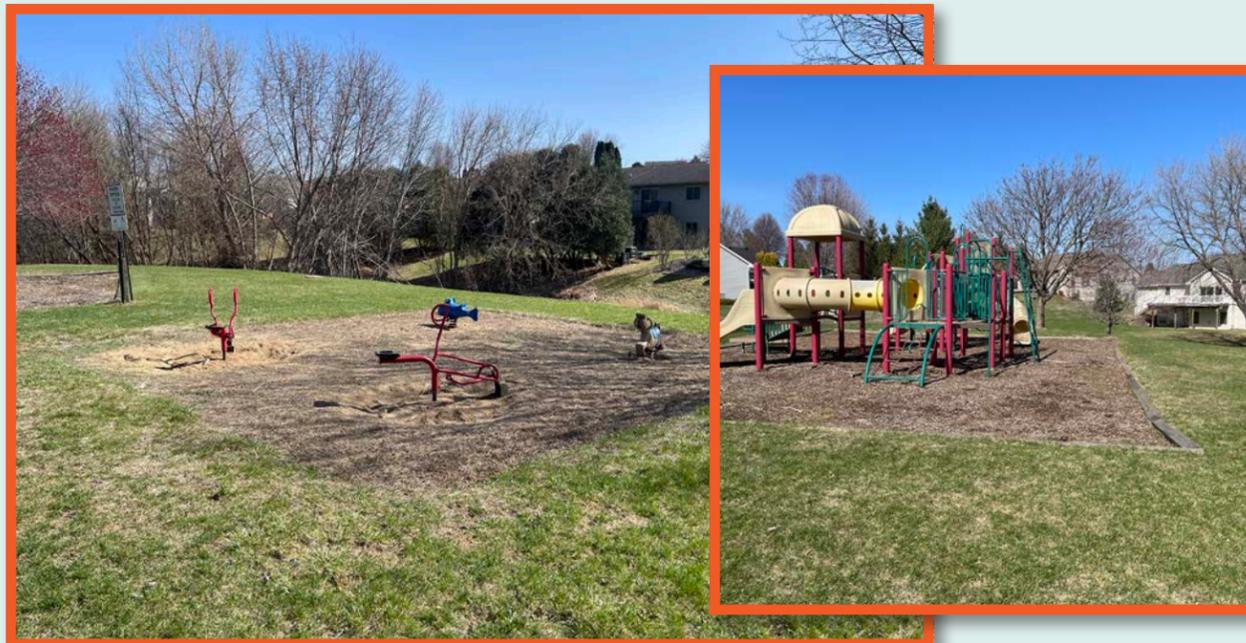
Usha Park is a fairly large park but offers very limited amenities. There is only one large play structure and one artificial turf cricket pitch. The playground is so disconnected from the parking lot that it does not feel like its a part of the park. ADA access is nonexistent. The park is ripe with opportunities but it feels desolate as it stands today.

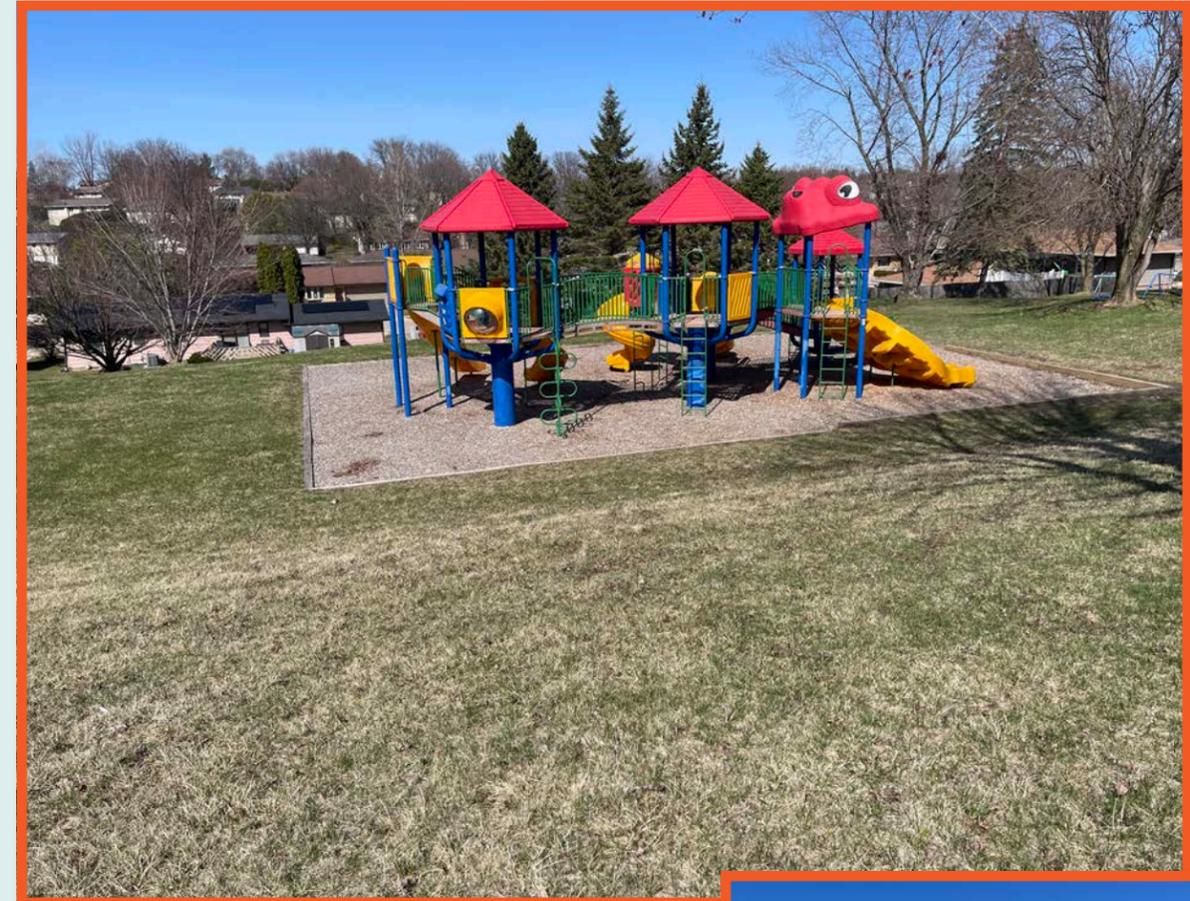
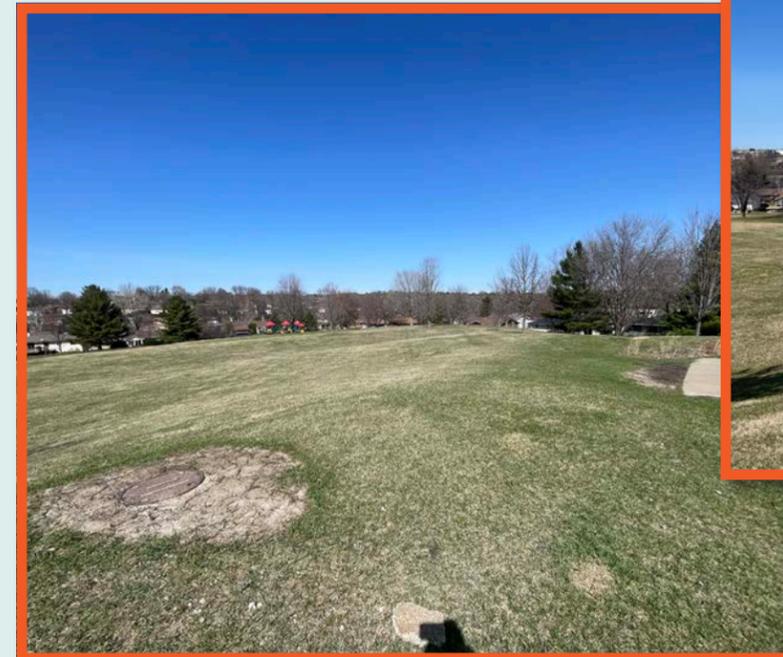
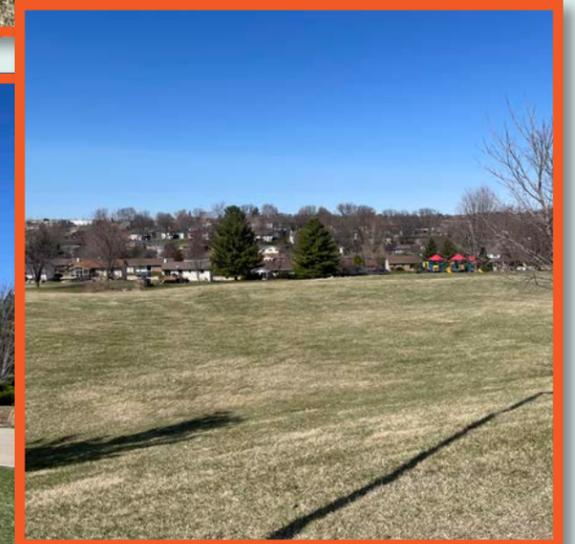
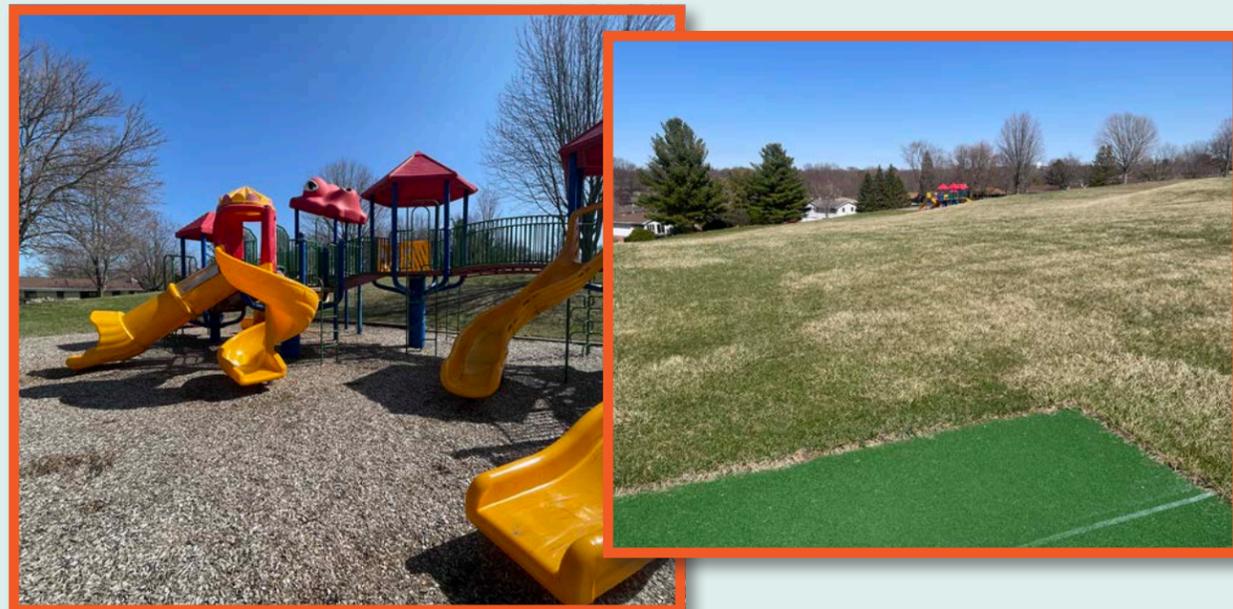
VALENTINE PARK

Valentine Park contains amenities such as picnic tables, restrooms, playgrounds, a basketball court, and a baseball field. While restrooms and some picnic tables appear in good condition, playground structures show rusting, chipped paint, and insufficient wood fiber. The basketball court has cracked asphalt and fading striping. The baseball field seems to be in decent condition, complete with fencing and dugouts, although there is no access to get there. The parking lot is large, allowing the greater southern Dubuque area to travel here instead of just the surrounding neighborhood.

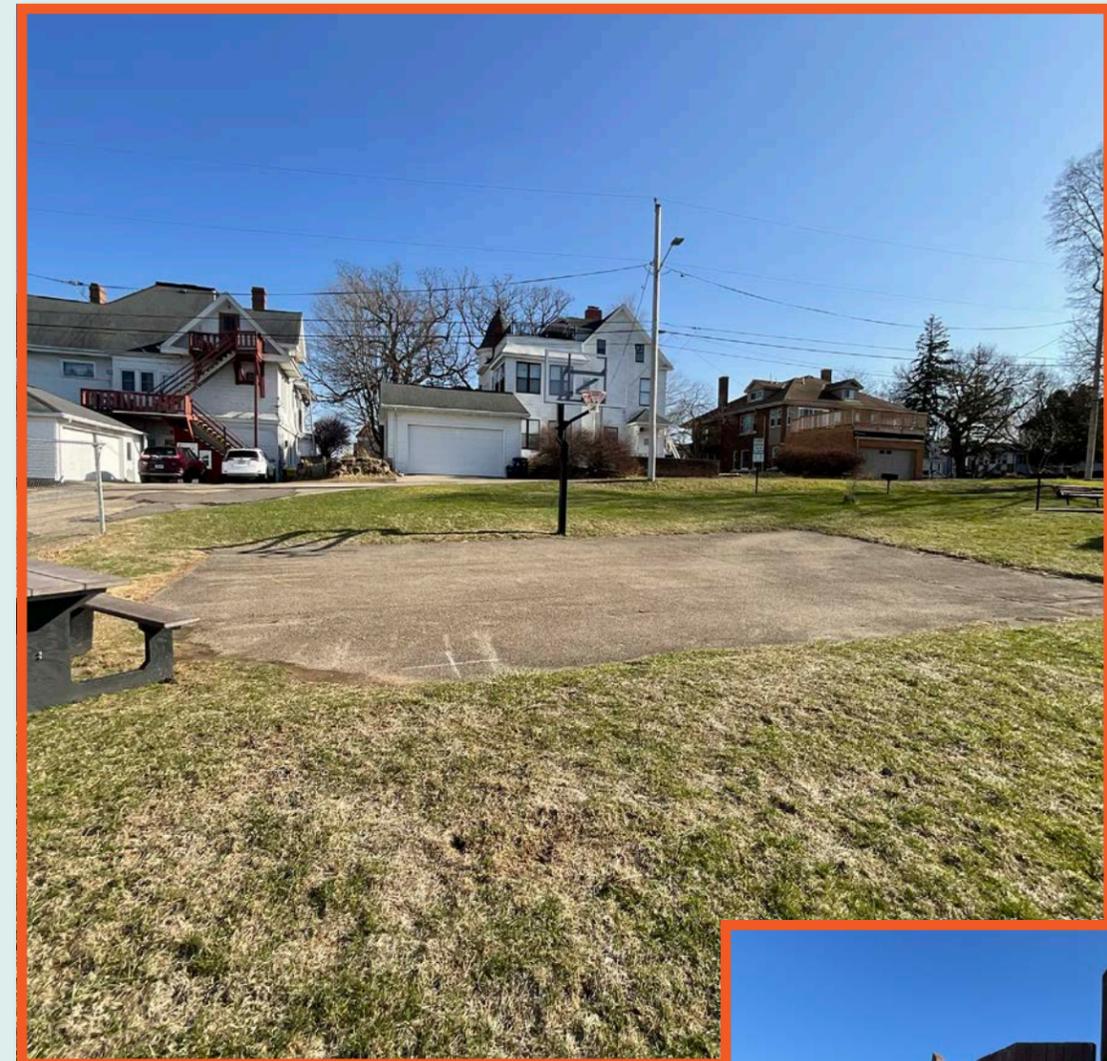
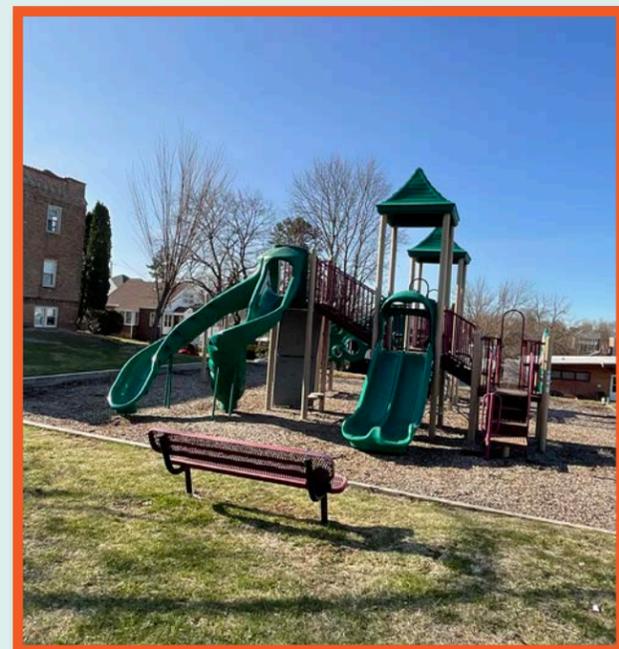
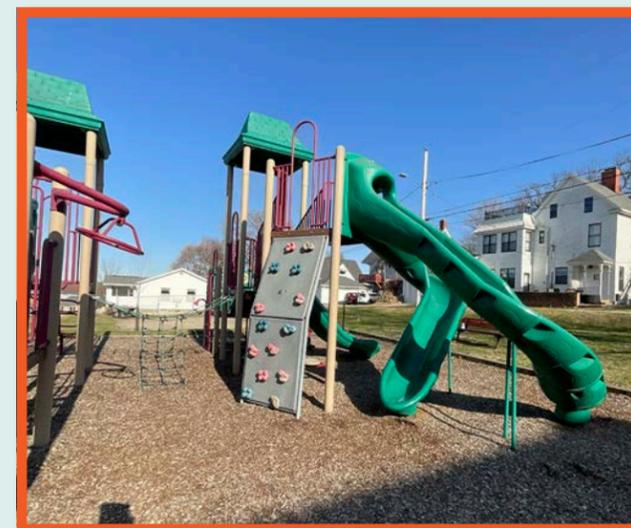
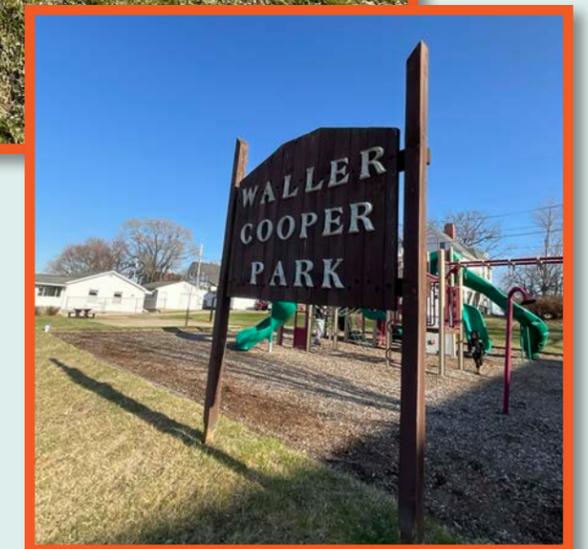
WASHINGTON PARK

Washington Park is a very nice park in Central Dubuque. The park provides nice walking paths to all the afforded amenities and is shaded from large mature trees. The walking path allows for pleasant viewsheds directed towards some of Dubuque's more historical architecture and has a very open and enjoyable environment.

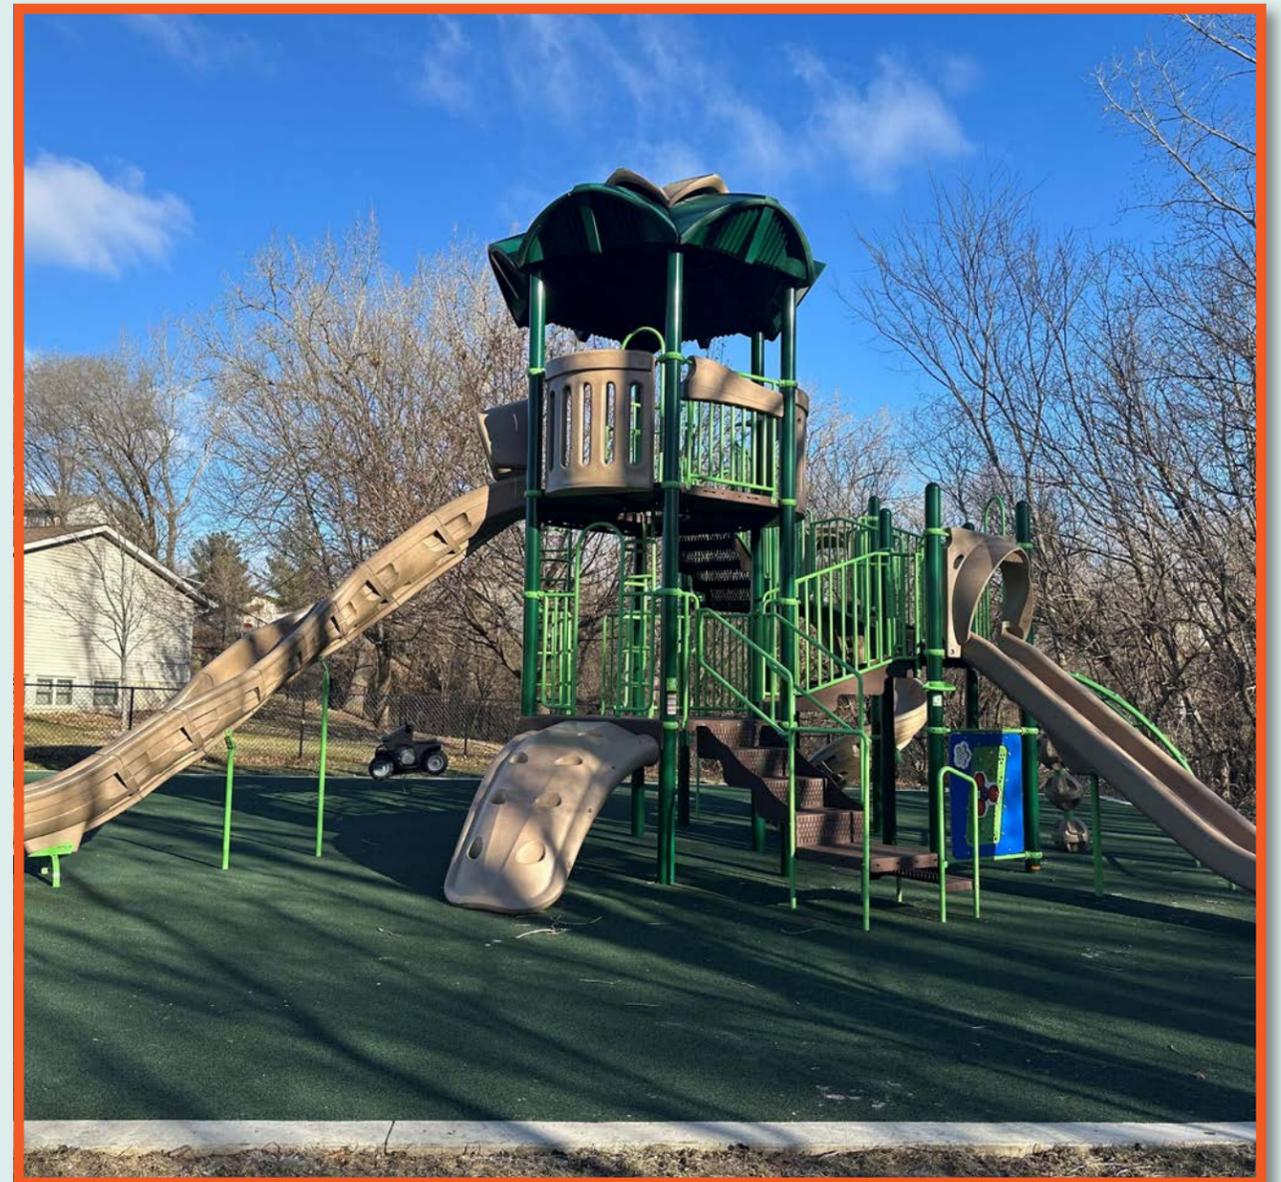
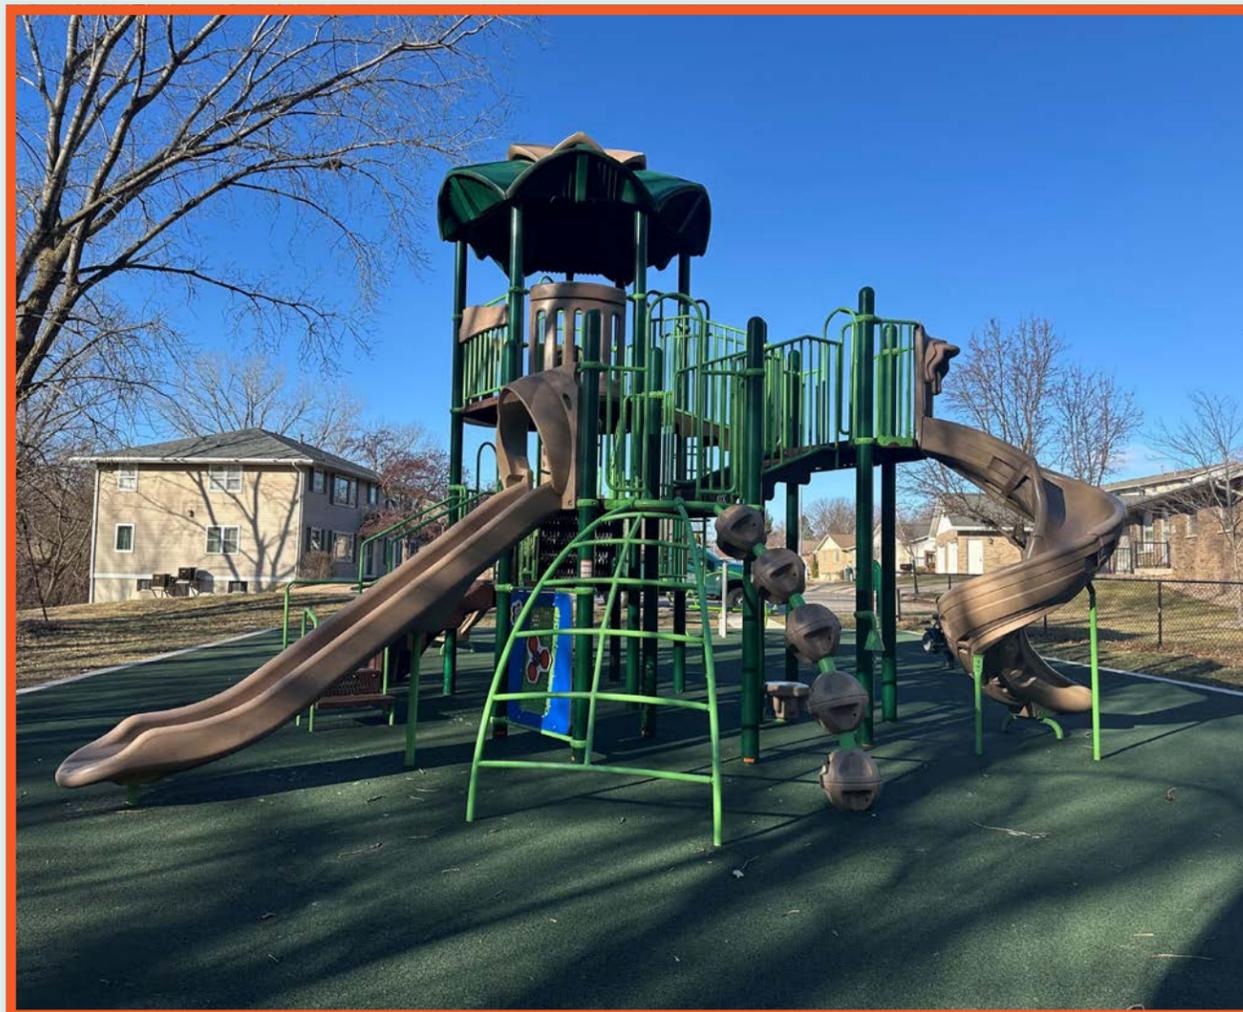
WESTBROOK PARK

Westbrook Park features a playground, bench swings, picnic tables, bike racks, and trash receptacles. The playground and bench swings are brand new. Picnic tables and bike racks are also new and in excellent condition. The park is beautiful and accessible.
