Appendix A

Park Inventory and Assessment Report

Dubuque
Parks and Recreation
Comprehensive Plan

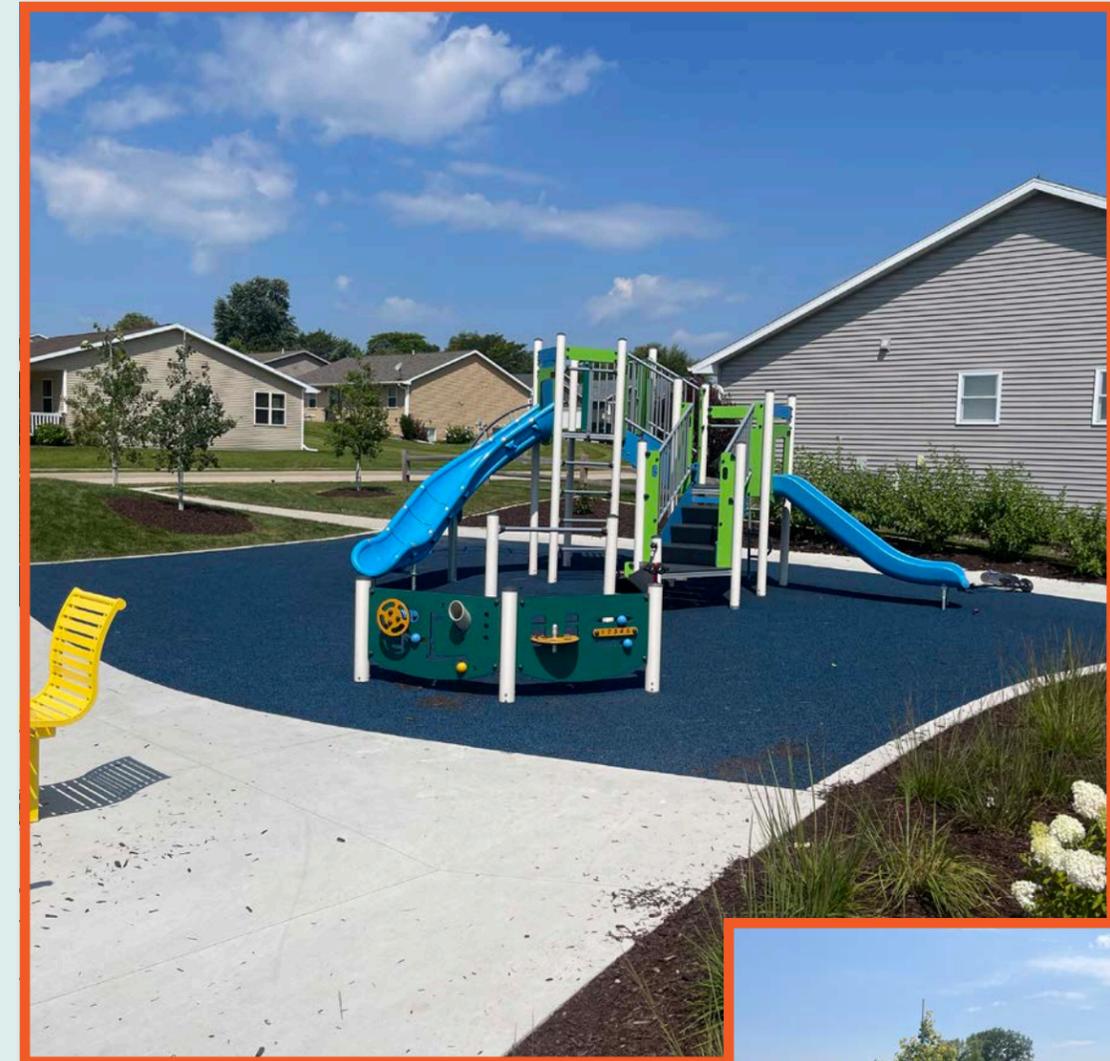
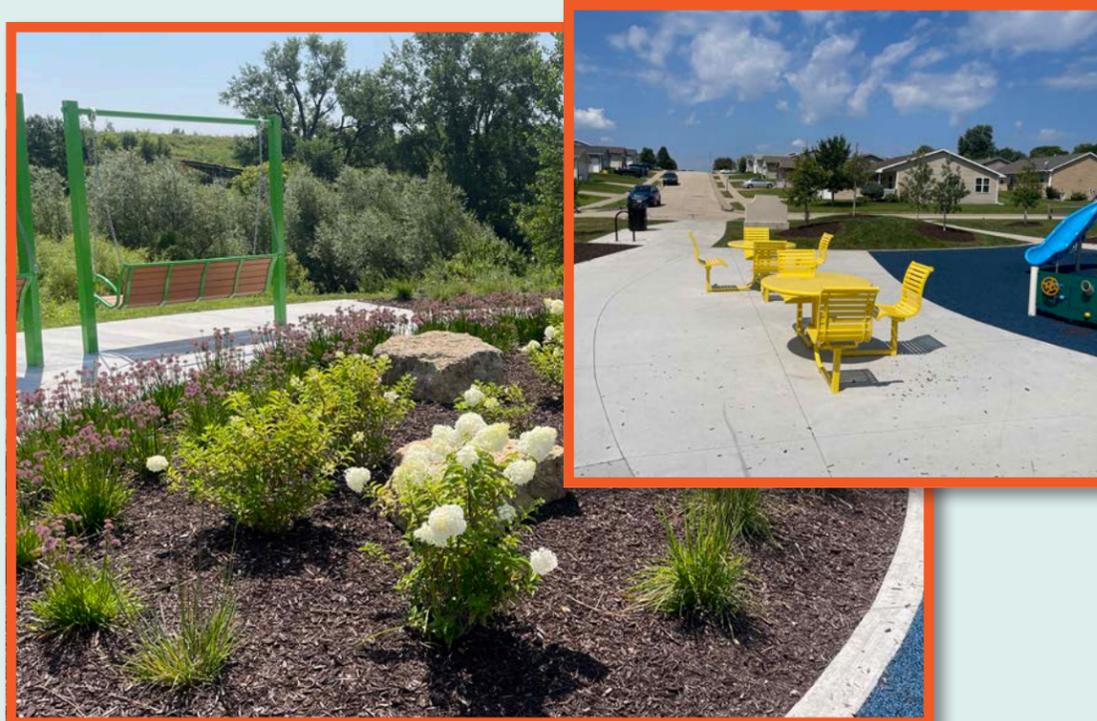
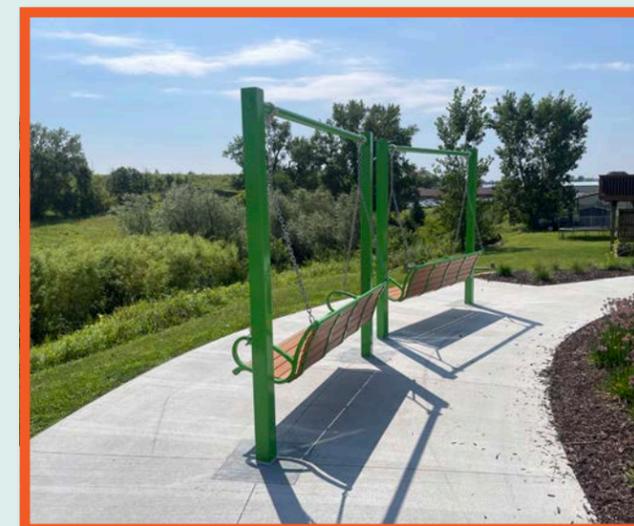
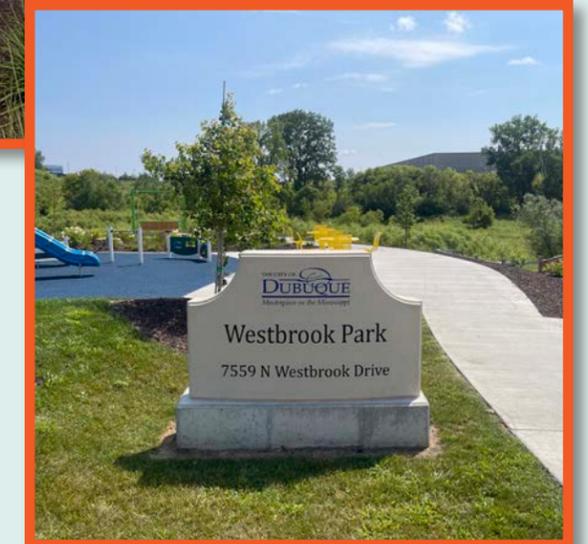
WESTBROOK PARK CONTINUED

Westbrook Park features a playground, bench swings, picnic tables, bike racks, and trash receptacles. The playground and bench swings are brand new. Picnic tables and bike racks are also new and in excellent condition. The park is beautiful and accessible.

AMENITY TYPE	QTY	GRADE	NOTES
Bike Rack	1	5	
Picnic Table (Metal)	2	5	
Playground Equipment (Large 5-12 Years)	1	5	
Playground Equipment (Small)	1	5	Sensory wall.
Playground Surfacing (Pour-in-Place Rubber)	1,100 SF	5	
Playground Curb Turndown	130 LF	5	
Sidewalk (Plain Grey)	2,135 SF	5	
Sign (Monumentation)	1	5	
Swing Benches	2	5	
Trashcan - Metal	1	5	
Wooden Split rail Fence - 24" Ht.	400 LF	5
